May 2014

Chinook Energy Inc.

Gwich'in Reclamation Program

C-36

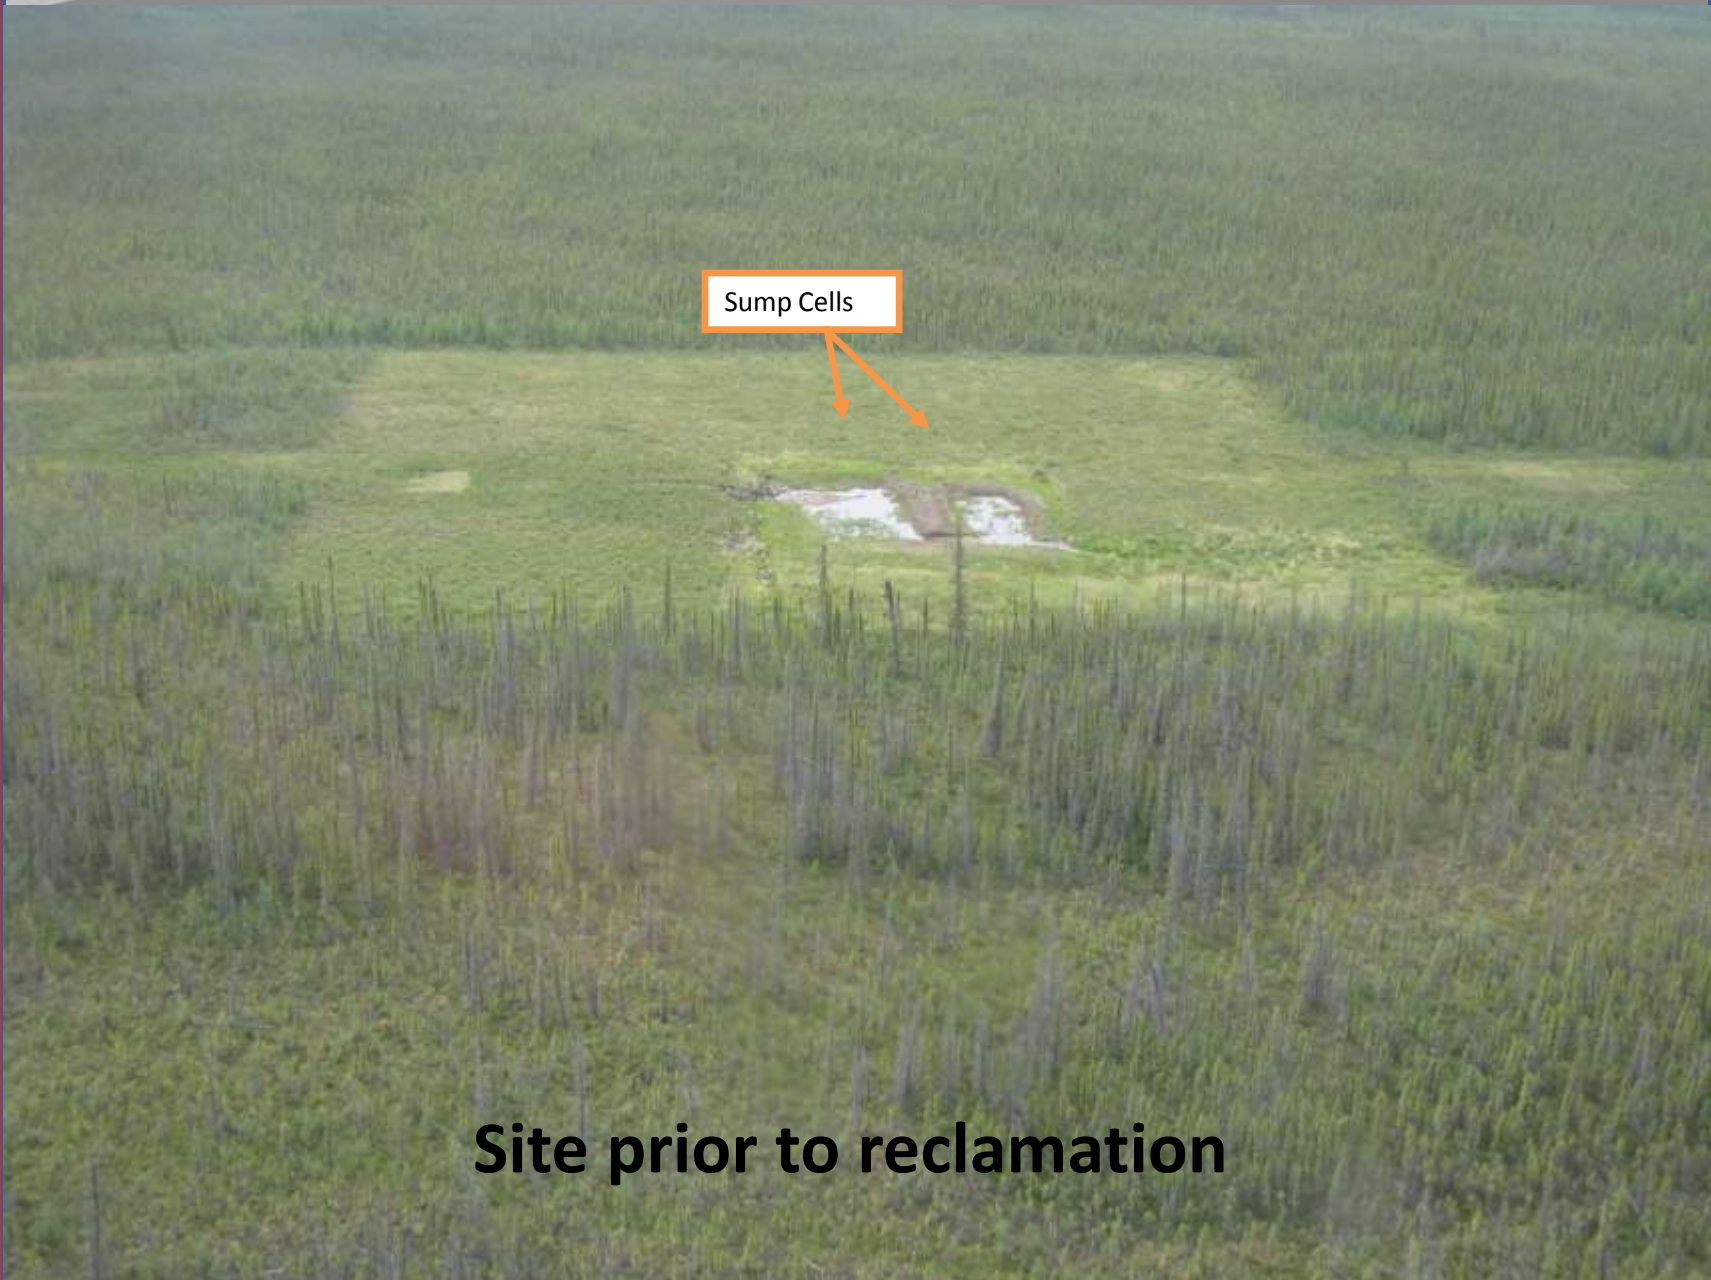
Site prior to reclamation

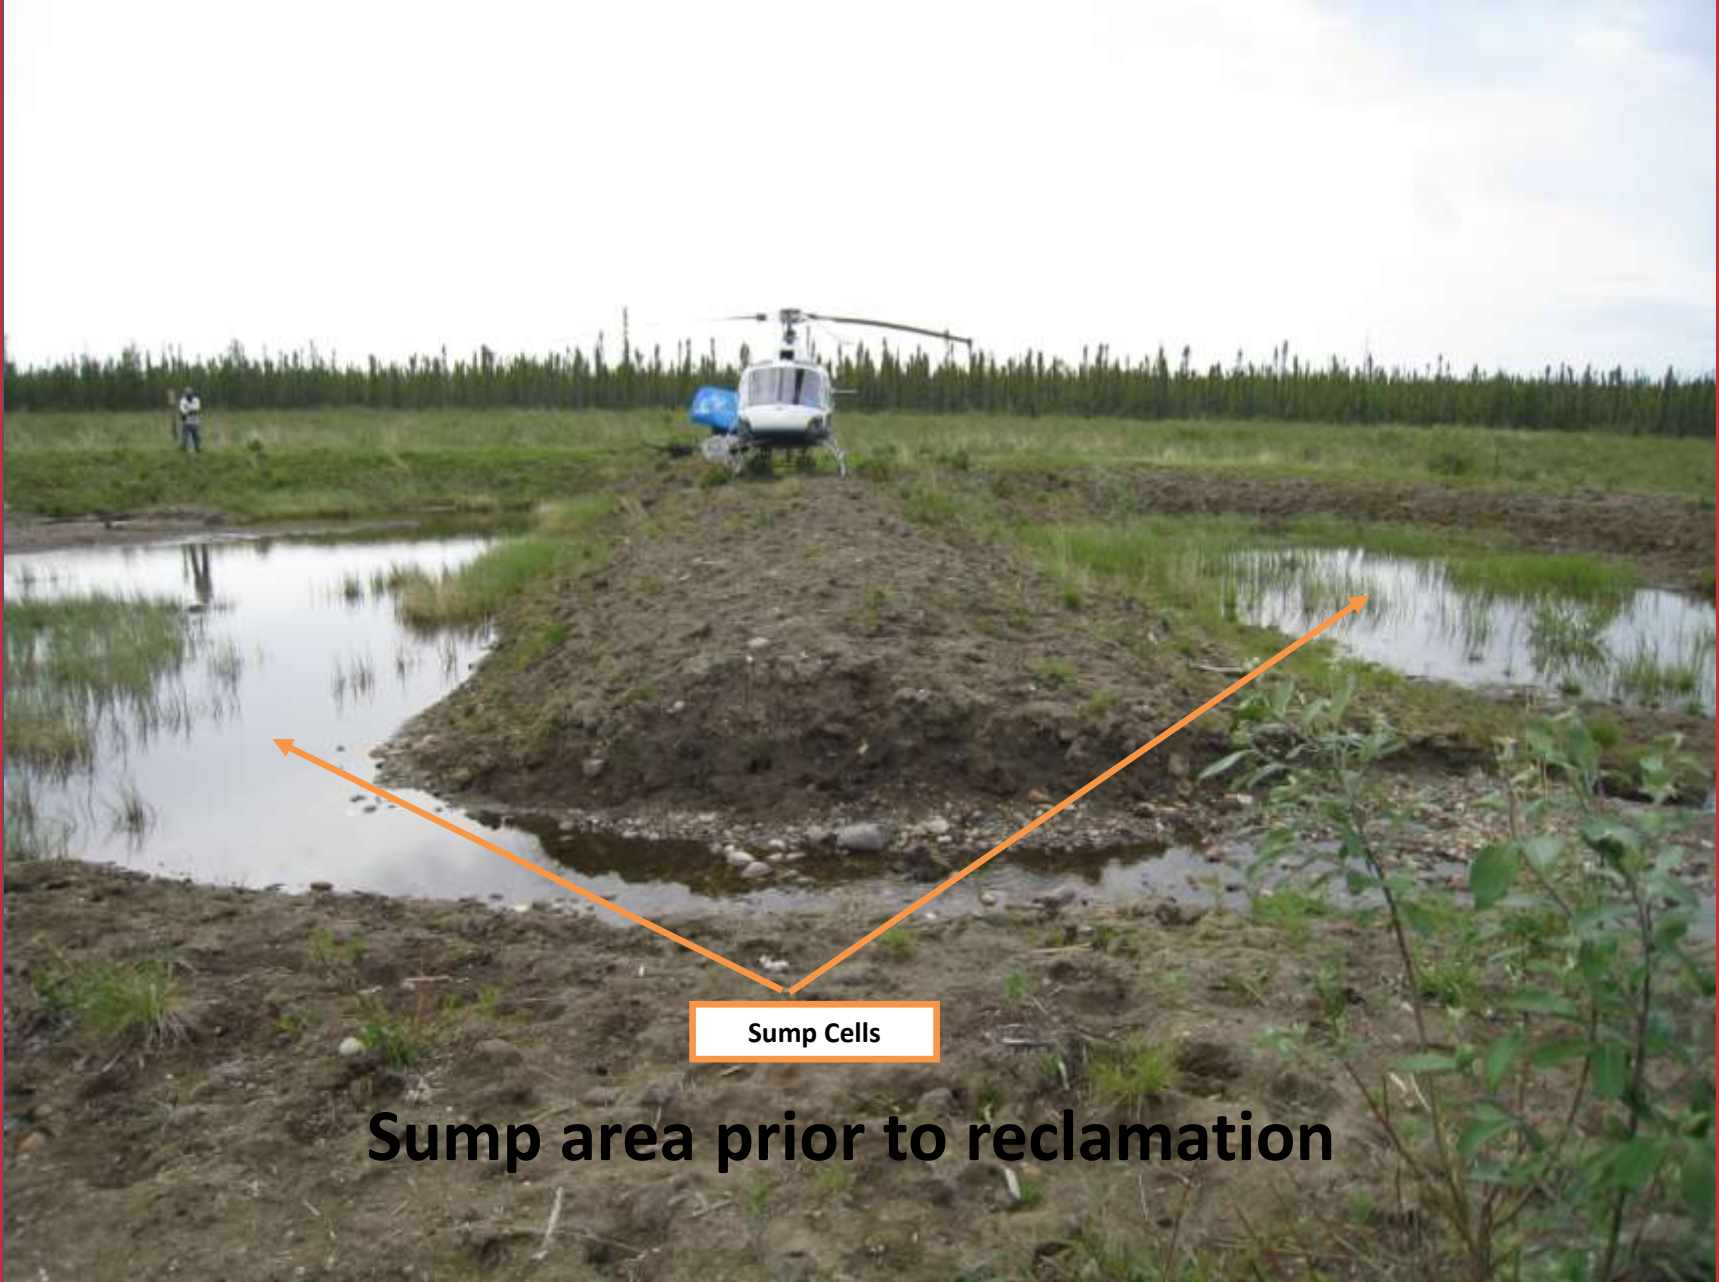
Sump Cells

Sump area prior to reclamation

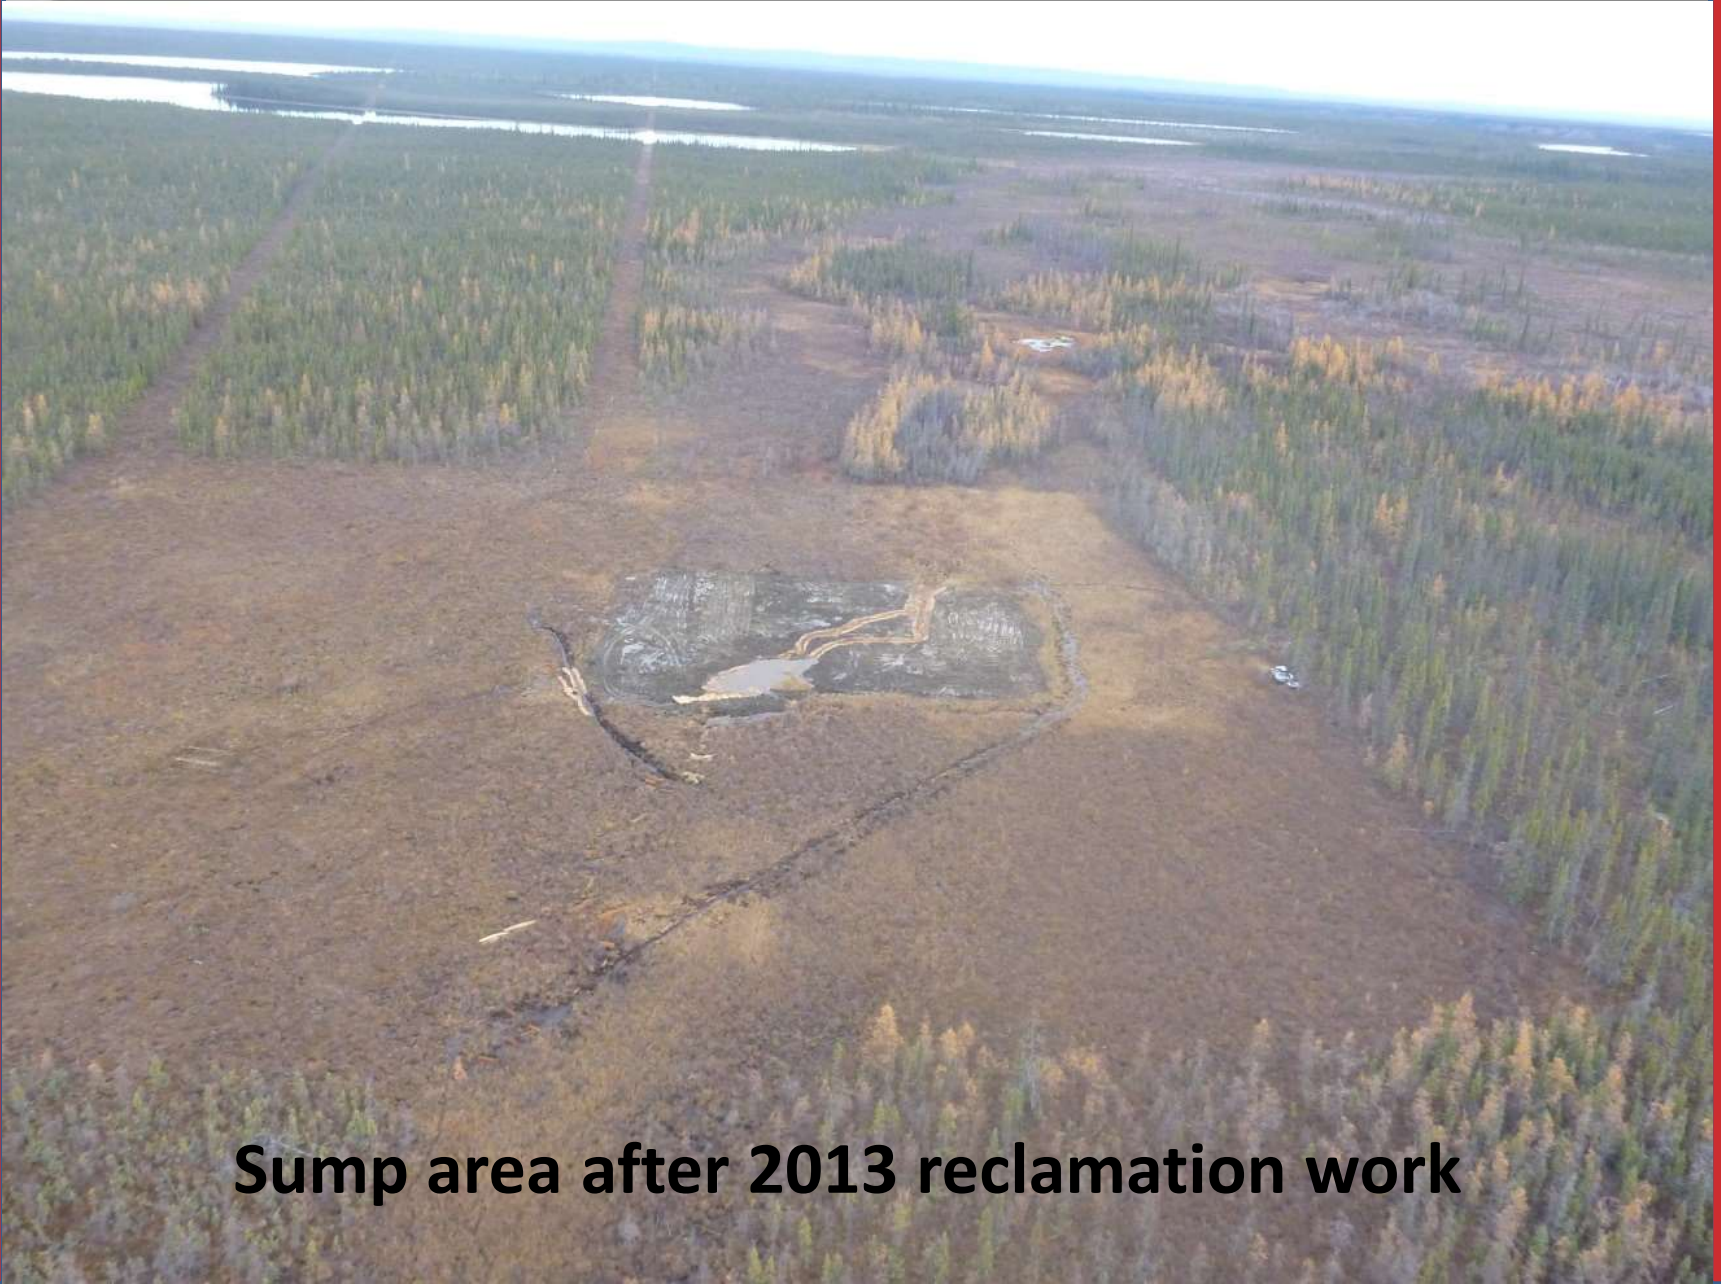
Sump area after 2013 reclamation work

- Pump out water was done daily as water was not standing but flowing.
- Approximately 30 loads of cement from D-07 site were used as the base layer of fill in the sump.
- Attempts to re-direct drainage were unsuccessful.
- Partially re-graded the sump using the soil material contained in the berms.
- Installed erosion control measures to minimize erosion from flowing water.
- Seeded the re-graded areas.

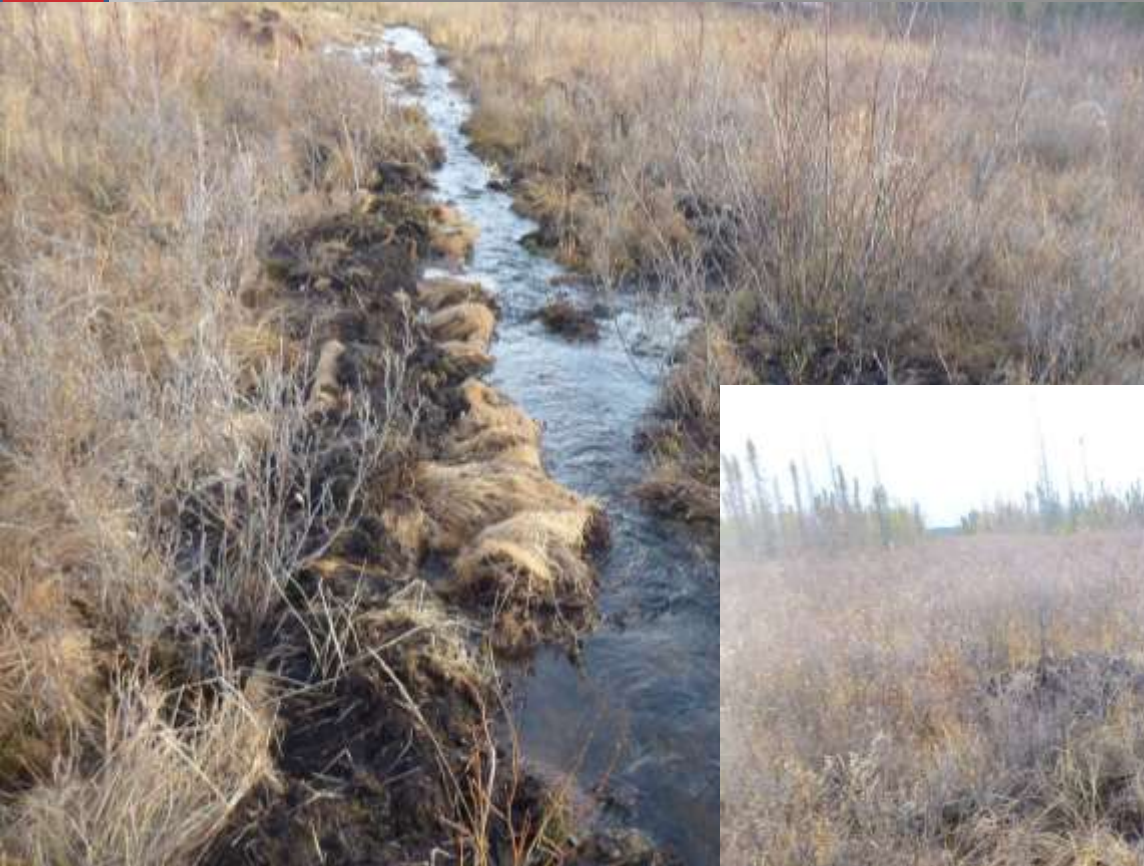
Flowing water through the site

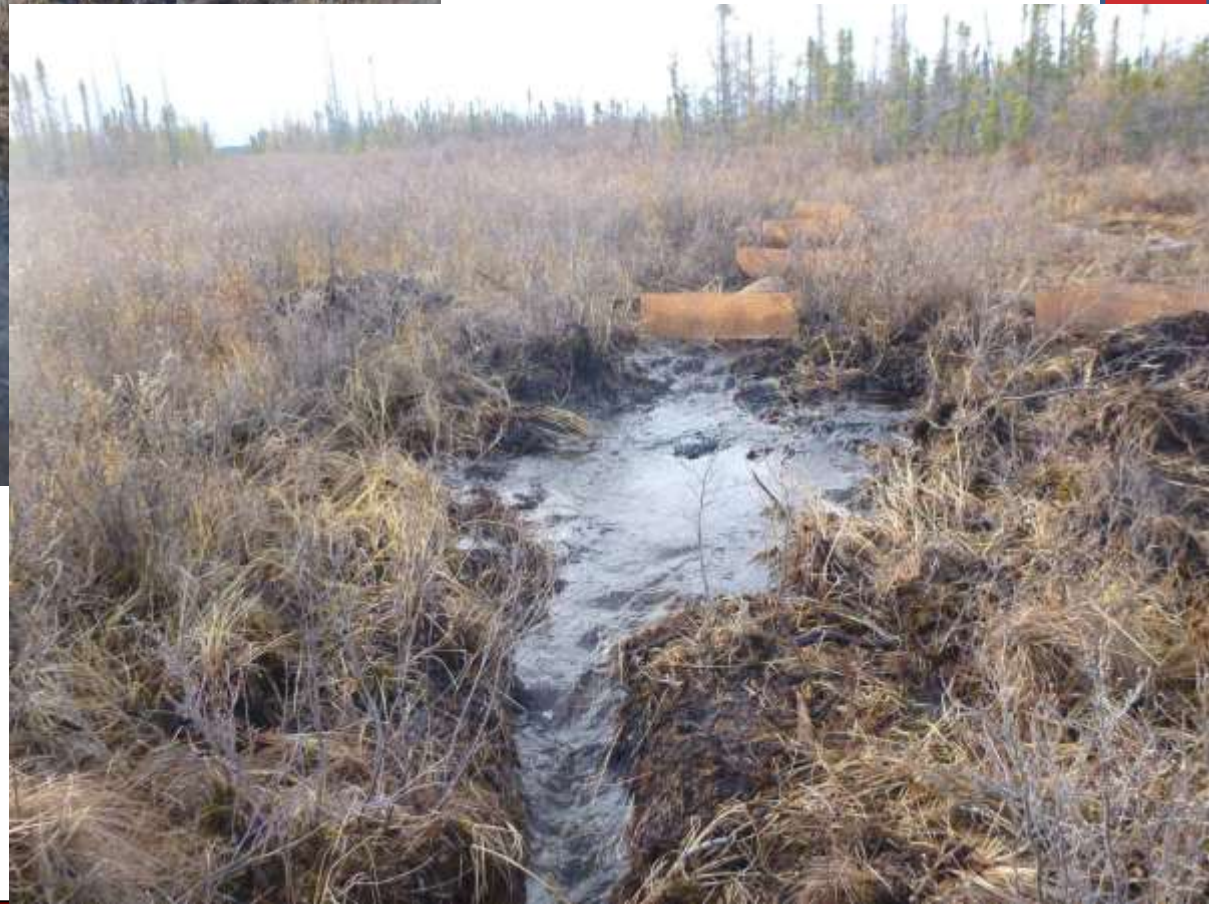
View of trenching in attempt to divert surficial flow from the sump area

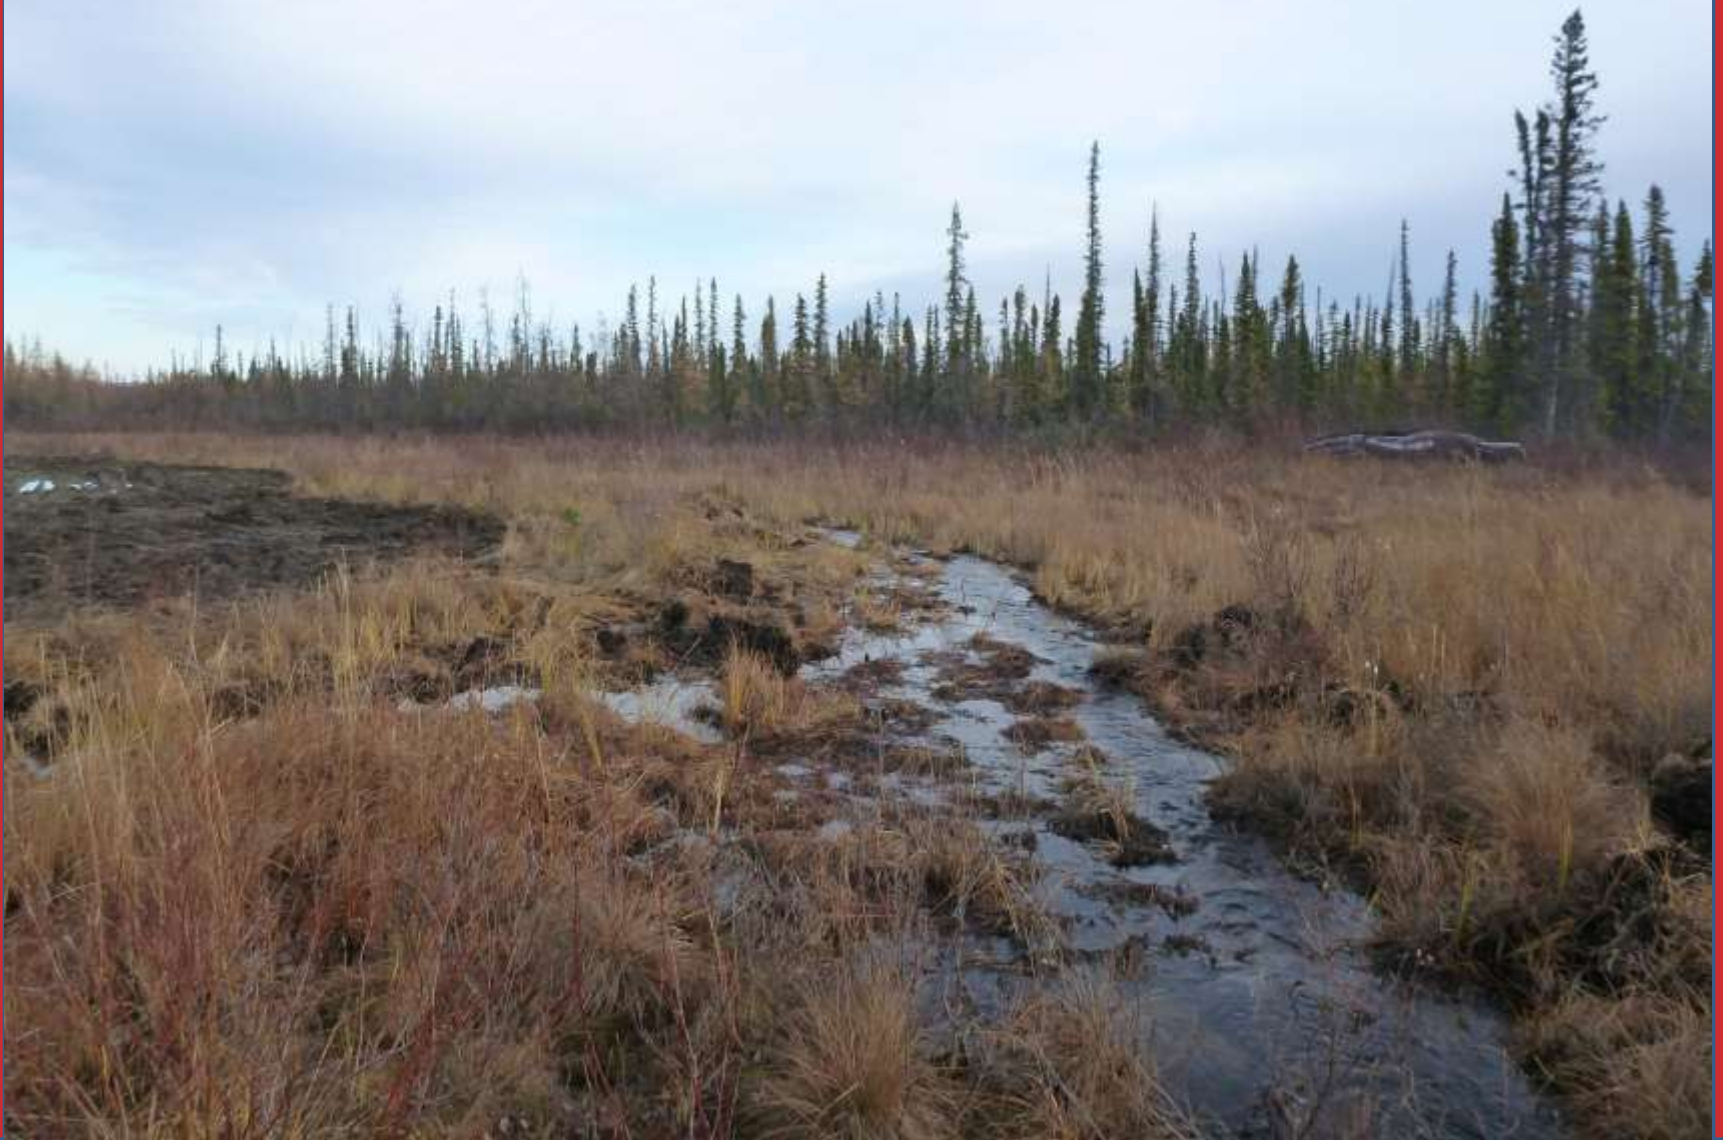
From the ground view of the difficult conditions for heli-portable equipment
