File Number	G2002A0011
Type of Operation	OIL AND GAS DRILLING - WELLSITE
Location	C 36 sump

ENVIRONMENTAL INSPECTION REPORT

Permittee:	Chinook Energy Inc.	Permit Expiry Date:	December 31, 2005
Land Use Permit No.	G2002A0011	Previous Inspection:	September 25, 2015
Quarrying Permit No.		Inspection Date:	September 21, 2016
Contractor:		Subcontractor:	
Location(s) Inspected:	C 36 sump		
Current Stage of Operation:	completed and reclaimed		
Program Modifications Approved:	NIL

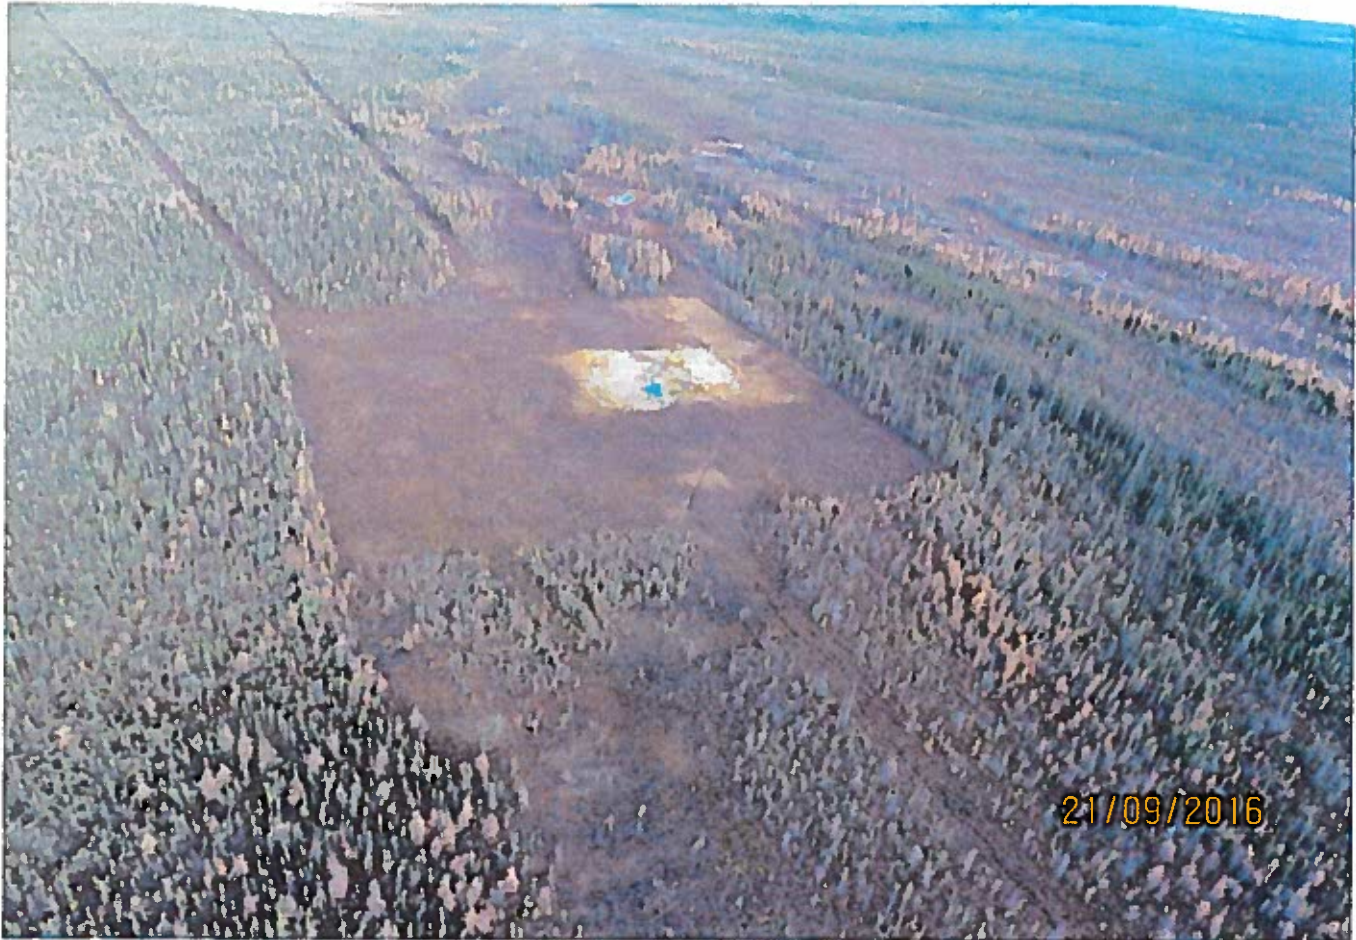
Figure 1

Aerial of site

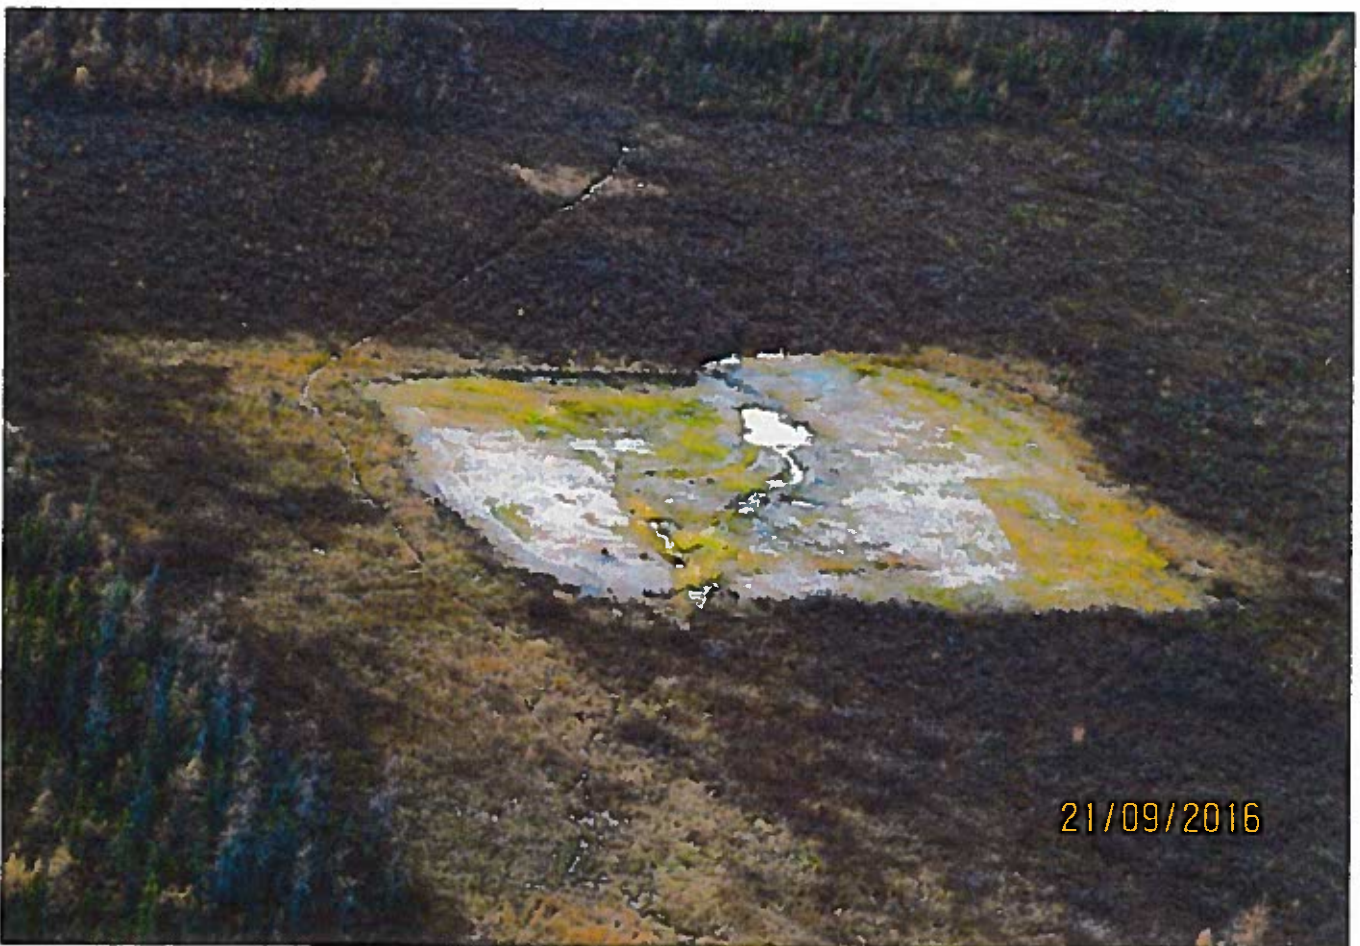
Figure 2

Aerial of site

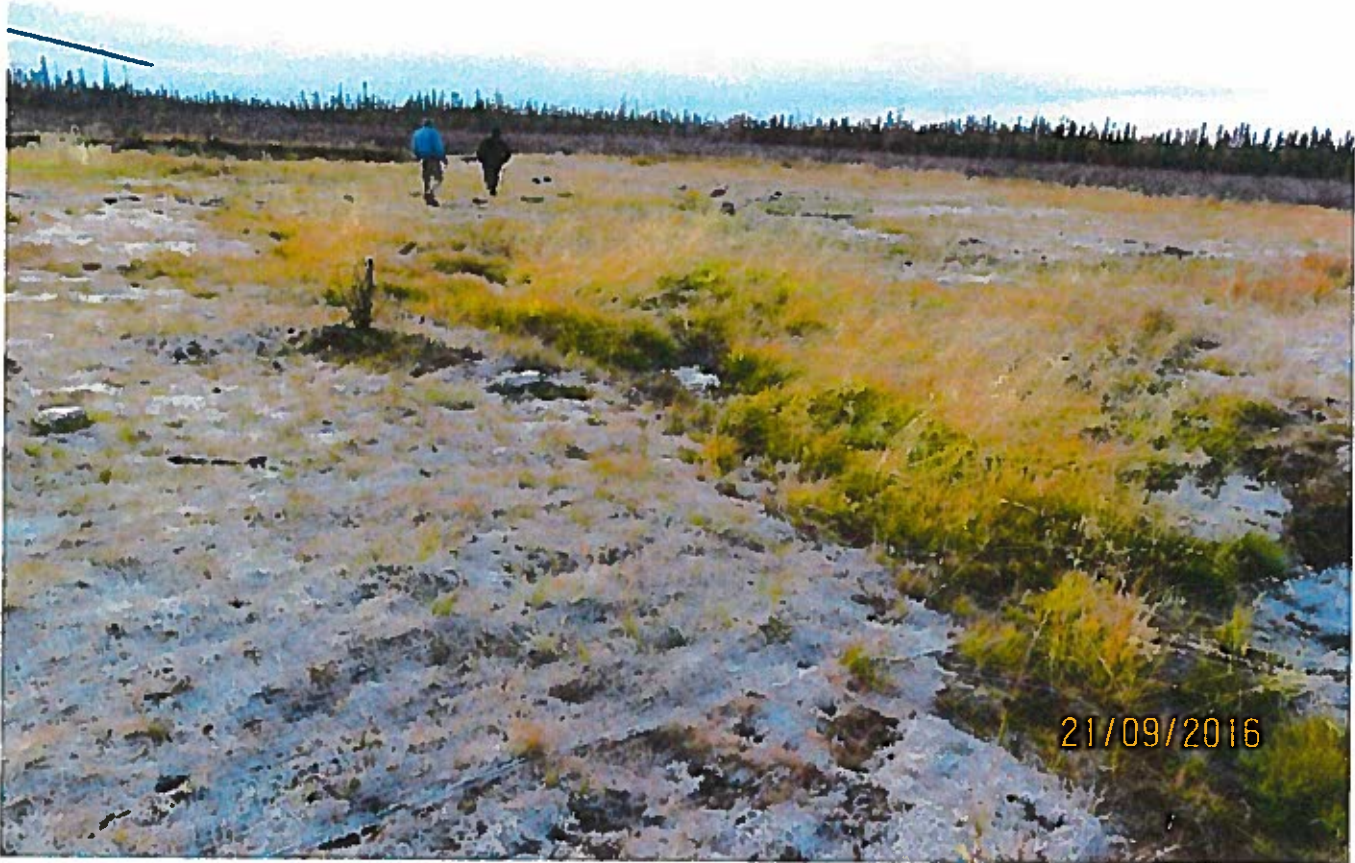
During this inspection it was observed that no change was observed and the sump cap is solid and holding with no evidence of any subsidence. Mattings were intact and vegetation is showing through out the sump. Sheening was evident within the sump and it is not certain if this maybe a natural occurrence. Inspectors are satisfied with the work done on the reclamation, however still request that a updated sample report be provided to ensure contents are intact prior to recommending closure of the file.

Figure 3
matting intact with vegetation

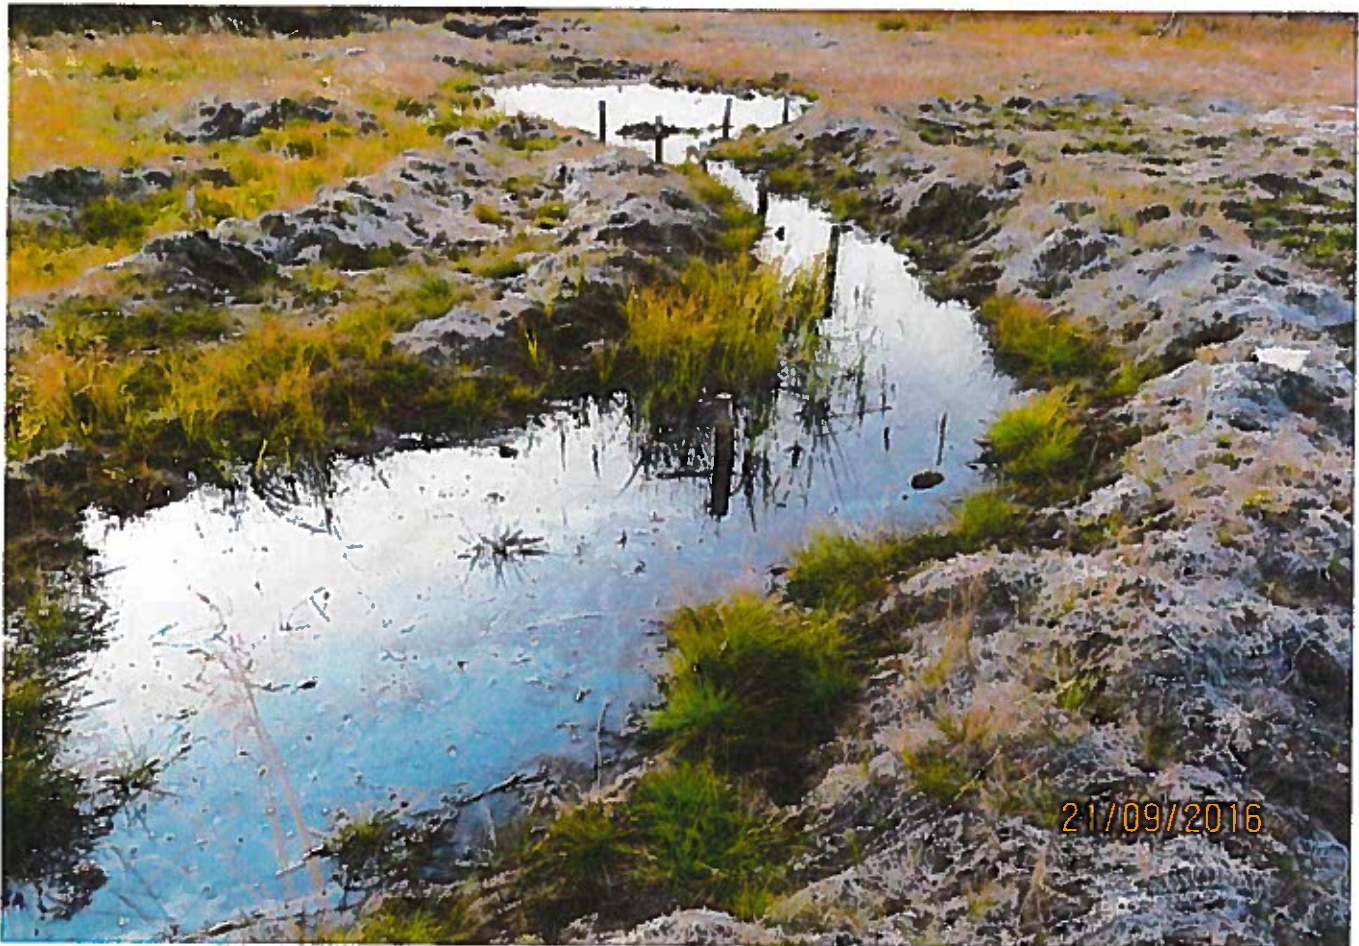
Figure 4
sheen on water
