File Number G2002A0012
Type of Operation OIL AND GAS DRILLING - WELLSITE
Location D39

ENVIRONMENTAL INSPECTION REPORT

Permittee:	Chinook Energy Inc	Permit Expiry Date:	December 31, 2005
Land Use Permit No.	G2002A0012	Previous Inspection:	September 25, 2015
Quarrying Permit No.		Inspection Date:	September 21, 2016
Contractor:		Subcontractor:	
Location(s) Inspected:	D39		
Current Stage of Operation:	completed		
Program Modifications Approved:	NIL

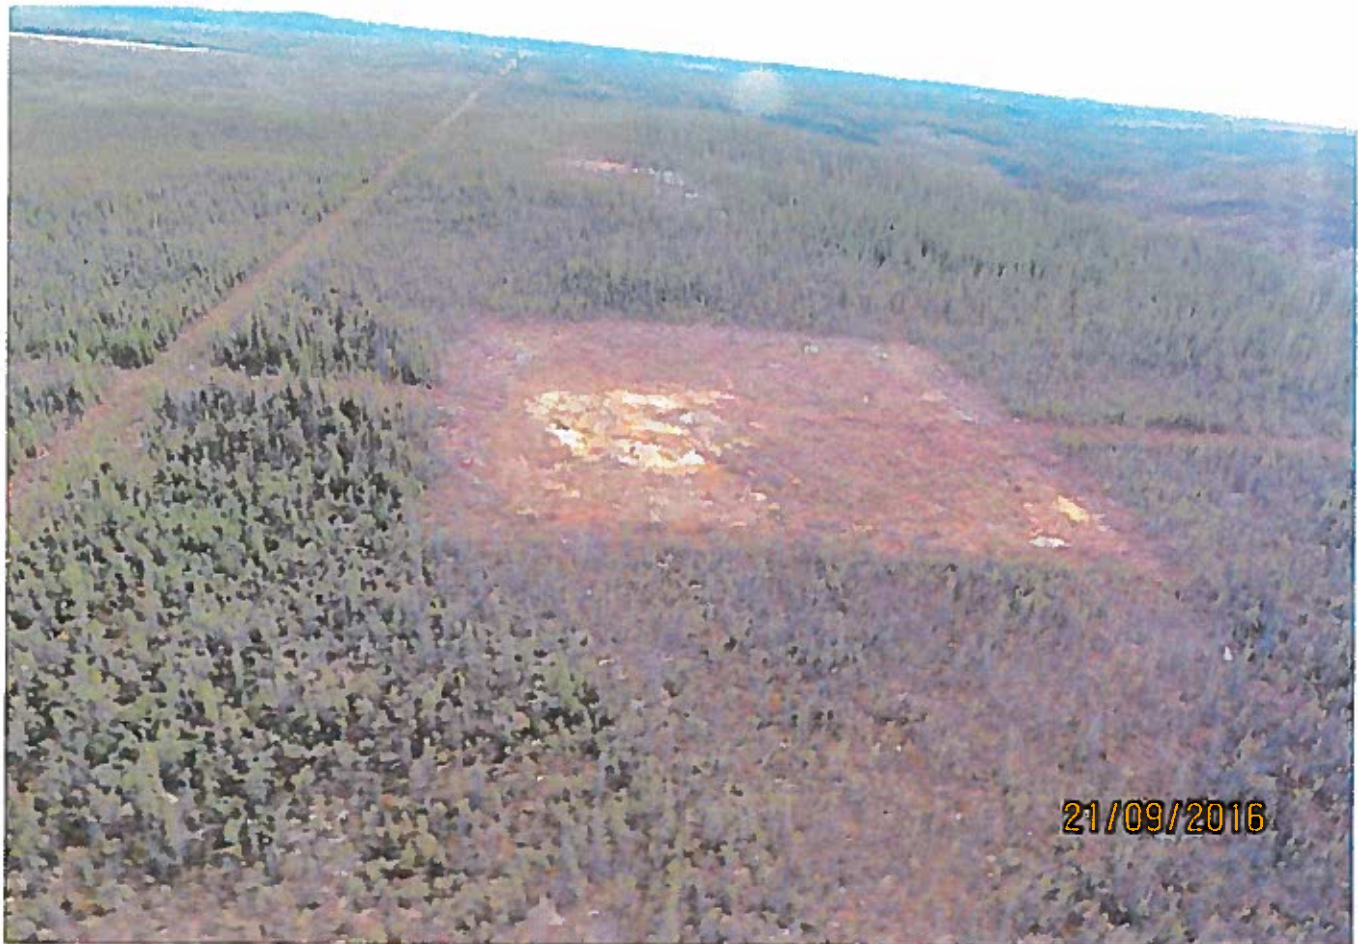
Figure 1

Aerial of D39

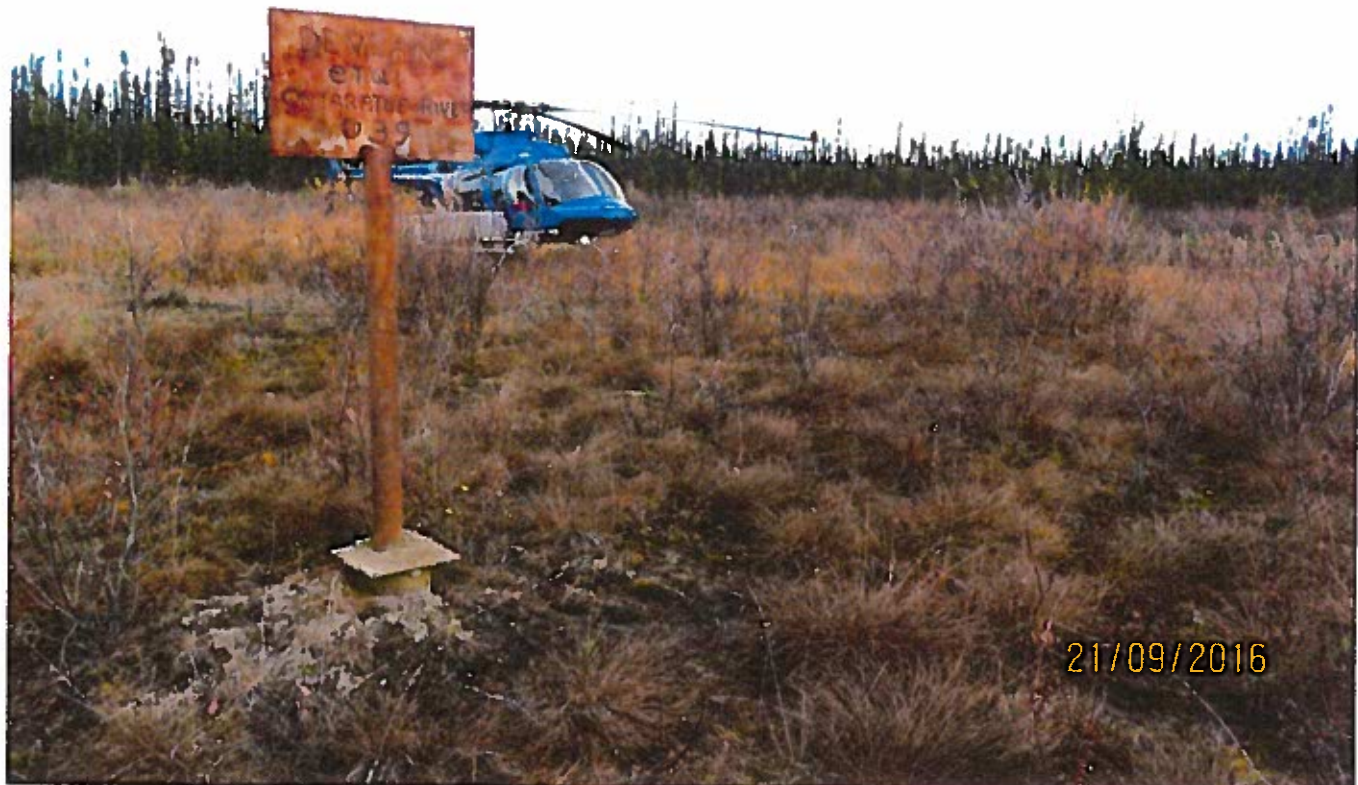
Figure 2

D39 Post

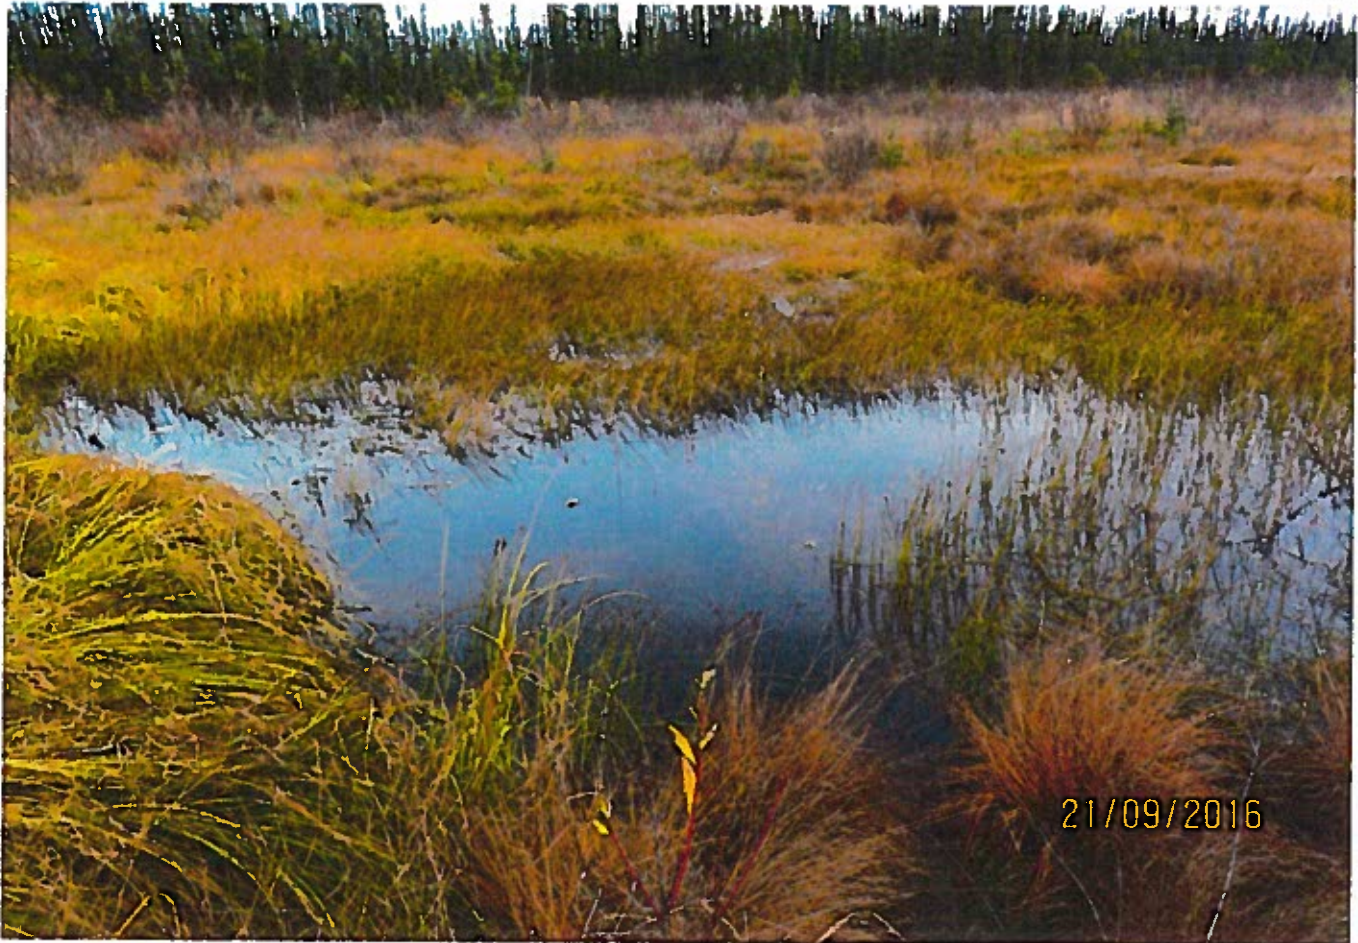
During this inspection no change has been observed from previous inspection reports with regards to any subsidence of the sump, it appears that no more water has accumulated within the sump.

Figure 3
ponded water at sump

It is still requested that a updated sample report be provided prior to a final inspection to recommend any closure of the file.

Await updated sample report from sump prior to a final inspection.

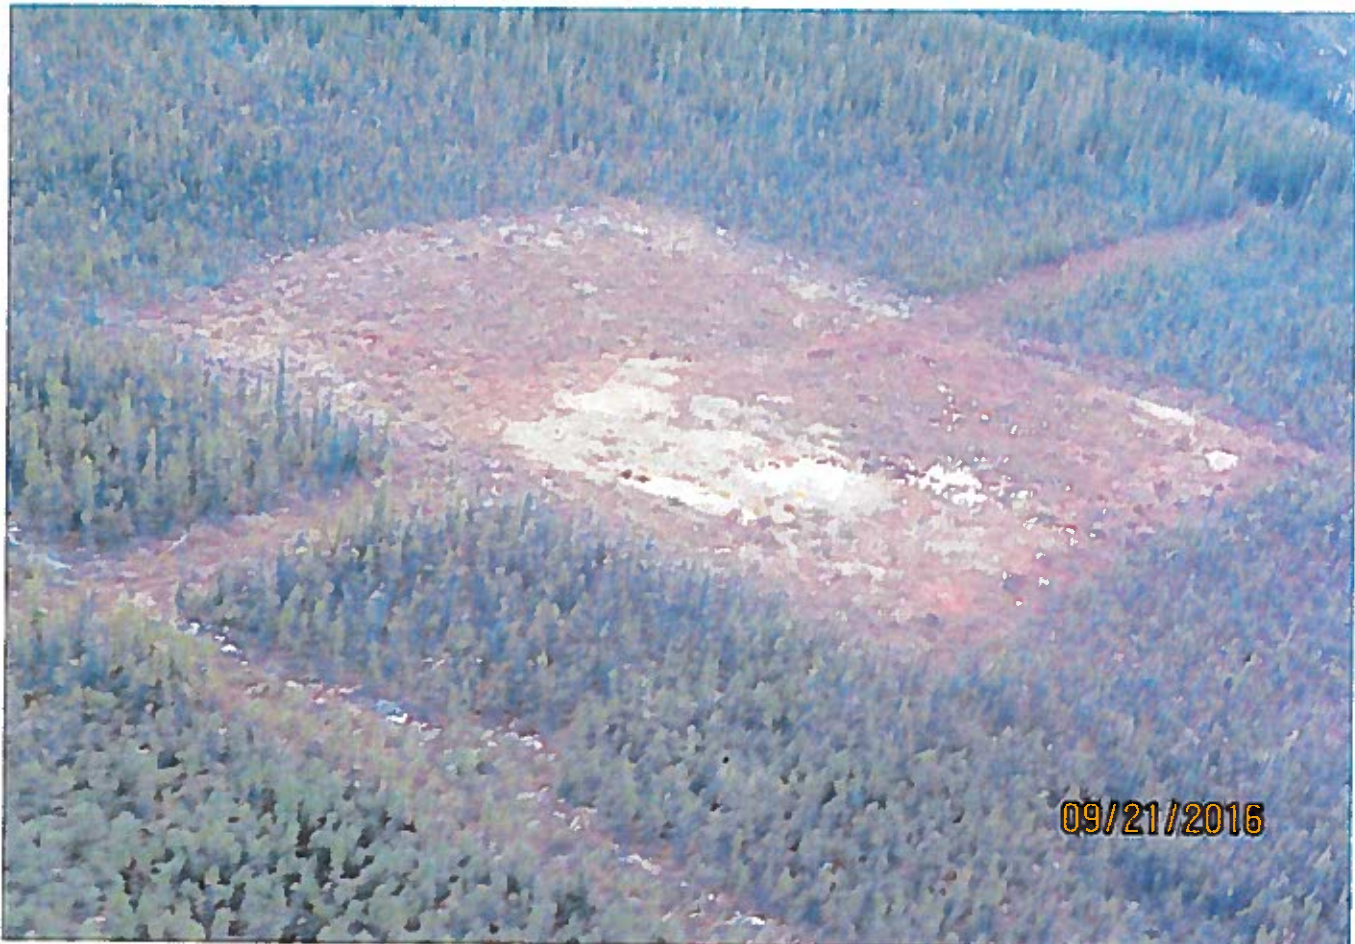
Figure 4
Aerial of D39
