**File Number** G02A013  
**Type of Operation** OIL AND GAS DRILLING - WELLSITE  
**Location** Thunder River N-73

### ENVIRONMENTAL INSPECTION REPORT

<b>Permittee:</b>	Chinook Energy Inc.	<b>Permit Expiry Date:</b>	December 31, 2005
<b>Land Use Permit No.</b>	G02A013	<b>Previous Inspection:</b>	September 21, 2016
<b>Quarrying Permit No.</b>		<b>Inspection Date:</b>	September 19, 2017
<b>Contractor:</b>		<b>Subcontractor:</b>	
<b>Location(s) Inspected:</b>	Thunder River N-73		
<b>Current Stage of Operation:</b>	completed and restored		
<b>Program Modifications Approved:</b>	NIL

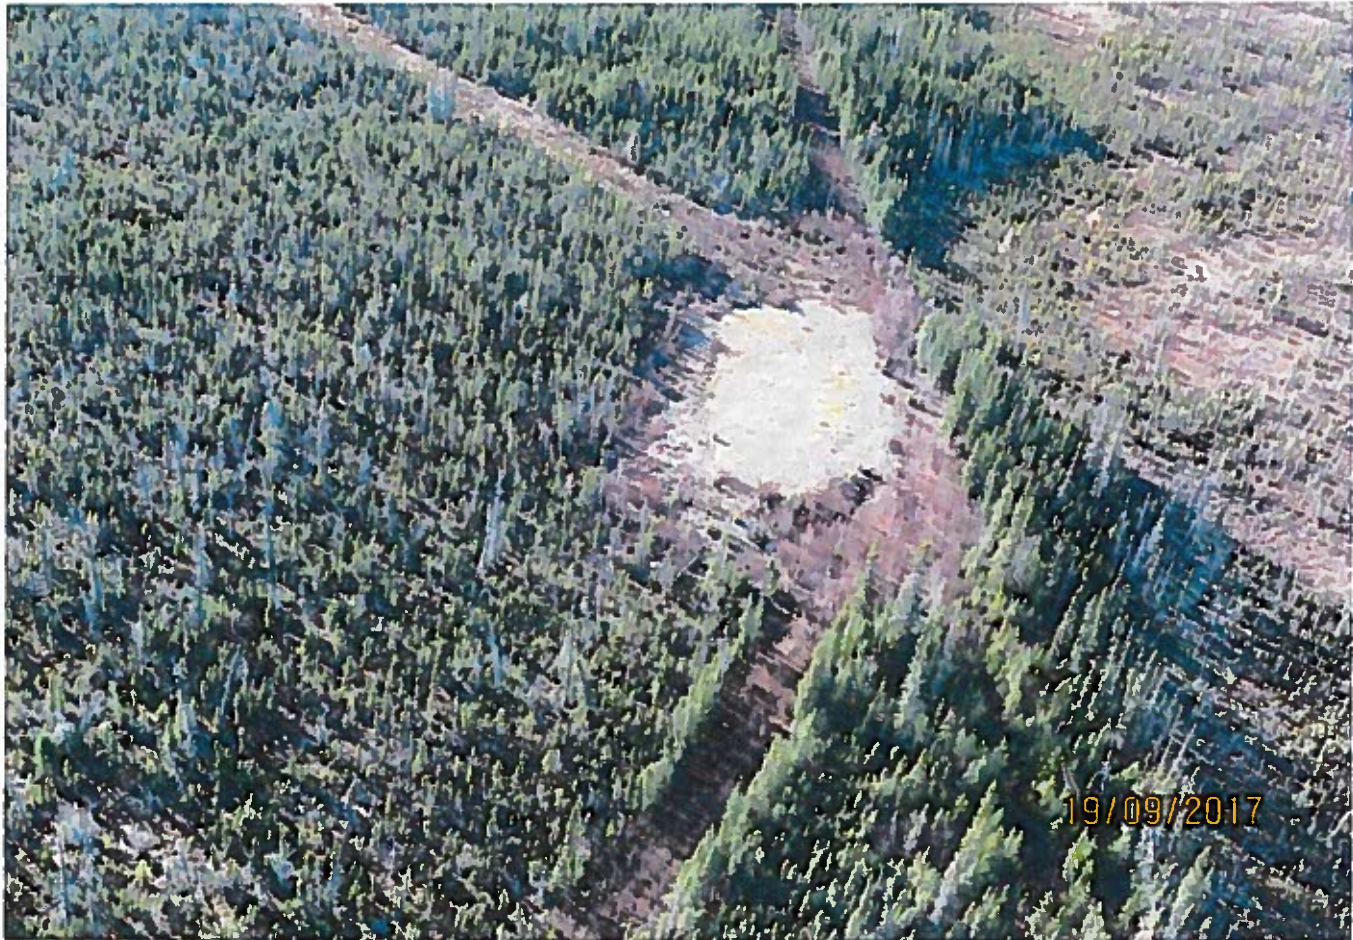
Figure 1

During the inspection it was observed that the sump had more vegetation cover from previous inspection done on Sept. 21 2016. The sump was solid with no evidence of any subsidence.
