RE: Municipal Water Licence (G03L3-001)

WATER LICENCE INSPECTION FORM

DATE:	October 9, 2007	COMPANY REP:	Deanna Black
LICENCEE:	Hamlet of Fort McPherson	LICENCE #:	G03L3-001

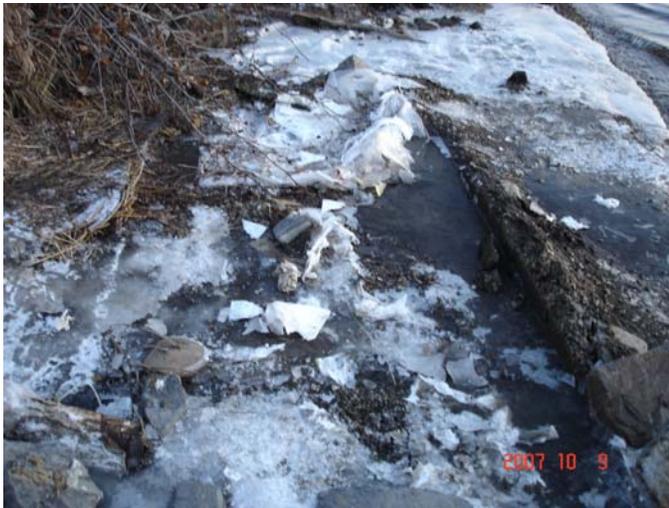
Figure 1

1. At the time of inspection the water intake line was not in use and a replacement pump and line were being used. During pump operation spill pads were under the pump when in use along the lake. Ernie Debastien (Dept. Public Works) said all oil and diesel were contained on spill pads, nothing went through. Spill pads were present that smelled of diesel from when the intake pump was in use. After the pump had been taken away some of the debris such as spill pads and their bag still needed to be removed. Staff were reminded to remove all pads, plastic debris and ice(meltwater under the pump) that smelled of diesel (Figure 1).

Area of spill pads which were underneath the pump by Deep Water Lake.

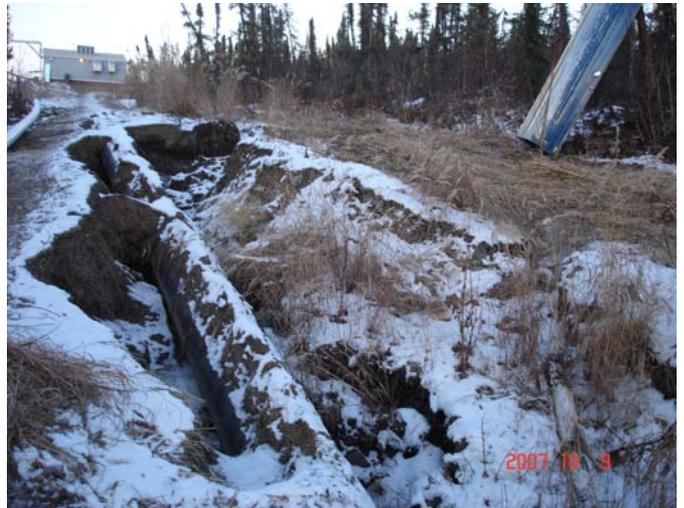
Figure 2

2. It was evident that there was subsidence along the water intake conveyance line and repairs had just been completed to repair the line. Ensure that the areas of subsidence along the intake conveyance line are repaired as further erosion and subsidence can occur (Figure 2).

Subsidence along water intake conveyance line.

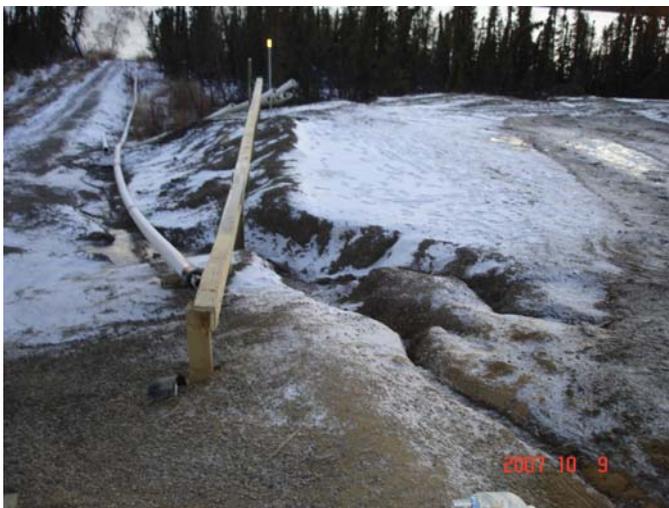
Figure 3

5. There is significant erosion of the turn around pad next to the the Deep Water Lake Water Supply Facility. This erosion of pad material can not continue as it will lead to further destruction of infrastructure. The cause of the erosion needs to be stopped and a permanent solution to the erosion needs to occur to prevent further damage (Figure 3).

An example of the erosion on the turn around pad next to the Deep Water Lake Water Supply Facility.

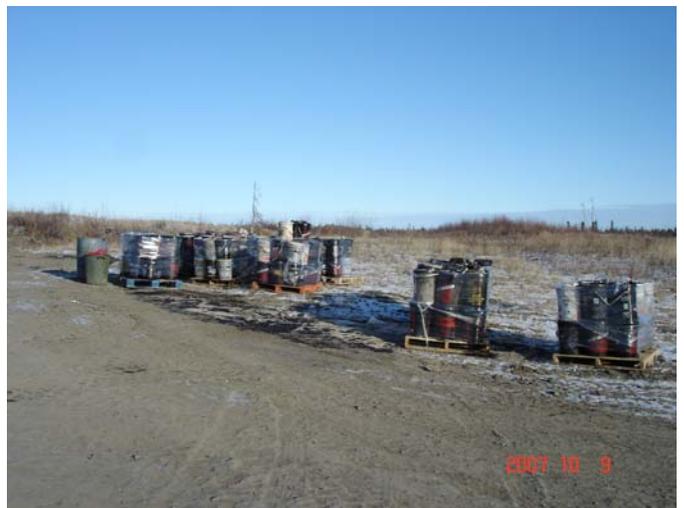
Figure 4

4. During inspection it was observed that waste oil storage containers with oil had been moved to a staging area by the large contaminated soil storage area to await being sent to disposal facilities. While it is encouraging to see waste oil and oil storage containers being shipped it was observed that there was a large amount of spillage outside the Solid Waste Disposal Facility hazardous wastes/waste oil storage area as some containers were leaking and oil was on the ground (Figure 4). It was mentioned that the oil and contaminated soil needed to be cleaned up. Due to the location of the spillage it would have been appropriate to call in the spillage to the Spill Line.

Spillage of used oil from containers at the staging area before being shipped to disposal facilities.
