RE: Municipal Water Licence (G03L3-001)

WATER LICENCE INSPECTION FORM

DATE:	September 25, 2008	COMPANY REP:	Mary Rose Tetlich
LICENCEE:	Hamlet of Fort McPherson	LICENCE #:	G03L3-001

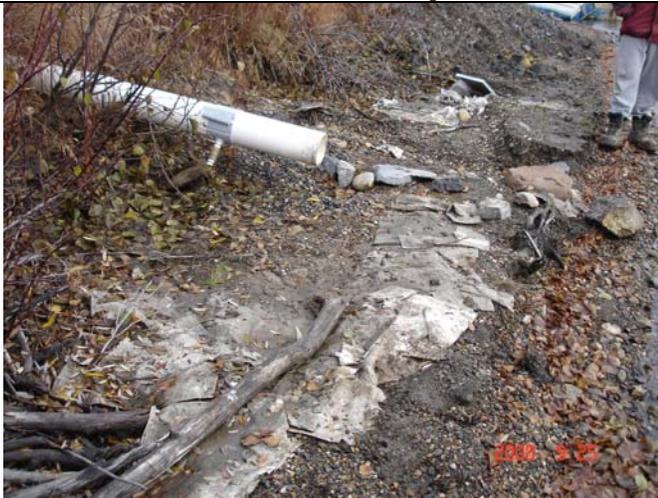
Figure 1

1. Original absorbant pads for a leaking auxillary pump operated at the Deep Water Lake Water Supply Facility (WSF) during the Fall 2007 intake pipe repair were not removed. The site must be cleaned up. The presence of absorbant pads if they are hydrocarbon stained would be a contamination risk to the Hamlet's Water Supply. It was understood that all the spill pads and debris had been removed. For future use of the auxillary pump - leaks need to be repaired, a spill/drip mat must be used under the pump with absorbant pads and a proper spill kit be located on site. (see Figure 1)

Absorbent pads used for a pump during a water intake repair in 2007 that should have been cleaned up and removed

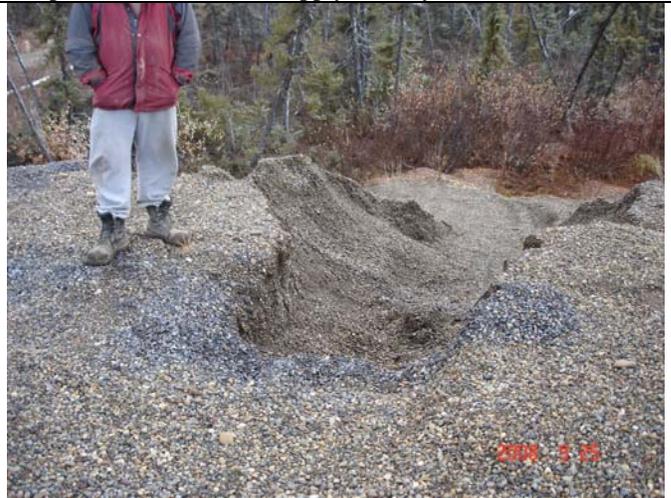
Figure 2

3. There is significant erosion of the turn around pad next to the the Deep Water Lake(WSF). This erosion of pad material can not continue as it will lead to further destruction of infrastructure. The cause of the erosion needs to be stopped. A permanent solution (like the use of a retaining wall or rip rap etc.)to the erosion needs to occur to prevent further damage. (see Figure 2)

Erosion needing repair at the turn around pad next to the Deep Water Lake Water Supply Facility.

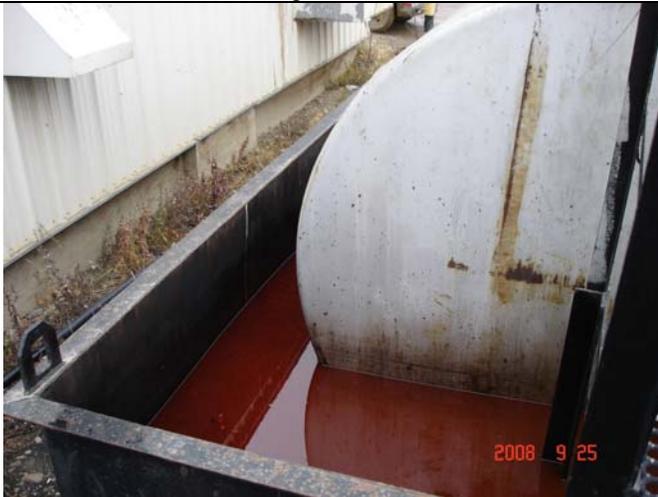
Figure 3

1. At the Water Treatment Plant the berm for the Fuel Storage Tank is full of diesel, water, ice and snow. While on inspection a contractor was present to remove the contaminated water to be taken to Inuvik for disposal. The problem of water getting into the metal berm for the Fuel Storage Tank should be dealt with permanently by some kind of covering or replacing the tank with a double walled storage tank. (see Figure 3)

Fuel contaminated water located within berm for Water Treatment Plant Fuel Storage Tank.

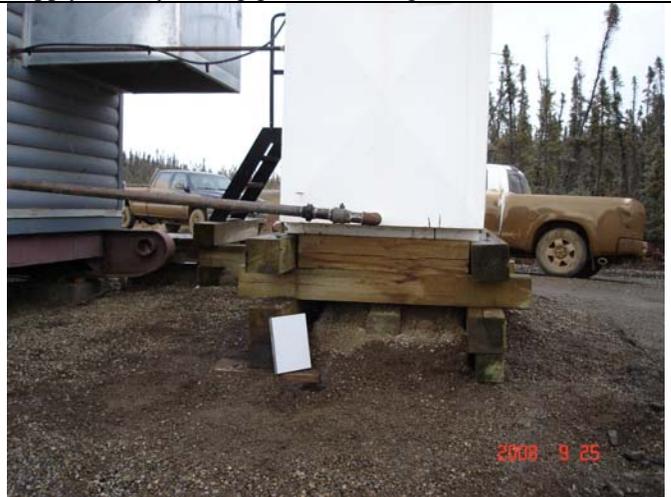
Figure 4

2. Deep Water Lake Water Supply Facility Fuel Storage Tank is a double walled tank that is mounted on a wood platform on a gravel pad. The gravel pad smelled of fuel mainly on the south side of the tank. Shane Debastien who was present mentioned that the south side of the tank with the pipe in the bottom was sunken originally and had to be repaired. During this time there might have been a leak and/or the tank has been overfilled. With the fuel/water draining off the tank the area would smell of fuel. The extent of contaminated gravel should be assessed and the area should be excavated of contaminated gravel and properly disposed of. (see Figure 4)

South side of Fuel Storage Tank at Deep Water Lake Water Supply Facility having gravel smelling of fuel contamination.
