RE: Municipal Water Licence (G03L3-001)

An inspection was conducted of the Municipal Water Supply and Waste Disposal Facilities on October 8, 2009. Enclosed is a copy of the Municipal Water Licence Inspection Report.

WATER LICENCE INSPECTION FORM

DATE:	October 8, 2009	COMPANY REP:	James Wilson
LICENCEE:	Hamlet of Fort McPherson	LICENCE #:	G03L3-001

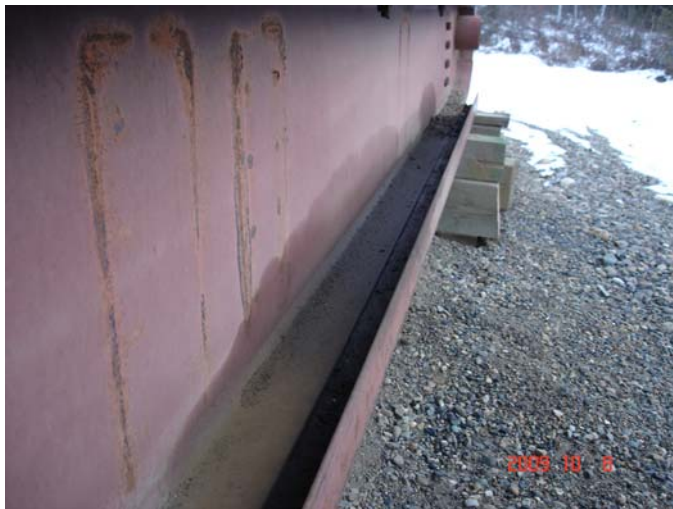
Figure 1

1. Generators are still leaking at the Deep Water Lake Intake Facility (DWLIF). Both generators need full coverage by drip trays to ensure leaking oil is contained within the generator room and not by-passing the trays. Drip trays will go a long way to keeping the generator room clean. Spill pads are present and soaked with oil indicating that there is a larger problem of leaking oil from the generators. Maintenance needs to be cleaner and/or the generators need repairs to stop the leaks. There is still oil along the floor and seeping through the wall and dripping outside on metal skids in the back of the generator shed. The seepage of oil from the generator room needs to stop as it is a potential contaminant to the outside environment including the Hamlet's water supply (see Figure 1).

Oil leakage in the generator room needs to be repaired and contained as it is leaking to the outside environment.

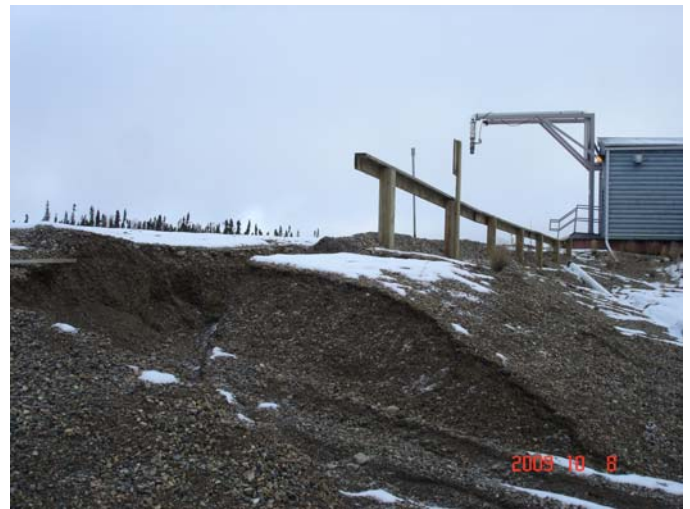
Figure 2

2. There is still significant erosion of the turn around pad next to the the DWLIF. This erosion of pad material can not continue as it will lead to further destruction of infrastructure. The cause of the erosion needs to be be stopped. A permanent solution (like the use of a retaining wall or rip rap etc.)to the erosion needs to occur to prevent further damage (see Figure 2).

Severe erosion is occurring to the turn around pad for the Deep Water Lake Intake Facility and needs to be prevented.

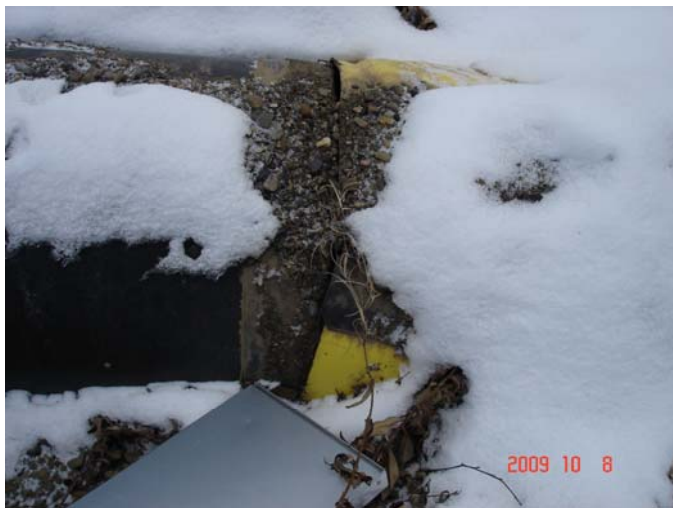
Figure 3

3. There a number of cracks in the insultating layer of the water intake pipe for the DWLIF. These cracks may promote further destruction of water intake infrastructure by exposure to the elements (see Figure 3).

One of a few cracks along the water intake line at the Deep Water Lake Intake Facility.

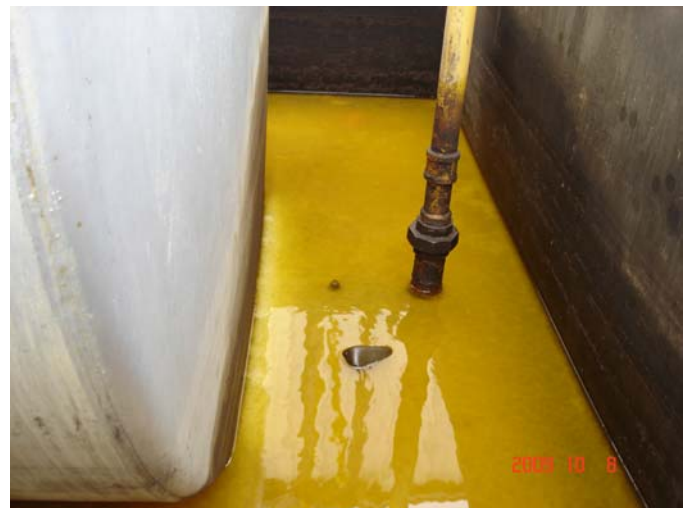
Figure 4

1. At the Water Treatment Plant the berm for the fuel storage tank is full of diesel and water. The problem of water getting into the metal berm for the fuel storage tank should be dealt with permanently by some kind of covering or replacing the tank with a double walled storage tank (see Figure 4).

Water present in fuel storage tank berm just outside the Water Treatment Plant.

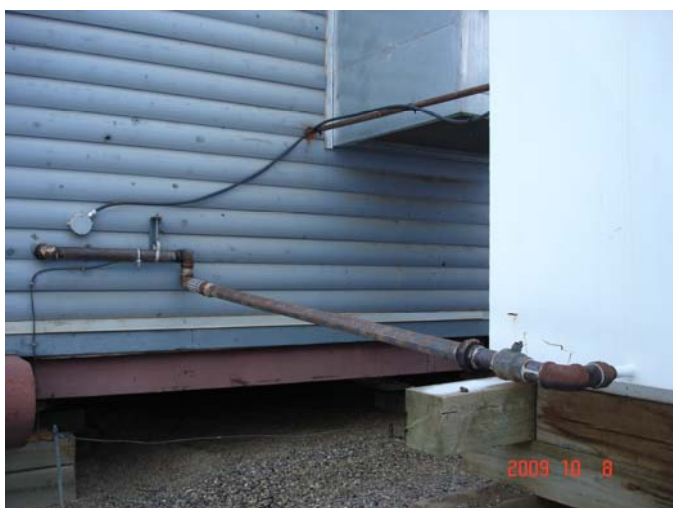
Figure 5

2. Deep Water Lake Intake Facility (DWLIF) fuel storage tank is a double walled tank that is mounted on a wood platform on a gravel pad. During the September 25, 2008 Inspection the gravel pad smelled of fuel mainly on the south side of the tank. Shane Debastien who was present mentioned that the south side of the tank with the pipe in the bottom was sunken originally and had to be repaired. During this time there might have been a leak and/or the tank at times has been overfilled. With the fuel/water draining off the tank the area would smell of fuel. The extent of contaminated gravel should be assessed and the area should be excavated of contaminated gravel and properly disposed of as this area is a potential risk to the Hamlet's water supply (see Figure 5).

3. The fuel supply line connecting to the bottom of the fuel storage tank at the DWLIF is a potential source of leakage and contamination. As noted in the above concern #2 there is the potential for tank movement and leakage of fuel.

There is a risk of a large volume spill due to the position of the fuel line connection. Any spill of this nature would pose an immediate risk to the Hamlet's water supply (see Figure 5).

Potential source of leakage and evidence of contamination at the fuel storage tank at Deep Water Lake Intake Facility.

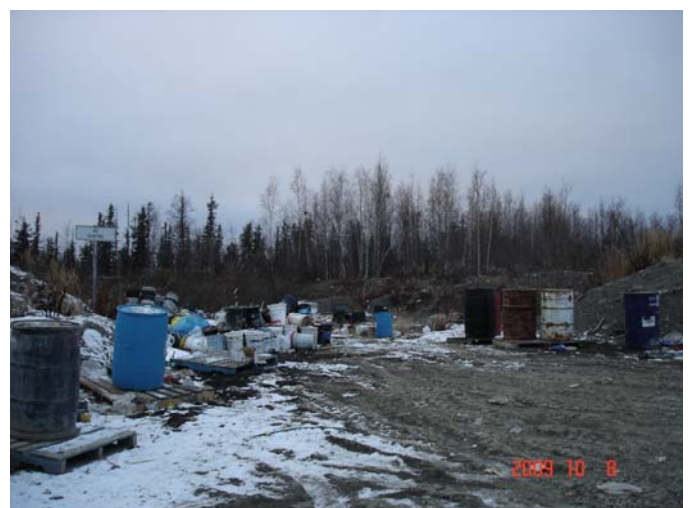
Figure 6

3. Batteries and waste oil have been removed from the SWDF hazardous wastes/waste oil storage area but work is still required. There were drums and pails outside the storage area that need to be moved back inside the bermed storage area. During the inspection there was obvious evidence of considerable release of oil as the ground is still saturated with oil and/or other materials. This material needs to be removed and disposed of properly. To prevent further spillage of oil in the storage area regular inspection and maintenance of the area is needed (see Figure 6).

4. Due to the presence of oil storage containers etc outside the SWDF hazardous wastes/waste oil storage area there is oil that was spilled and ran down in front of the storage area. The spilled oil and contaminated soil needs to be cleaned up from in front of the storage area. This will prevent further contamination and the deposit of containers outside the storage area (see Figure 6).

Oil containers and oil stained soil outside of Solid Waste Disposal Facility hazardous wastes/waste oil storage area.
