**RE: Municipal Water Licence G03L3-001
CLASS B - MUNICIPAL**

MUNICIPAL WATER LICENCE INSPECTION FORM

LICENCE #:	G03L3-001	EXPIRY DATE:	August 31, 2013
LICENCEE:	Hamlet of Fort McPherson	PREVIOUS INSPECTION:	September 17, 2010
COMPANY REP:	Senior Administrative Officer	INSPECTION DATE:	August 19, 2011

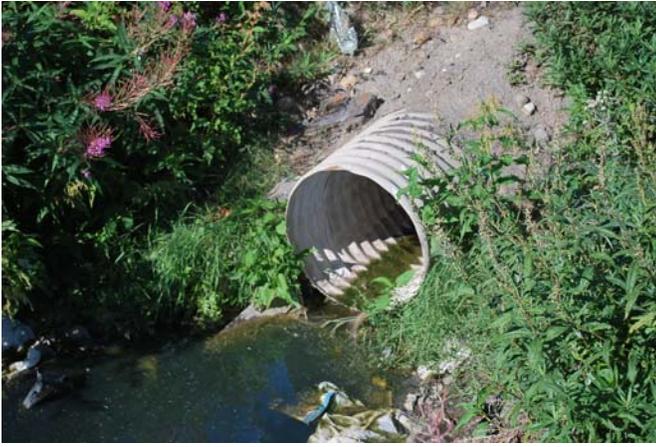
Figure 1

1. Decant structure valve was closed at the time of inspection. There is seepage of sewage past the decant structure, it is flowing in a very small stream (see Figure 1). This has been consistent since the recent construction on the culvert/decant structure. The sewage lagoon was high and there may be bypassing wastes around the closed decant structure. This problem needs to be assessed to see if the decant structure/culvert is secure otherwise repairs will need to occur. There should not be any decanting material unless samples have been taken to confirm compliance with discharge criteria.

Decant structure valve was closed at the time of inspection. There is seepage of sewage past the decant structure, it is flowing in a very small stream.

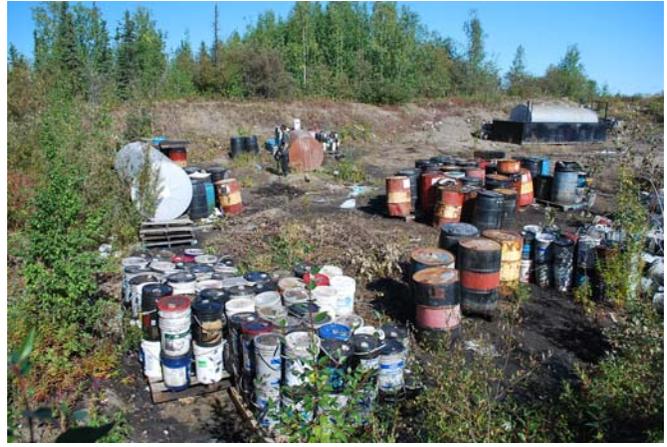
Figure 2

4. There is a large amount of spilled oil in the Waste Oil Storage Area (see Figure 2). Waste oil has been consolidated and put in large tanks on site. One tank with a metal berm was used previously at the Water Treatment Plant. While this is a method to store oil it needs to be decided what to do with the oil once it is put in the large storage tanks. Ultimately the oil needs to be disposed of and can only be stored for so long as there is a tremendous risk of further uncontrolled leaks/spills and even vandalism.

There is a large amount of spilled oil in the Waste Oil Storage Area. The contaminated soil needs to be cleaned up, contained and properly disposed of. The Hamlet needs to ensure there is a proper procedure to maintain the organization and cleanliness of the waste oil storage area.

It is recommended for the ease of transportation and disposal that the oil is stored in secure, strong drums that can be sealed when full. The storage of oil in the larger tanks has created another problem and a plan is needed to empty it for proper disposal which would consist of shipping out for disposal or burning in local waste oil burners.

The remaining contaminated soil needs to be cleaned up, contained and properly disposed of. The Hamlet needs to ensure there is a proper procedure to maintain the organization and cleanliness of the waste oil storage area. When there has been spillage, make sure the soil and waste oil is cleaned up, contained and properly disposed of. Further, ensure that the hazardous waste storage area is regularly inspected, maintained and materials stored properly. This will ultimately keep the area clean and encourage the public to segregate waste properly.

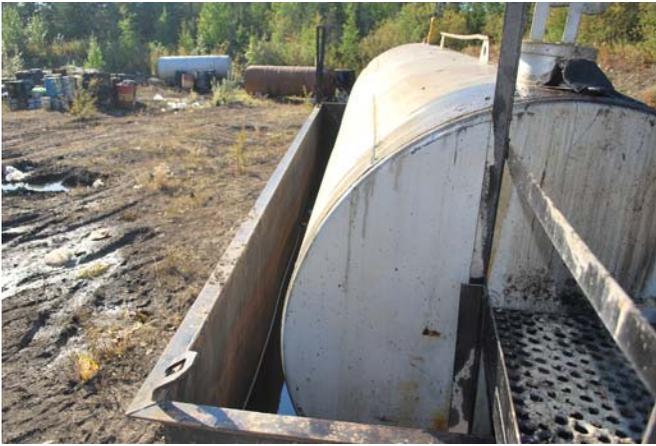
Figure 3

The metal berm for the one storage tank is now full of water and oil due to spillage while filling the tank with smaller containers. This is a further environmental issue to deal with (see Figure 3). The storage tank/berm also needs to be covered to prevent water/precipitation from entering. Covering with metal has been used in other places.

The metal berm for the one storage tank is now full of water and oil due to spillage while filling the tank with smaller containers. This is a further environmental issue to deal with.

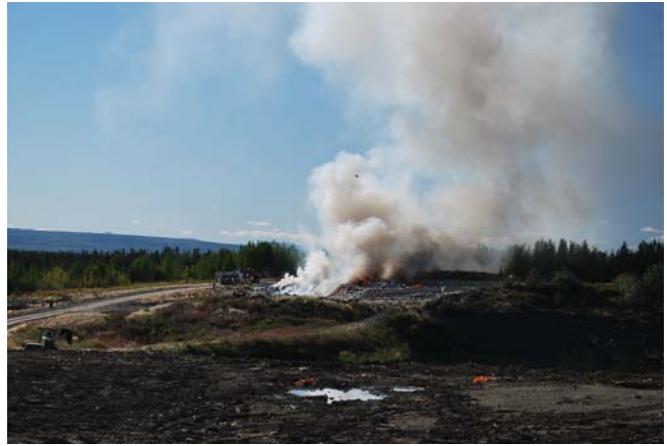
Figure 4

It was stated by Carson Greenland this was paper/cardboard related products. The fire is in a specific area and monitored but then as time went on surrounding exposed domestic waste at the SWDF waste cell all caught on fire (see Figure 4). A fire truck and bulldozer were needed to put the fire out. In this instance it would be wise to have a specifically designated area for burning approved waste, like an incinerator or a contained area. The Community of Tsiigehtchic uses a very large tall culvert with a screen on top to burn their paper, cardboard, and wood waste.

Paper/cardboard related products were on fire in a specific area and monitored but then as time went on surrounding exposed domestic waste at the SWDF waste cell all caught on fire.

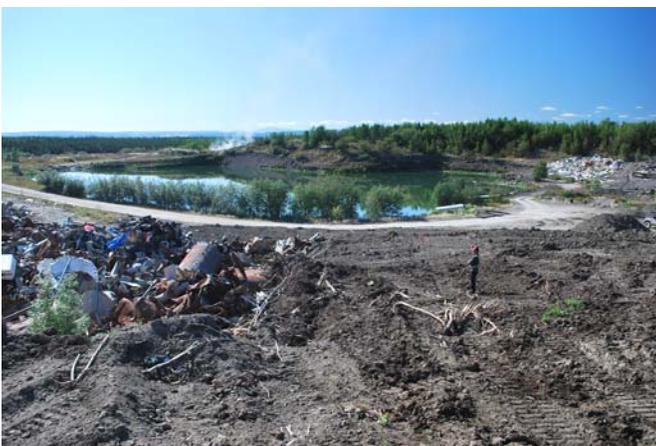
Figure 5

Part of the bulk metal waste area has been covered with fill material.

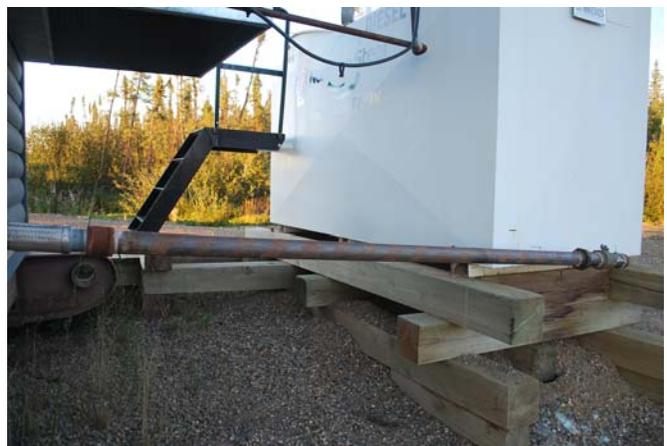
Figure 6

3. There was some staining on the ground noticed below the piping and the side of the fuel storage tank at the Deep Water Lake Intake Facility (DWLIF) (see Figure 6). There needs to be confirmation of the source and assurances that there is not any leaking pipes, connections etc. This staining was not noticed in previous Inspections.

There was some staining on the ground noticed below the piping and the side of the fuel storage tank at the Deep Water Lake Intake Facility. There needs to be confirmation of the source and assurances that there is not any leaking pipes, connections etc. This staining was not noticed in previous Inspections.
