# Final Remediation Pre-Treatment Assessment Report

Project No. 1000417  
Department of Transportation  
Government of the Northwest Territories  
James Creek Maintenance Camp  
No. 8, Dempster Highway, NWT

28 March 2013

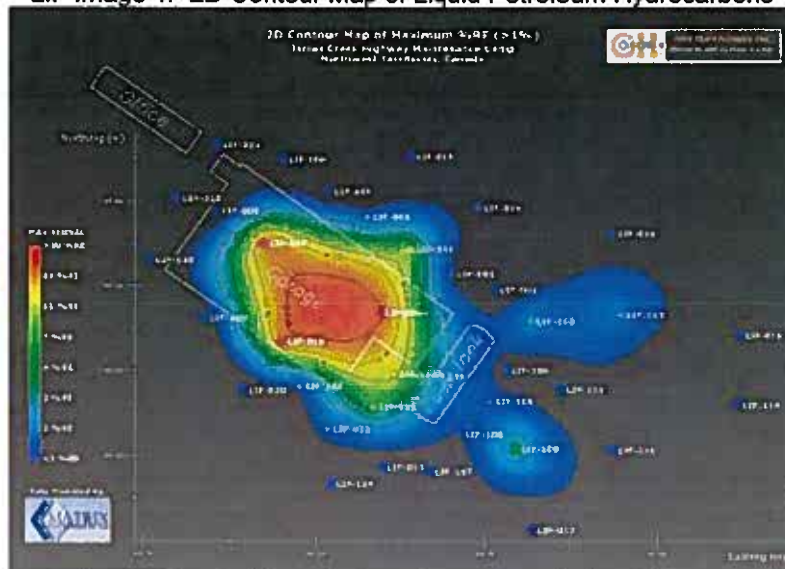
LIF Image 1: 2D Contour Map of Liquid Petroleum Hydrocarbons

*This model represents the liquid petroleum hydrocarbon plume below the garage building (outlined in white) where the spill occurred in 2008. The higher concentrations of hydrocarbons are shown in red while the areas shown in blue represent the lower hydrocarbon concentrations.*

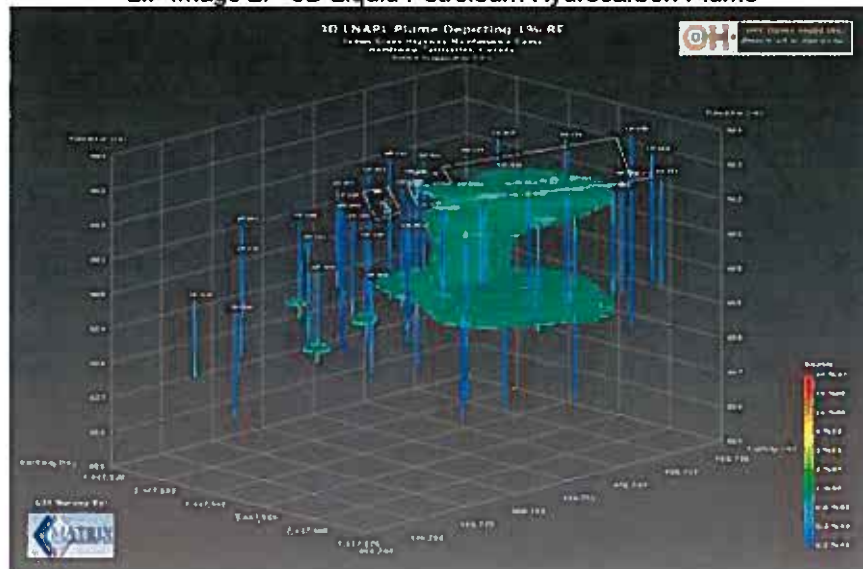
LIF Image 2: 3D Liquid Petroleum Hydrocarbon Plume

*This model shows the three dimensional location and shape of the liquid petroleum hydrocarbon plume below the garage building (outline of building shown in white) showing the horizontal and vertical extent of the impairment. The blue vertical lines are the placements of borings surrounding the garage building.*

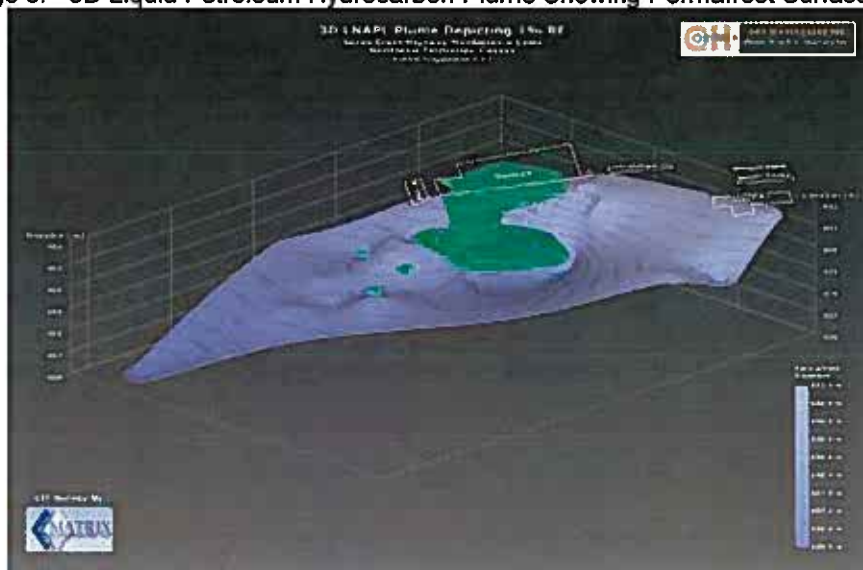
LIF Image 3: 3D Liquid Petroleum Hydrocarbon Plume Showing Permafrost Surface Contours

*This model shows the three dimensional image of the liquid petroleum hydrocarbon plume below the garage building (outline of building shown in white) as compared to the permafrost surface contours.*

The LIF model shows clearly a 'bowl'-like formation in the permafrost surface under the garage. The LIF system also identified other types of hydrocarbon impairment below the garage floor - contaminants other than the diesel contamination that prompted the current Assessment.

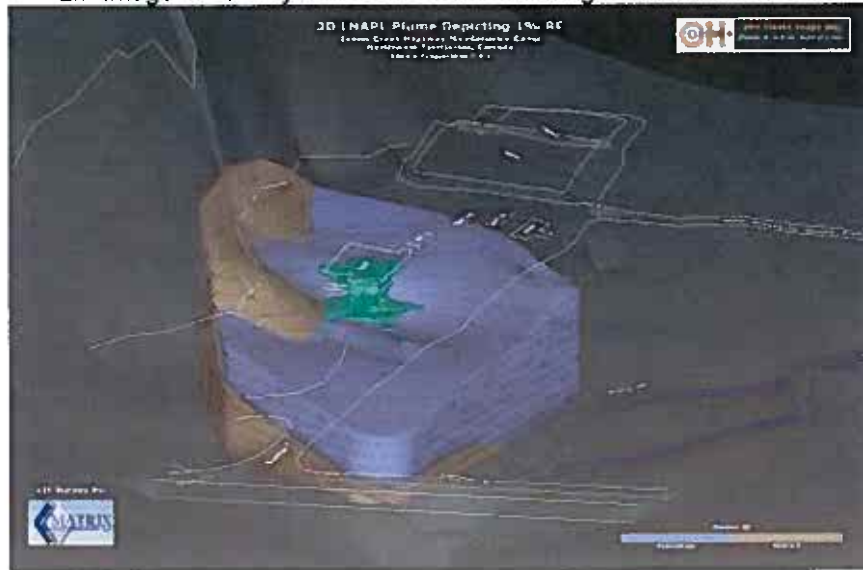
LIF Image 4: 3D Hydrocarbon Plume Showing Permafrost and Bedrock

This model shows the three dimensional image of the liquid petroleum hydrocarbon plume below the garage building (outline of building shown in white) and all site features, the permafrost contours and the depth of the bedrock. NOTE: Model is zoomed out at a 3-1 vertical exaggeration

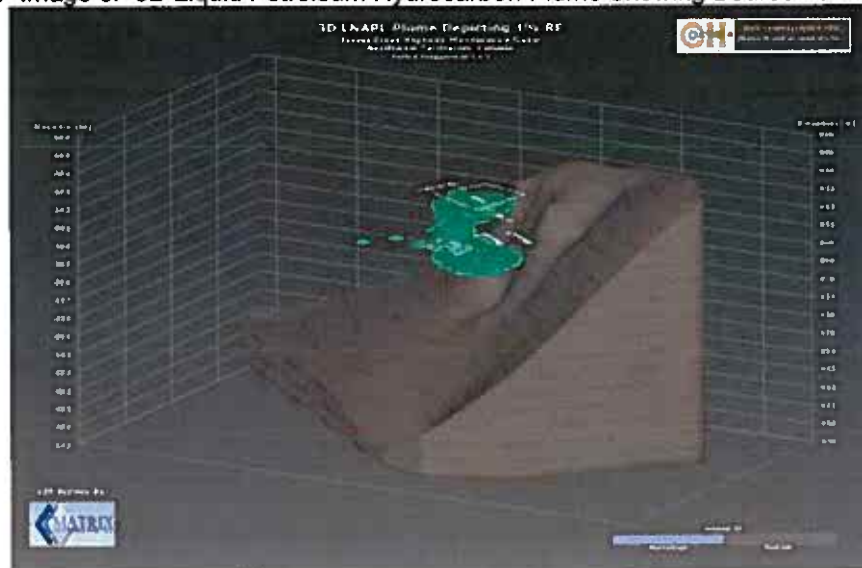
LIF Image 5: 3D Liquid Petroleum Hydrocarbon Plume Showing Bedrock Surface

This model shows the three dimensional image of the liquid petroleum hydrocarbon plume below the garage building (outline of building shown in white) and the depth of the bedrock. NOTE: Model is zoomed out at a 5-1 vertical exaggeration
