File Number G13H004
Type of Operation FUEL CACHES
Location KM 14.2 James Creek

ENVIRONMENTAL INSPECTION REPORT

Permittee:	GNWT Department of Transportation	Permit Expiry Date:	August 11, 2018
Land Use Permit No.	G13H004	Previous Inspection:	July 29, 2016
Quarrying Permit No.		Inspection Date:	August 05, 2016
Contractor:		Subcontractor:	
Location(s) Inspected:	KM 14.2 James Creek		
Current Stage of Operation:	On-going		
Program Modifications Approved:

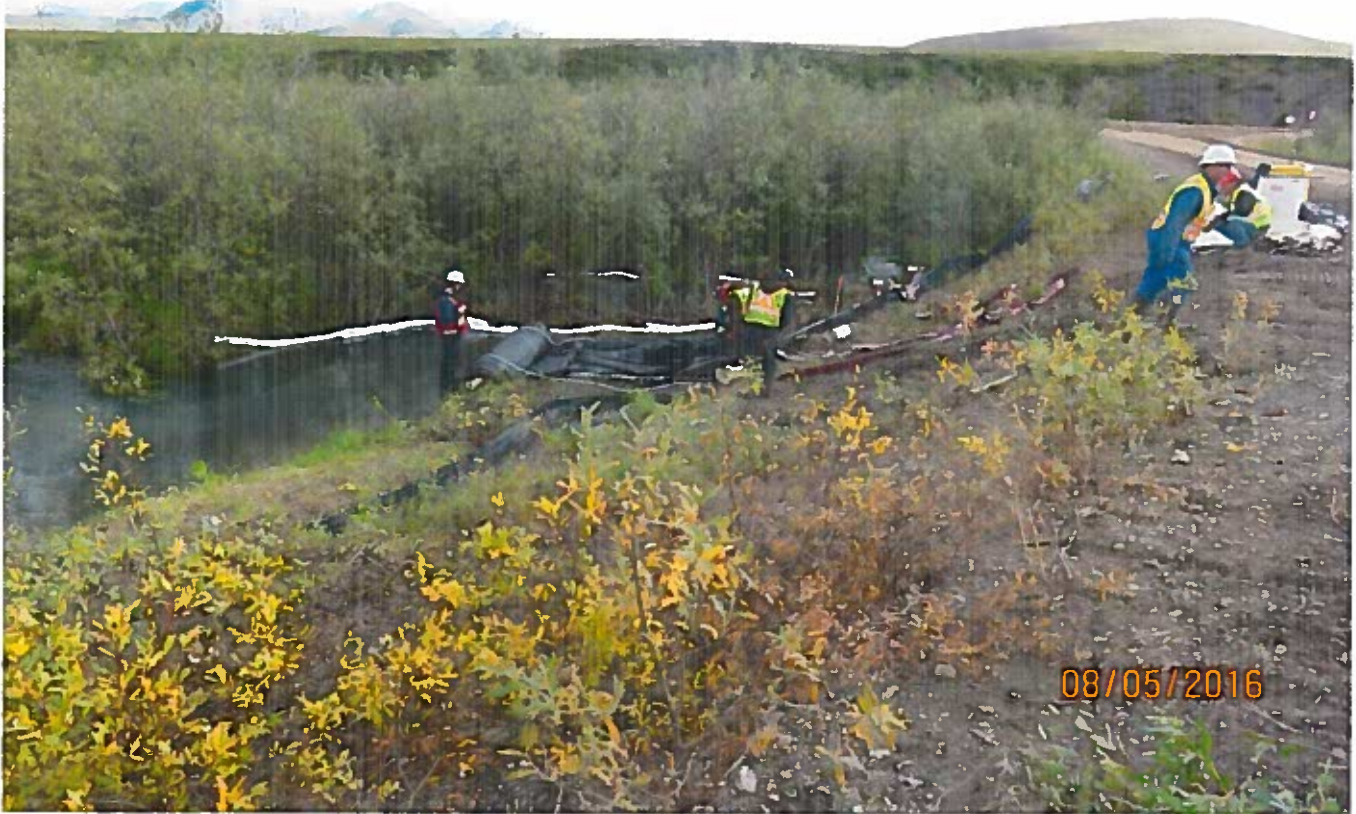
Figure 1

The crew were constructing a dam in the creek next to the access road to prevent hydrocarbons from migrating down stream. The absorbent booms in the creek are changed periodically and was advised by the crew, the booms are less saturated with the hydrocarbons as they are replaced.

Dam being constructed

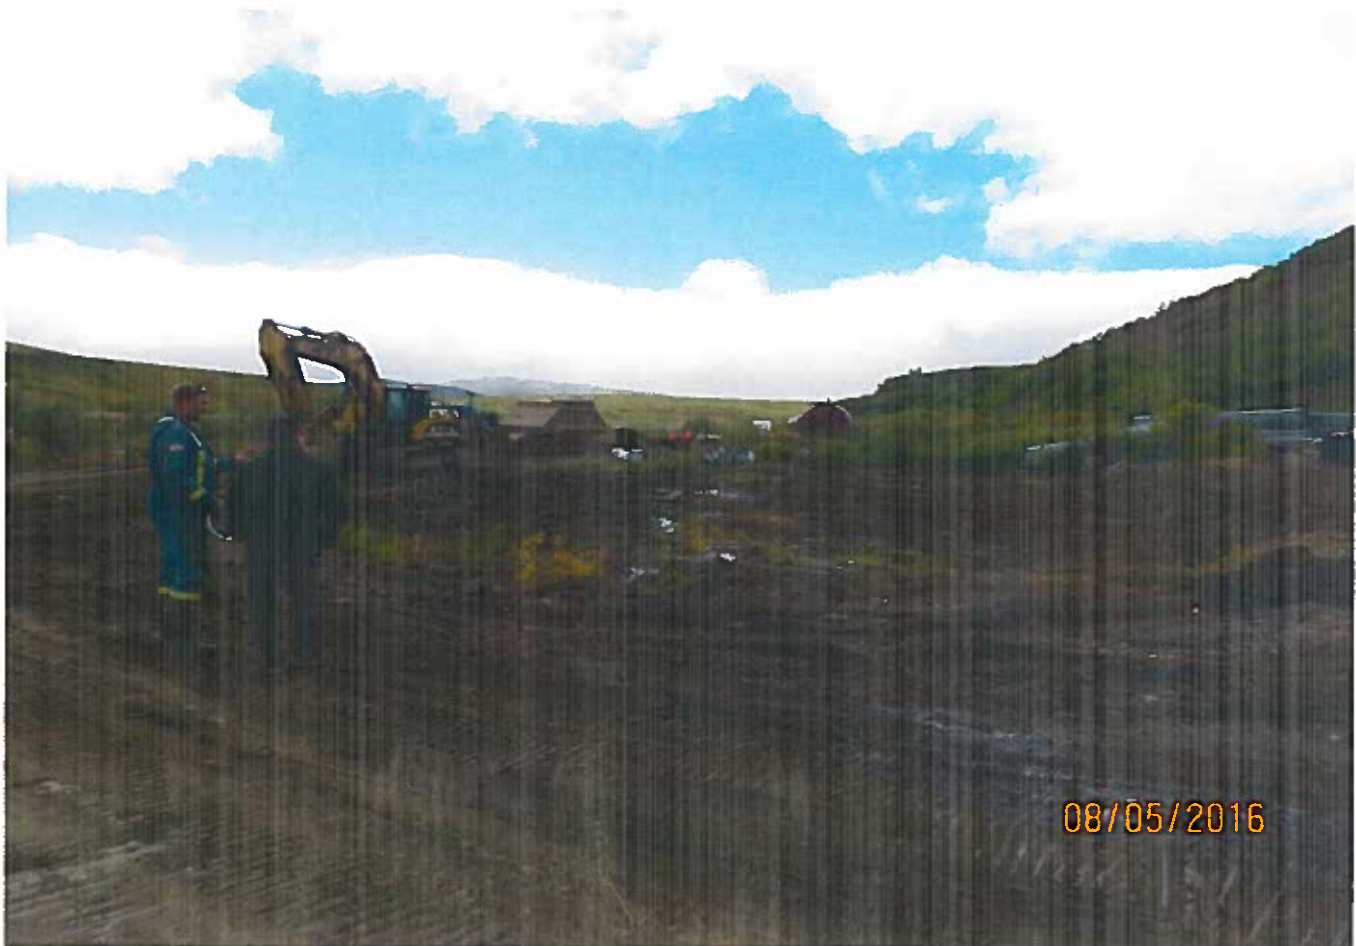
Figure 2

At the east section from the fuel tank the over burden was removed from the area between the south access road to the Dempster and the fuel tank. Excavation and removal of the impacted material will start in this area then work towards the creek and all this material will be immediately loaded on to trucks and shipped south.

Impacted area between south access road and fuel tank

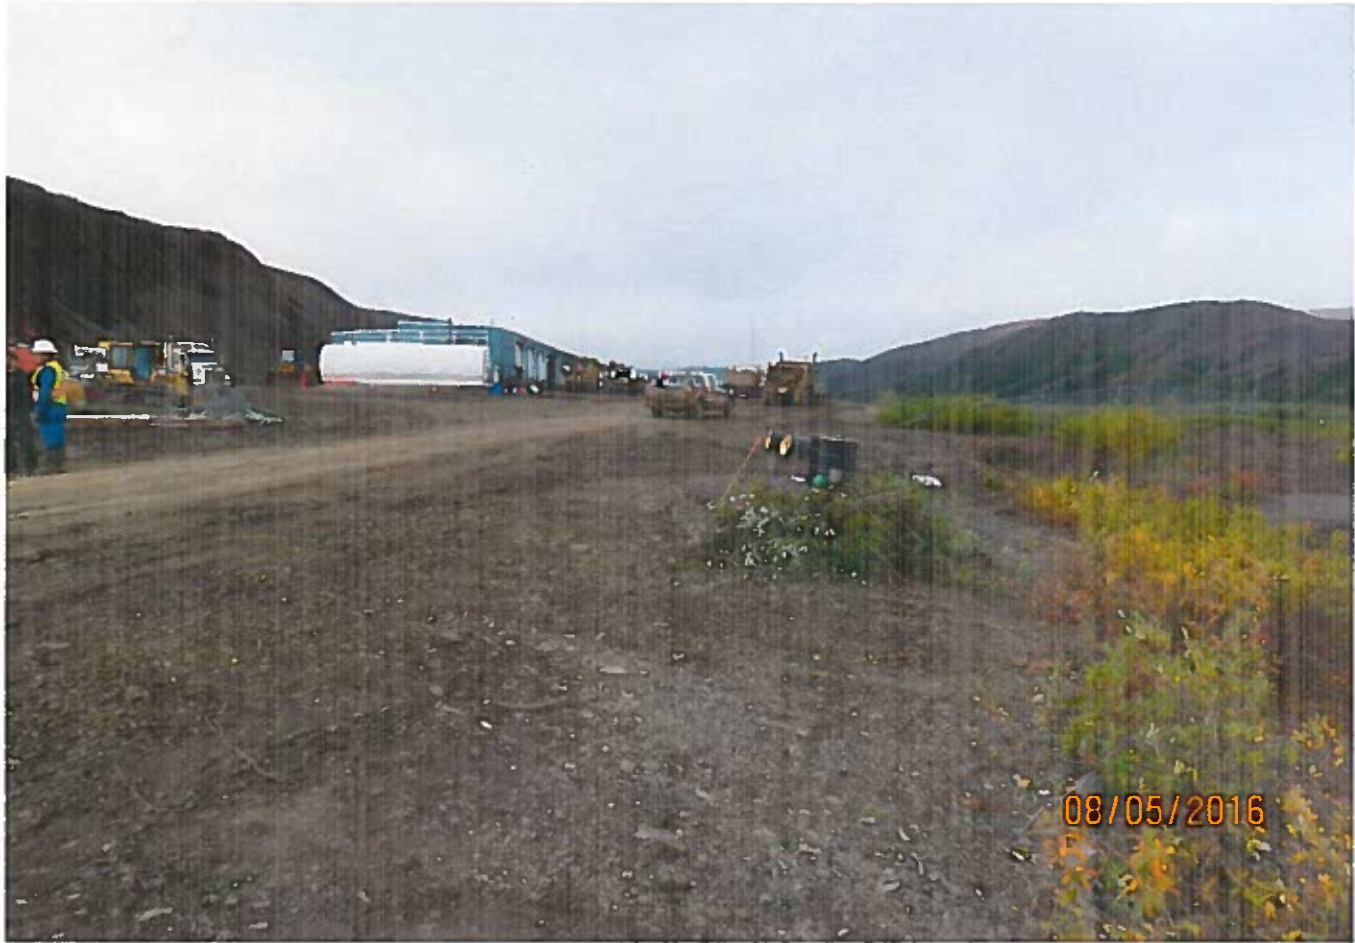
Figure 3

This area will be excavated near the end

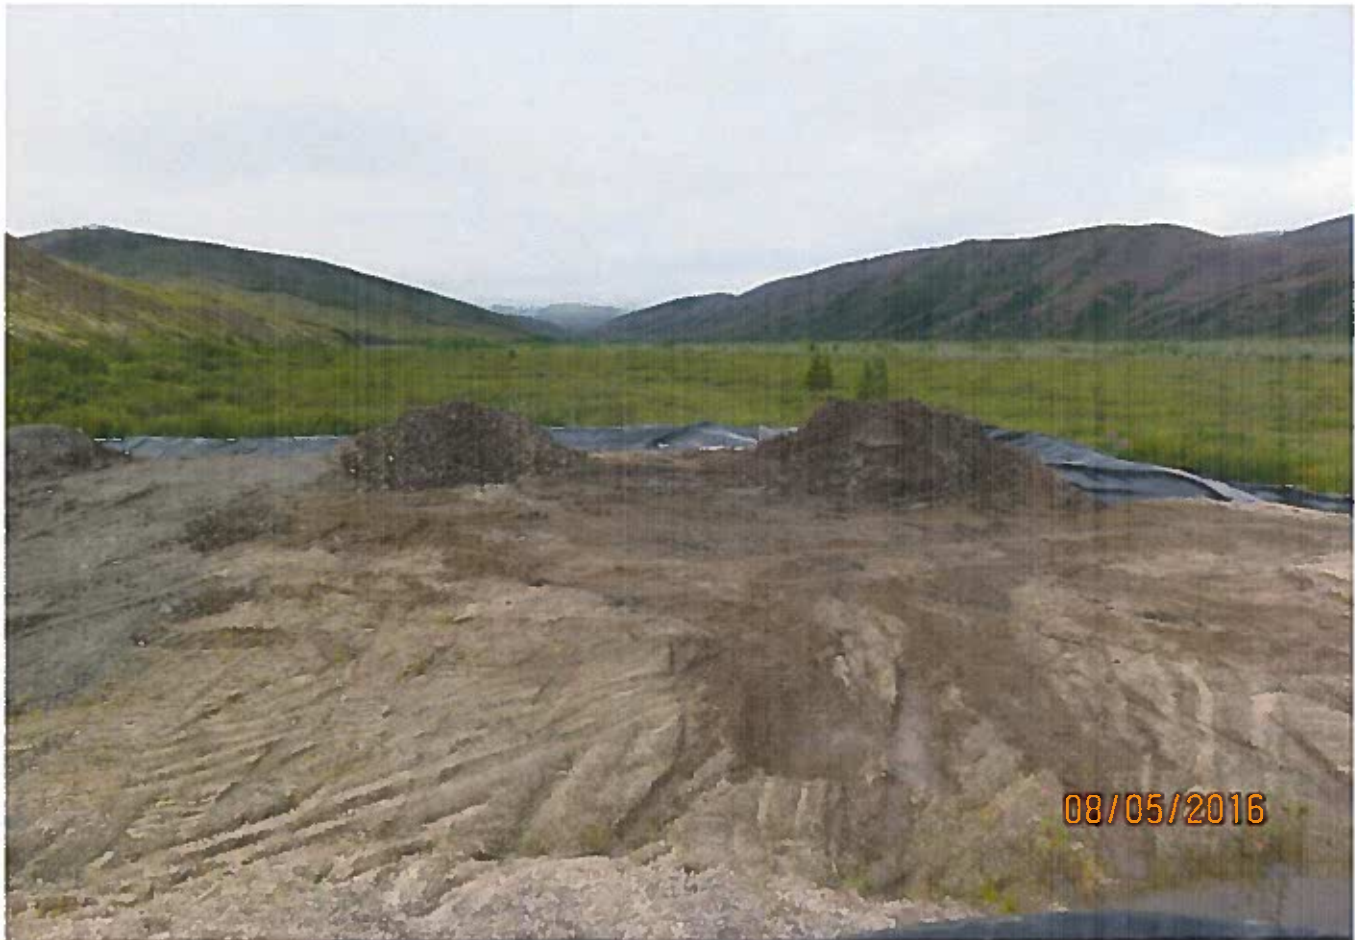
Figure 4

The impacted over burden was placed in the berm behind the James creek camp site for the time being and will be removed later and shipped south.

over burden stored in berm behind James Creek camp
