File Number G13H004
Type of Operation FUEL CACHES
Location James Creek Km 14.2

ENVIRONMENTAL INSPECTION REPORT

| Location(s) Inspected: | James Creek Km 14.2 | | |

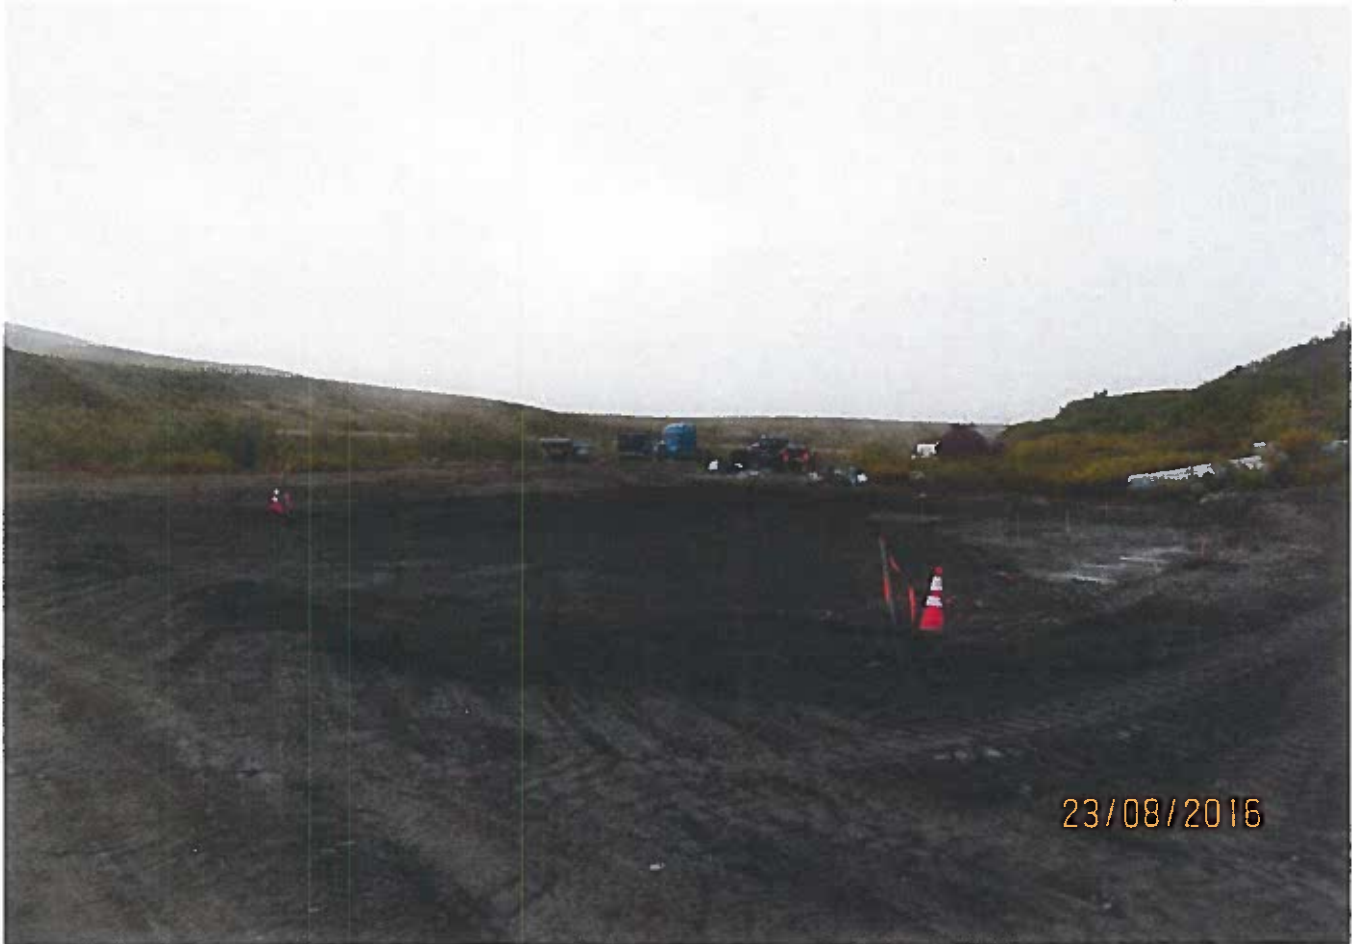
Figure 1

During this inspection it was observed that work with the fuel spill is on going and at present it is estimated that approximately 2200 cubic meters of contaminated soil was removed from site to a proper disposal facility in Whitehorse. It was also observed that there is more contaminated material in the land farm, this material is also to be removed from site as indicated in the remediation Plan provided. The concern here would be the fact the current material on site has not been turned or maintained properly as indicated in past inspections.

Area of contaminated soil removed by hill side

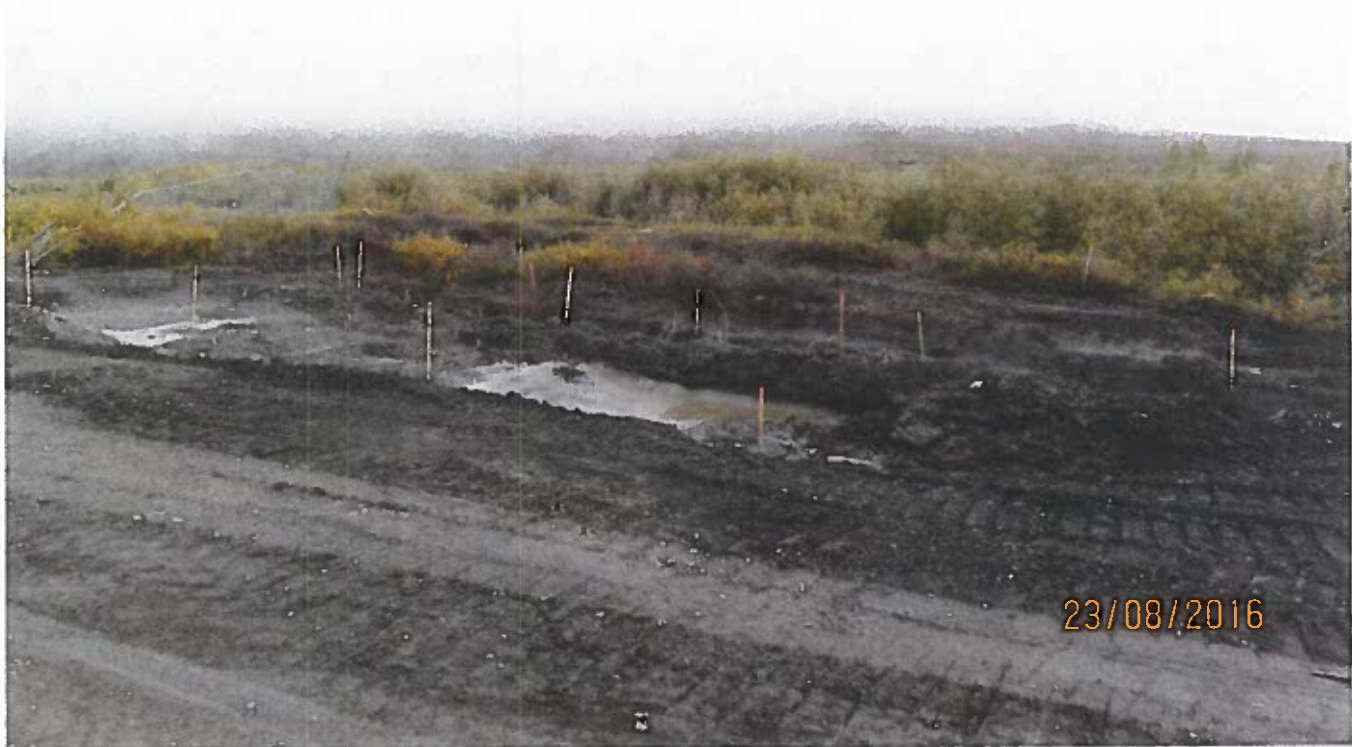
Figure 2

Posts indicated as sample locations taken

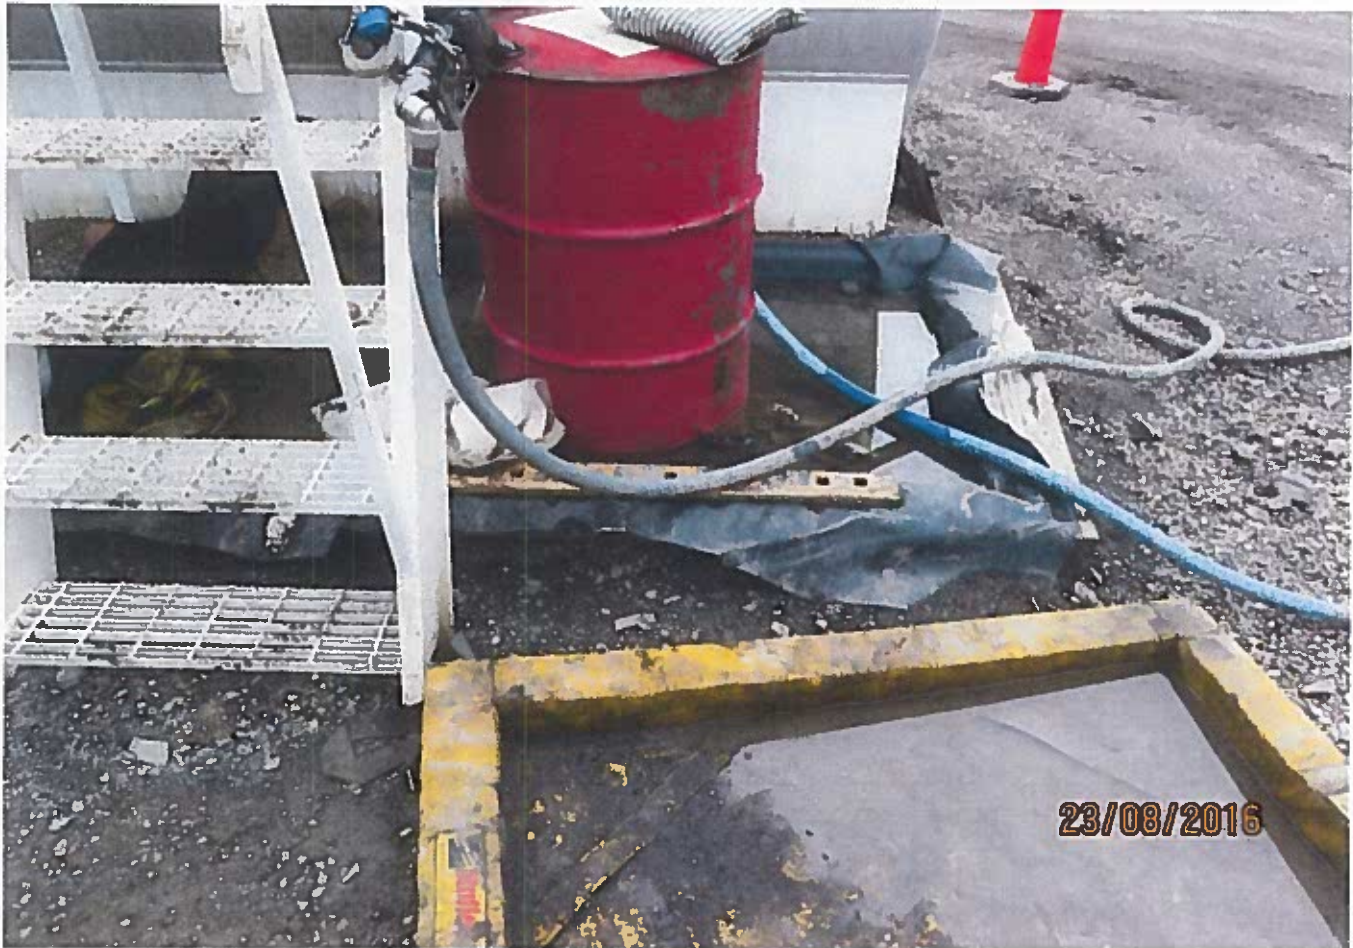
Figure 3

west side of the fuel storage tank water is filling in the drip trap and should be emptied.

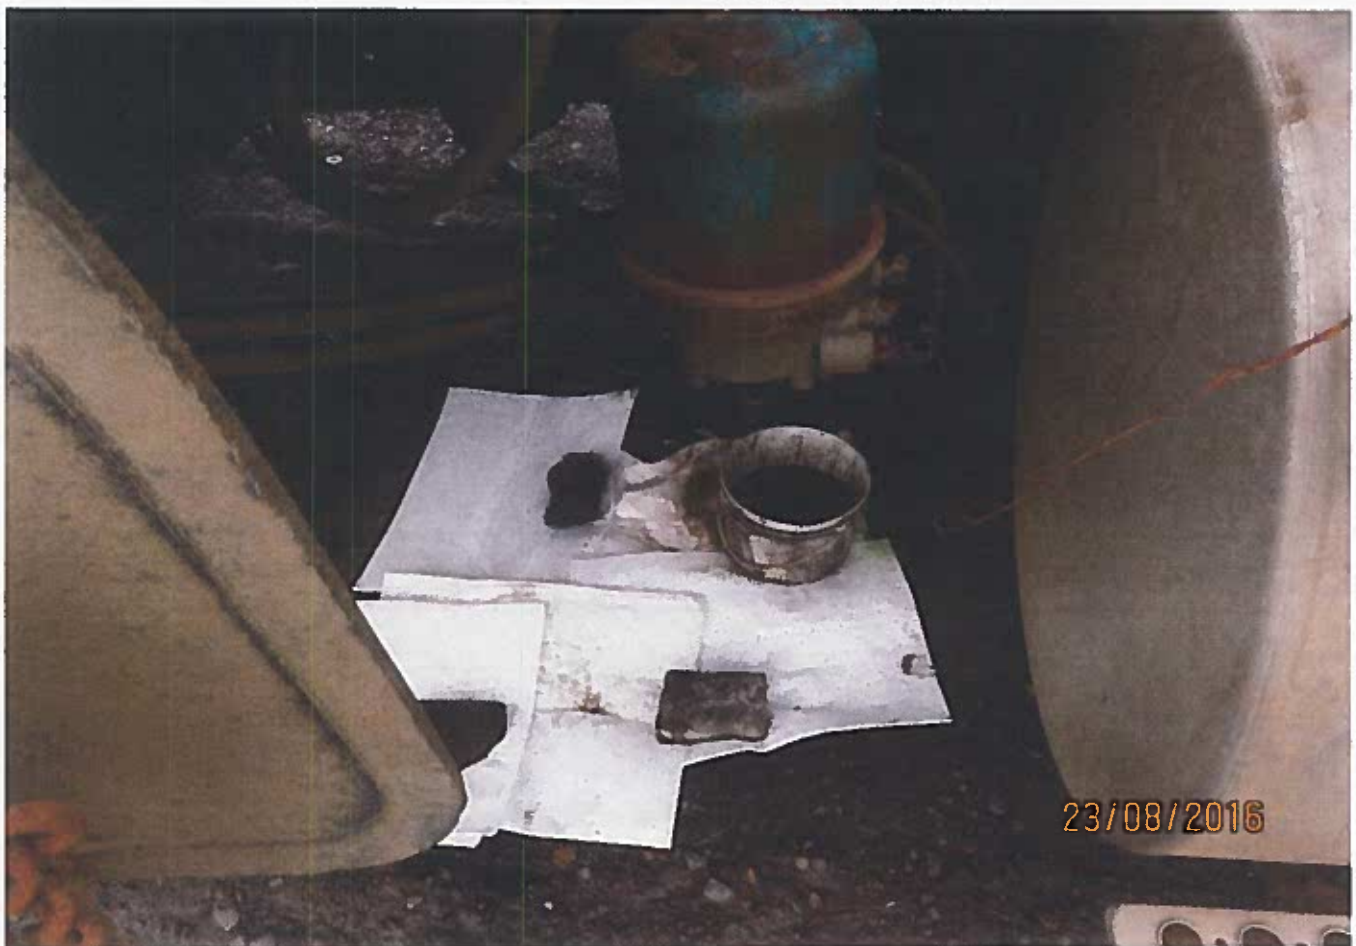
Figure 4

work on equipment outside of garage.

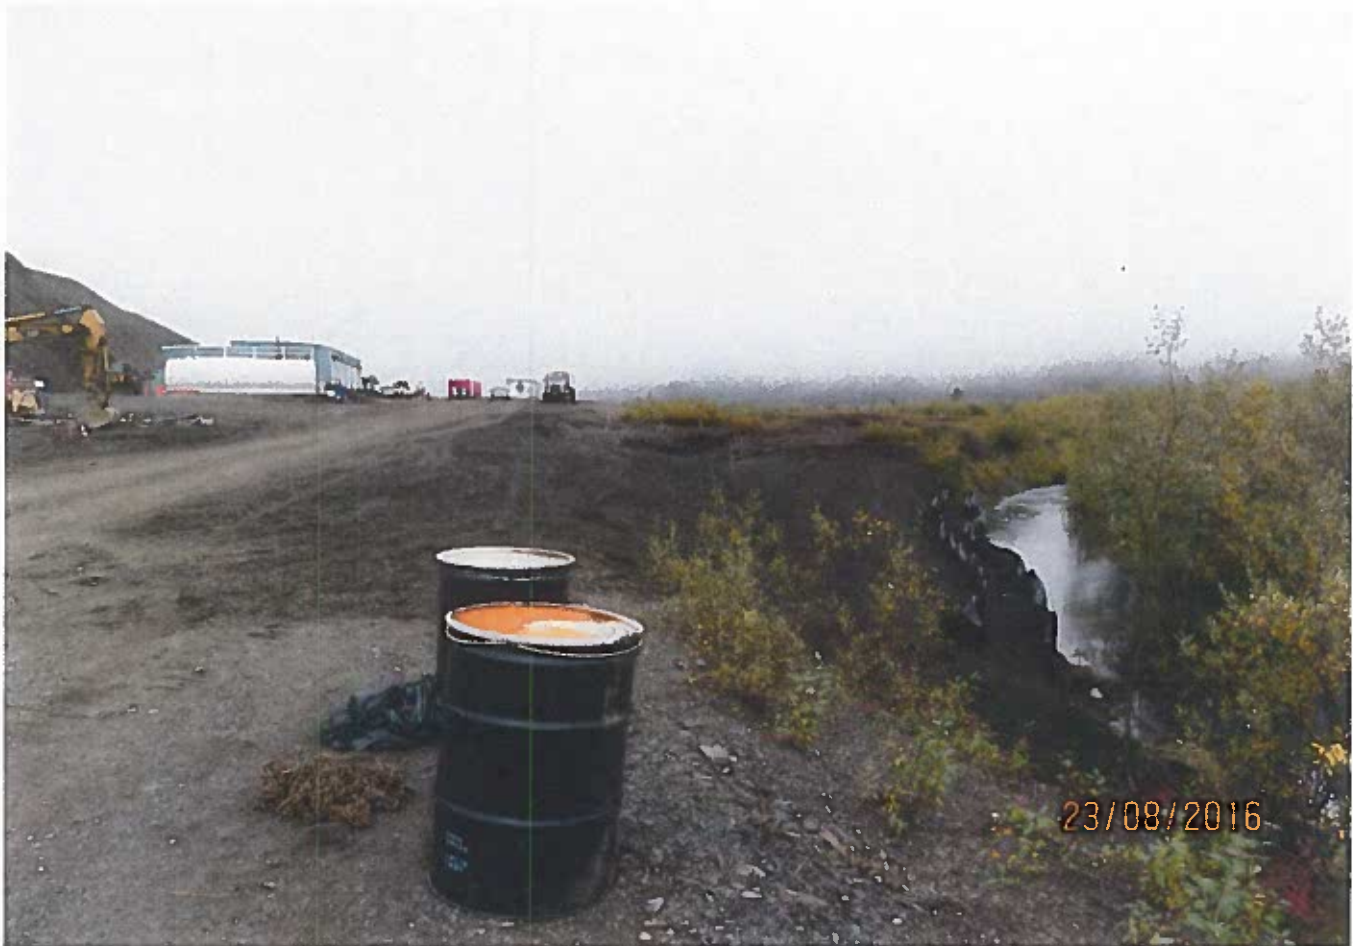
It was also learned that liners were placed prior to back filling the material. Please provide a detailed report as to where and how the liners were placed in by the creek to avoid underground travel of contaminates not removed from entering the creek.

Figure 5
view of back filled material by creek

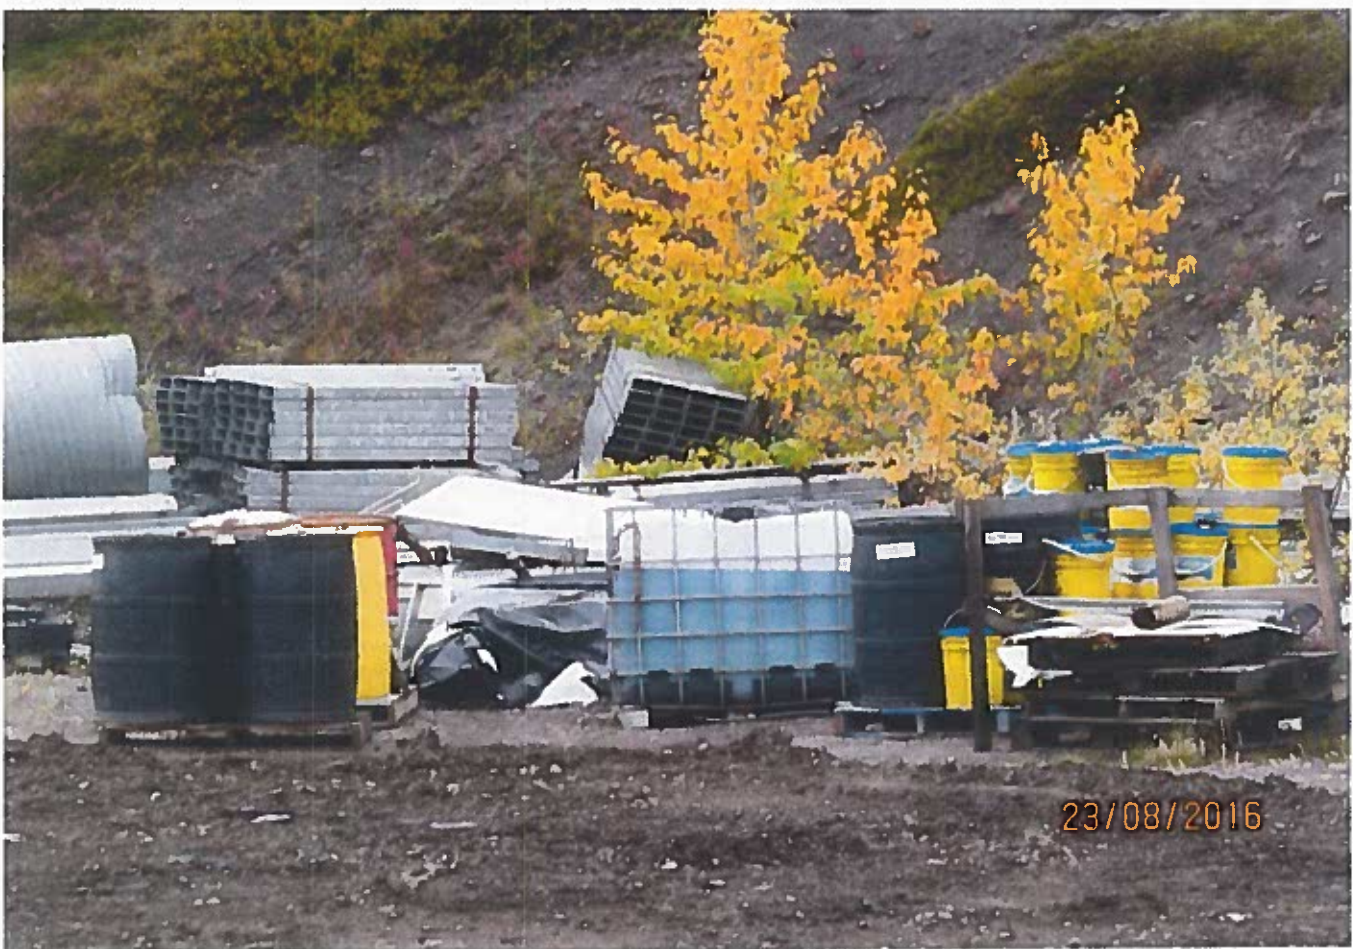
Also observed that used oil is stored on site and should be removed from site by the hill side

near the entrance area.

This observation is non compliant with L.U.P. condition 26(1)(g) item #10 *Waste Petroleum Disposal*

Figure 6
used oil stored and to be removed from site

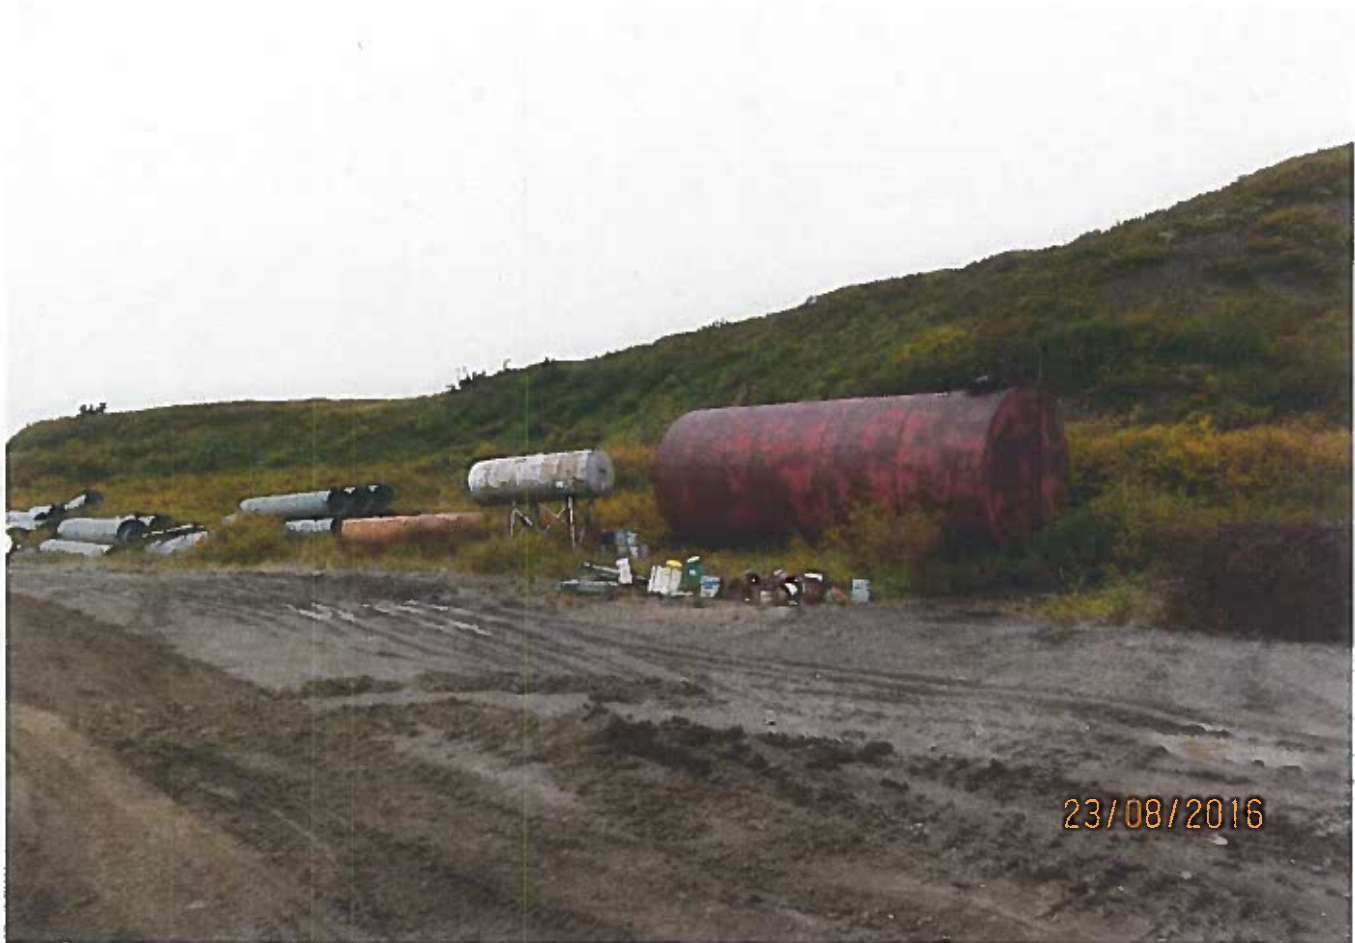
Figure 7

It was also observed that there are a number of metal debris , three tanks at by the hill side that are no longer in use by the left side of the entrance area that should be removed as these tanks may at some time produce hazards waste from leakage or run-off with rusts. It was further observed that near the land farm on a flat bed some garbage is piled there and as well on the ground which should be removed.

These observations are non compliant with L.U.P. condition 26 (1)(e) item # 6 Clean work Area and 26(1)(i) item # 13 Remove Garbage

3 unused tanks to be removed

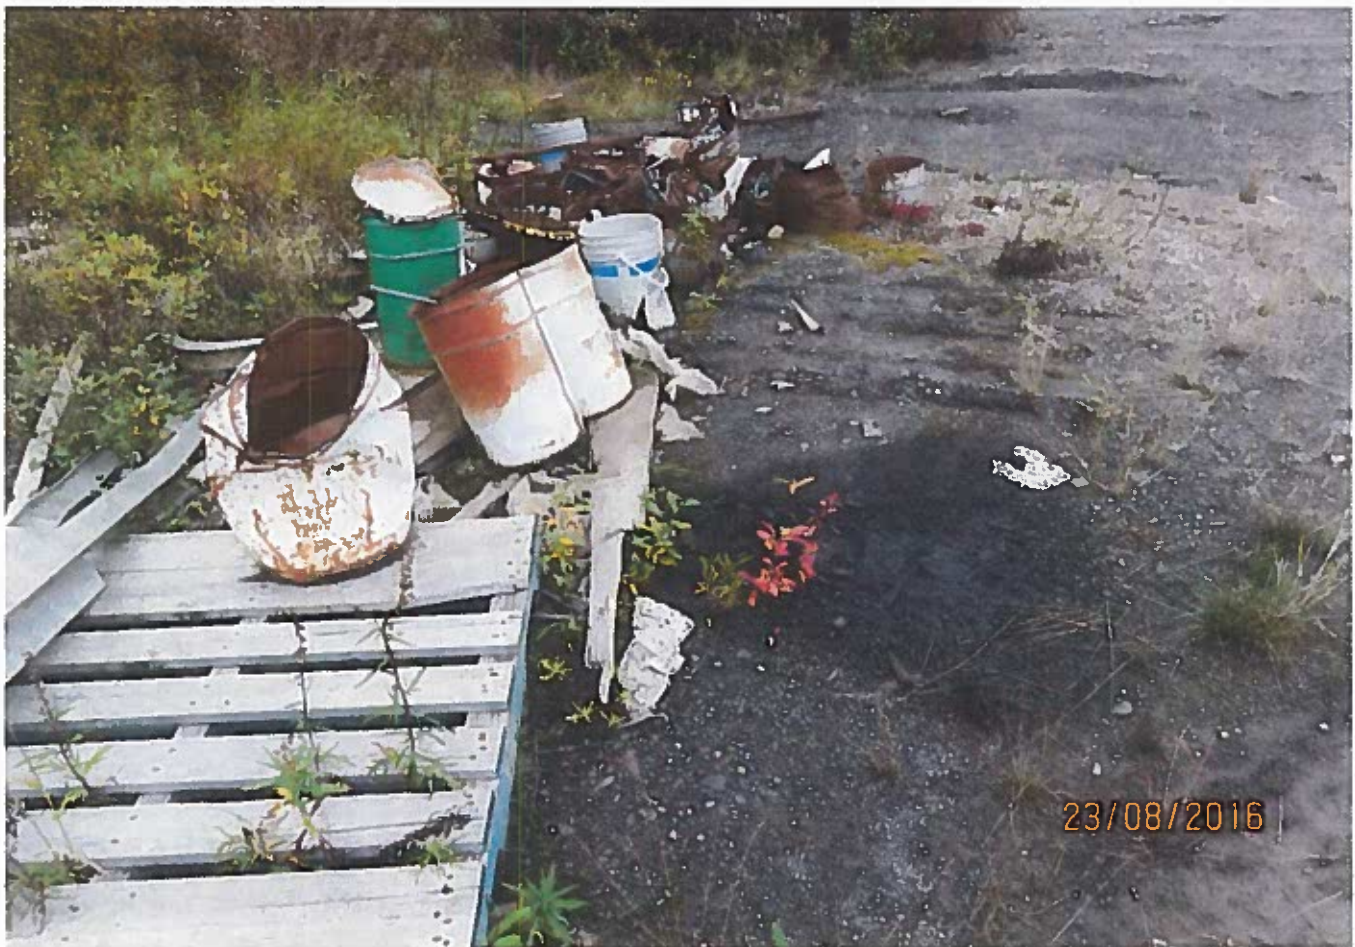
Figure 8

It was also observed by the old tanks that there was a small hydrocarbon or oil spill that is not cleaned up, this item is in non compliance with L.U.P. condition 26(1)(m) item # 27 *Clean up Spills*

spill to be cleaned up

It is further recommended that more work is to be done to the clean up in regards to containment of the spill.

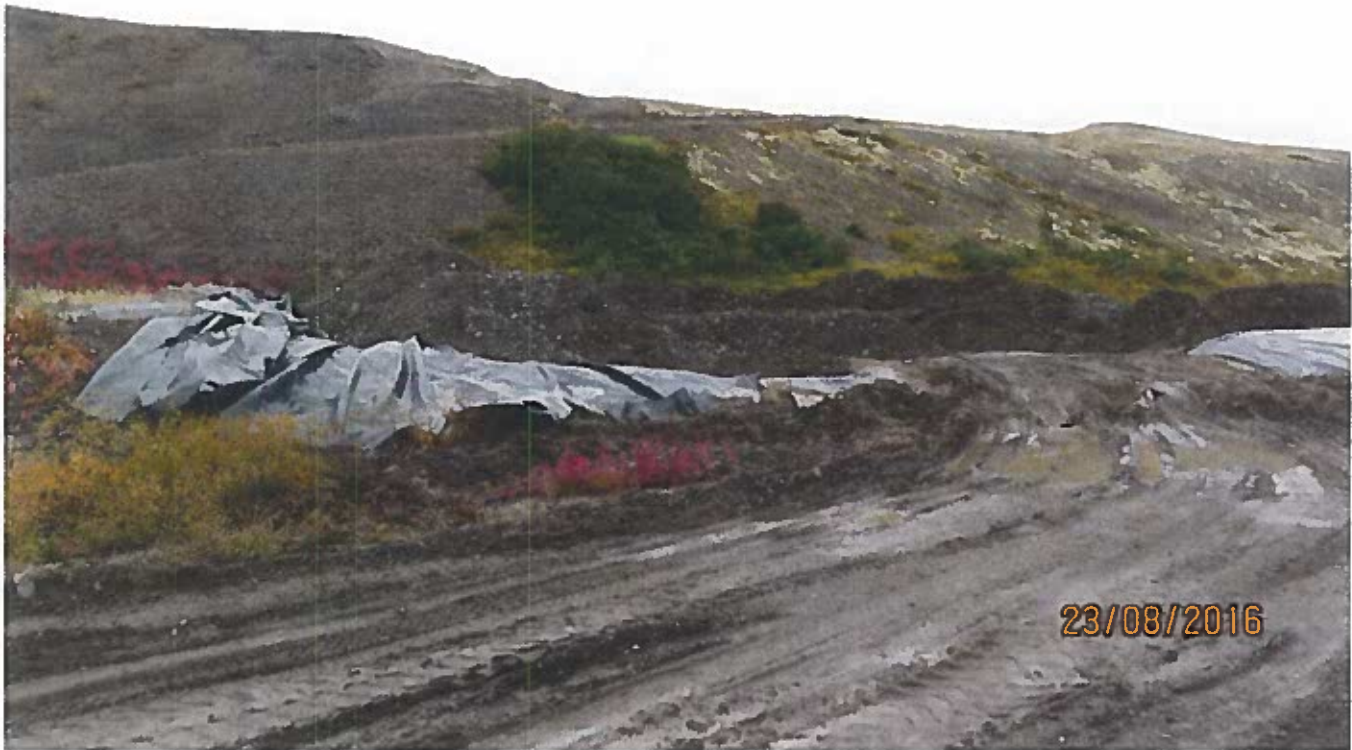
Figure 9
view of land farm with recently placed contaminated soil

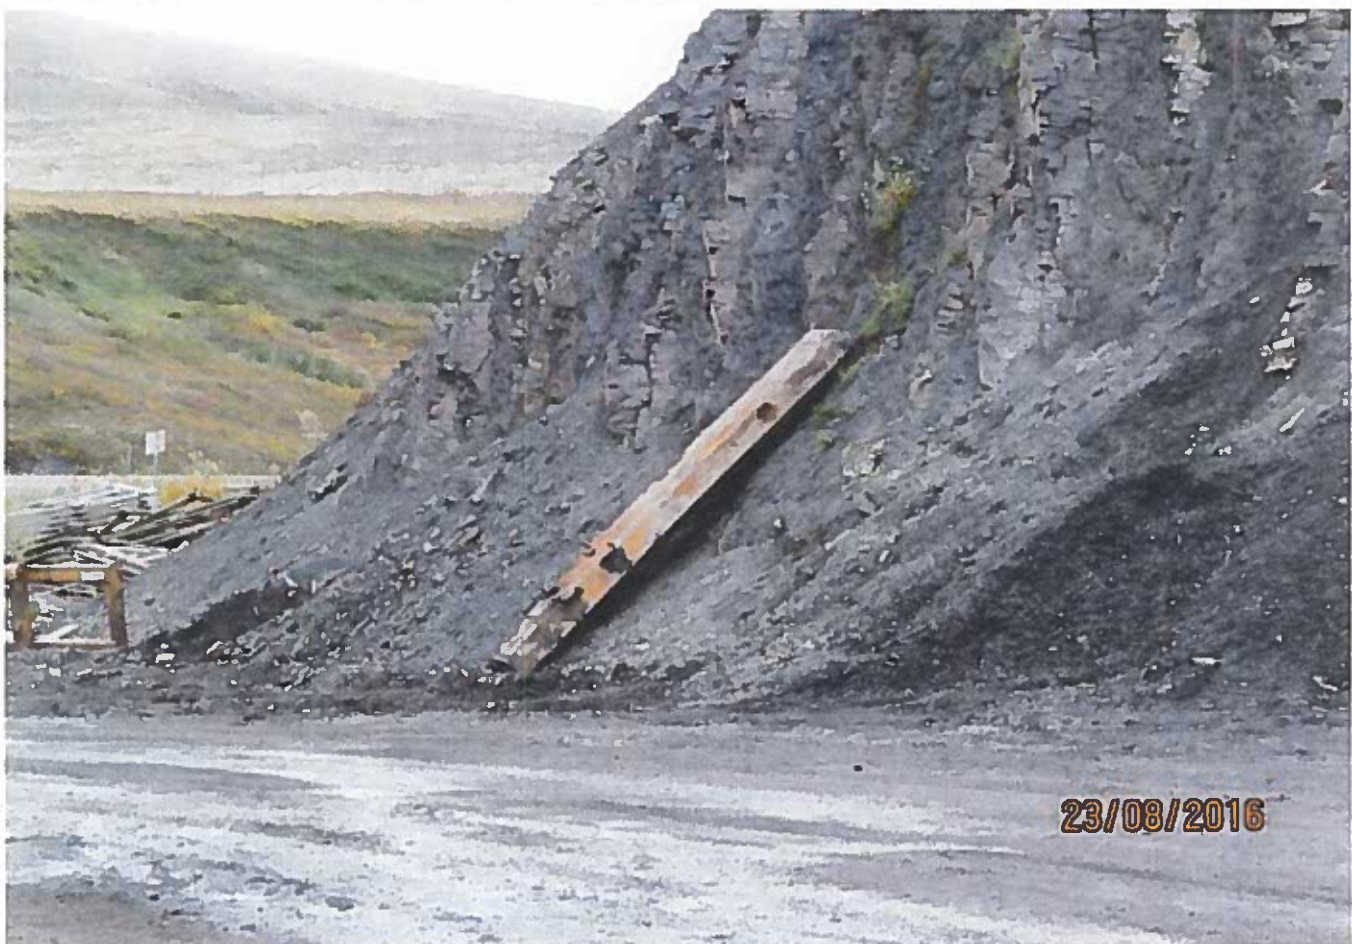
Figure 10
unused equipment blade

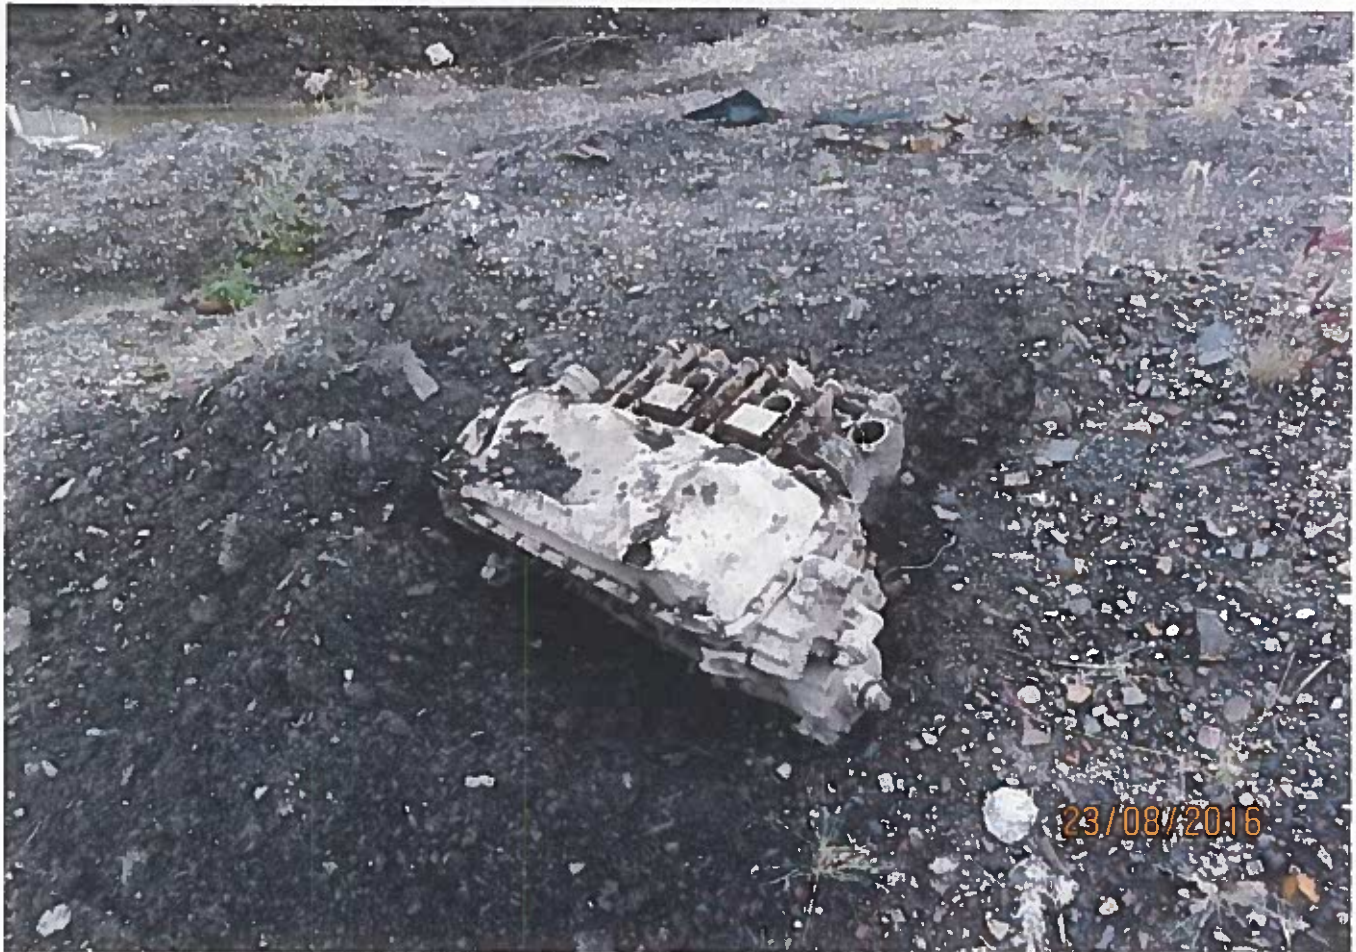
Figure 11
old engine

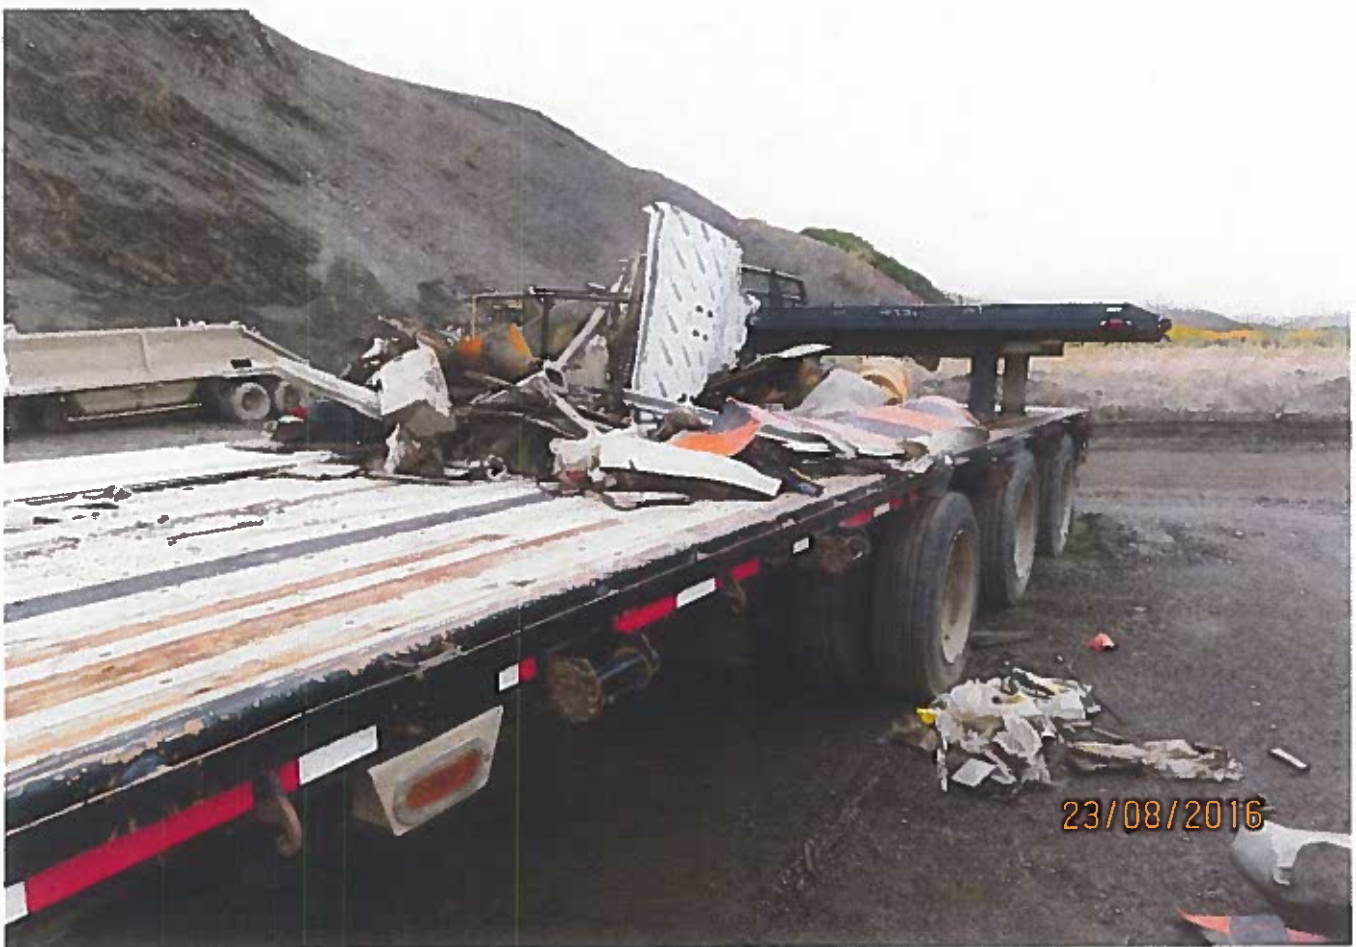
Figure 12
garbage and debris
