File Number G13H004
Type of Operation FUEL CACHES
Location James Creek

ENVIRONMENTAL INSPECTION REPORT

Permittee:	GNWT Department of Infrastructure	Permit Expiry Date:	August 11, 2020
Land Use Permit No.	G13H004	Previous Inspection:	February 20, 2019
Quarrying Permit No.		Inspection Date:	March 06, 2019
Contractor:	DOI	Subcontractor:	
Location(s) Inspected:	James Creek		
Current Stage of Operation:	On-going		
Program Modifications Approved:

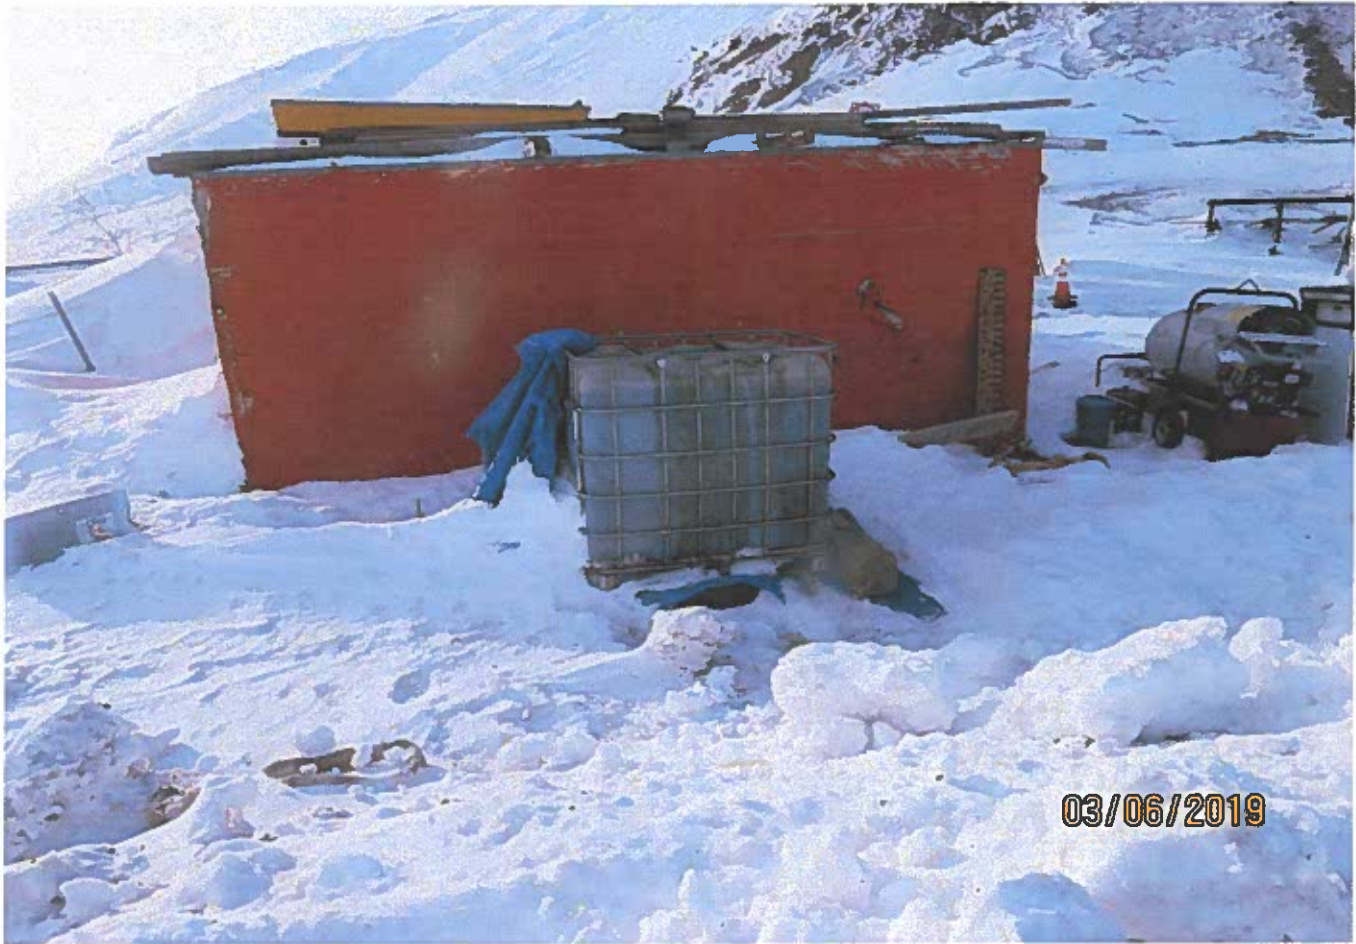
Figure 1

The large storage container of used oil has not been placed in a secondary containment or removed as requested in the last inspection report dated February 20, 2019.

Please have these issues dealt with in a timely manner.

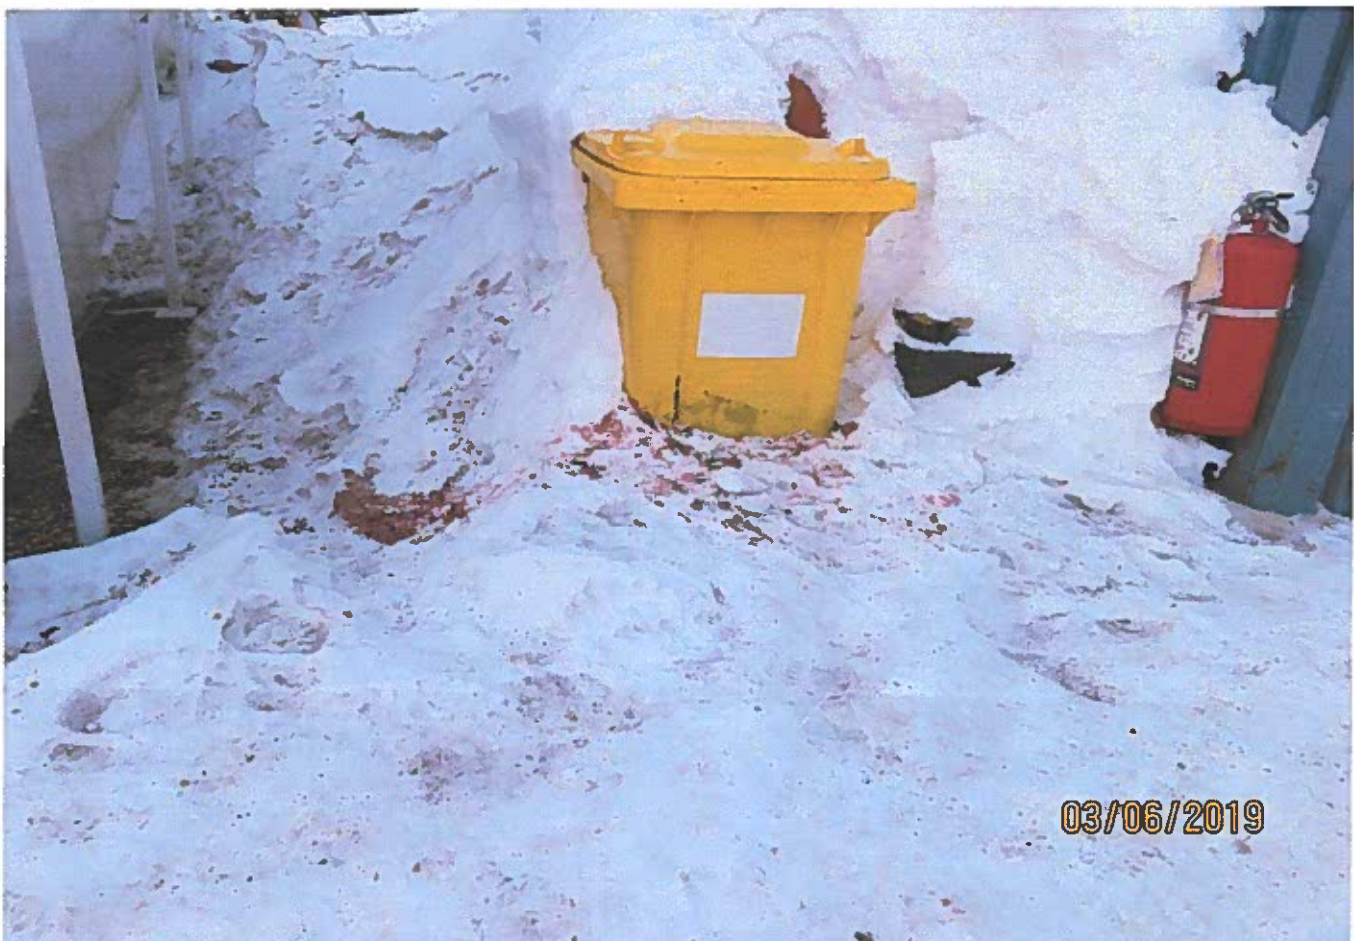
Figure 2

There is some spills in 2 places on site which look like hydraulic fluid, 1 near the fueling pump and 1 at the garage door entrance closest to the fueling pump. The rest of the site looks in good order.
