**File Number** G13H004  
**Type of Operation** FUEL CACHES  
**Location** James Creek Km 14.2

## ENVIRONMENTAL INSPECTION REPORT

<b>Permittee:</b>	GNWT Department of Infrastructure	<b>Permit Expiry Date:</b>	August 11, 2020
<b>Land Use Permit No.</b>	G13H004	<b>Previous Inspection:</b>	September 25, 2018
<b>Quarrying Permit No.</b>		<b>Inspection Date:</b>	October 11, 2018
<b>Contractor:</b>	DOI	<b>Subcontractor:</b>	
<b>Location(s) Inspected:</b>	James Creek Km 14.2		
<b>Current Stage of Operation:</b>	on-going		
<b>Program Modifications Approved:</b>

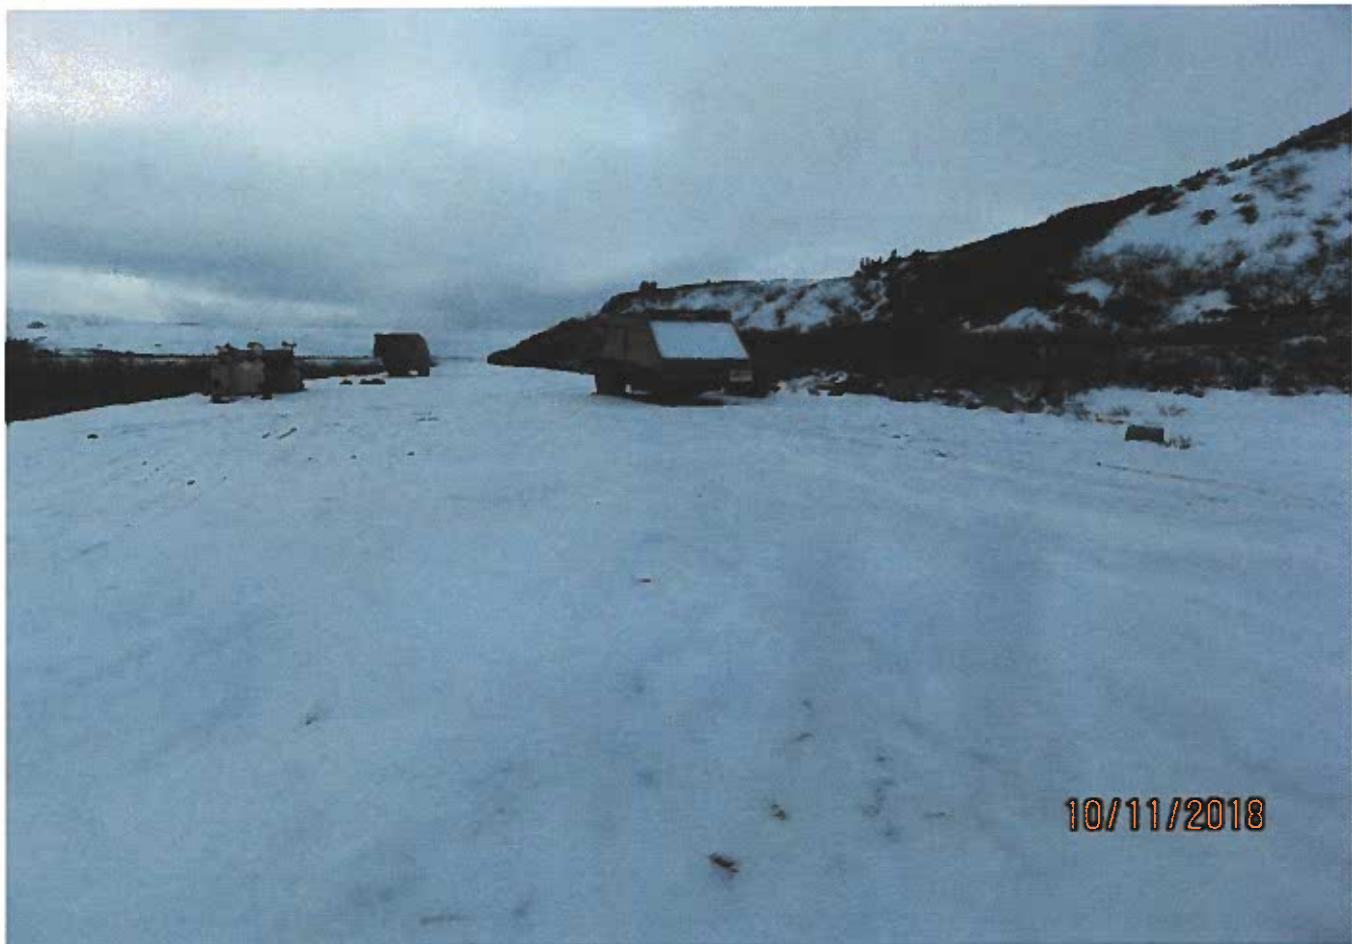
Figure 1

The hydraulic fluid in the end dump ram was not drained or capped and now there is a spill under the ram. With snow cover in the area, it is unknown how much is on the ground under the ram. The canvas material beside the land farm was not removed as requested in the August 23, 2018 and September 25, 2018 inspection reports. If this end dump is not on the equipment list for the Land Use permit for this site then it should be removed.
