RE: Land Use Permit G13H004
FUEL CACHES
James Creek

ENVIRONMENTAL INSPECTION REPORT

Permittee:	GNWT Department of Transportation	Permit Expiry Date:	August 11, 2018
Land Use Permit No.	G13H004	Previous Inspection:	August 28, 2015
Quarrying Permit No.		Inspection Date:	August 28, 2015
Contractor:		Subcontractor:	
Location(s) Inspected:	James Creek		
Current Stage of Operation:			
Program Modifications Approved:

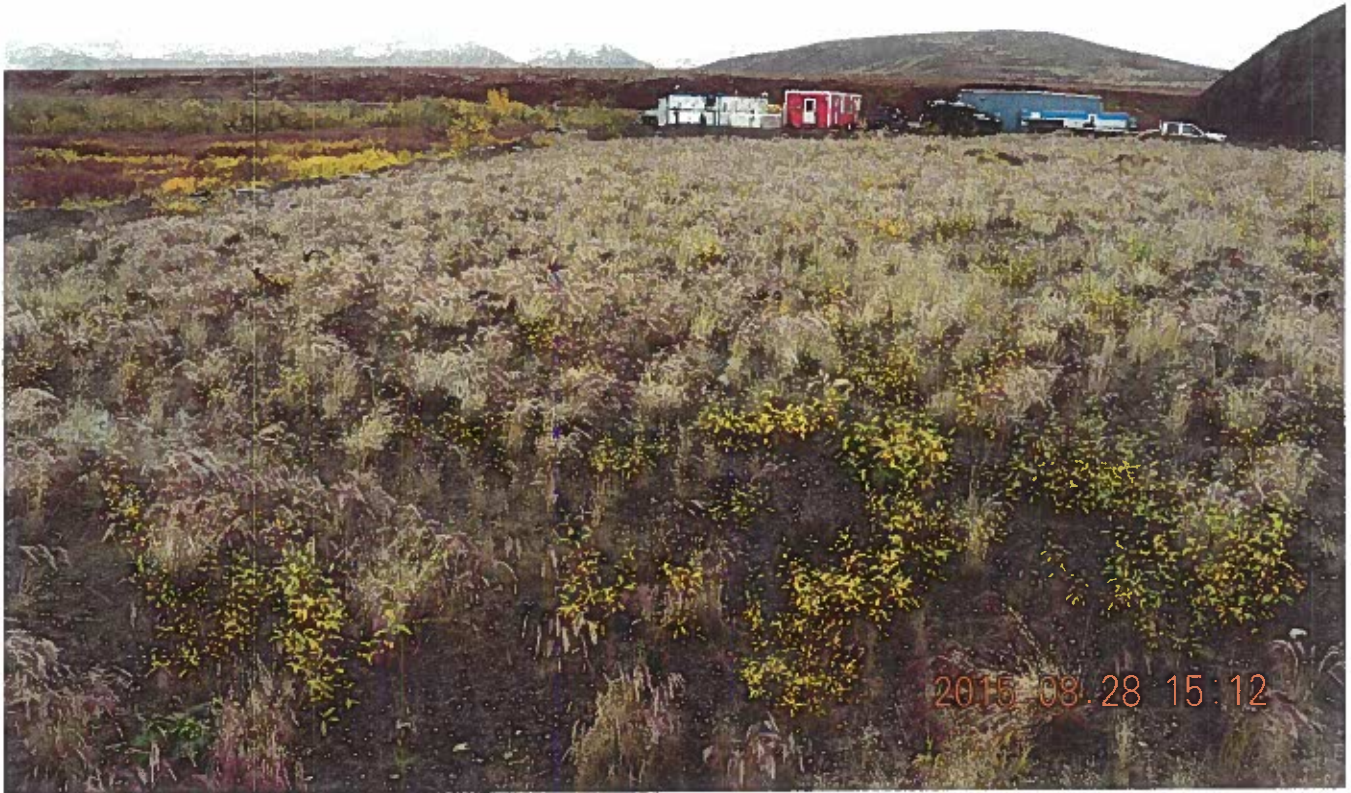
Figure 1

At the contaminated land farm the contaminated gravel should be covered to ensure rain and spring runoff of petroleum products does not spread into nearby watercourses as stated in the Terms and Conditions.

Contaminated soil inside the berm has not be turned

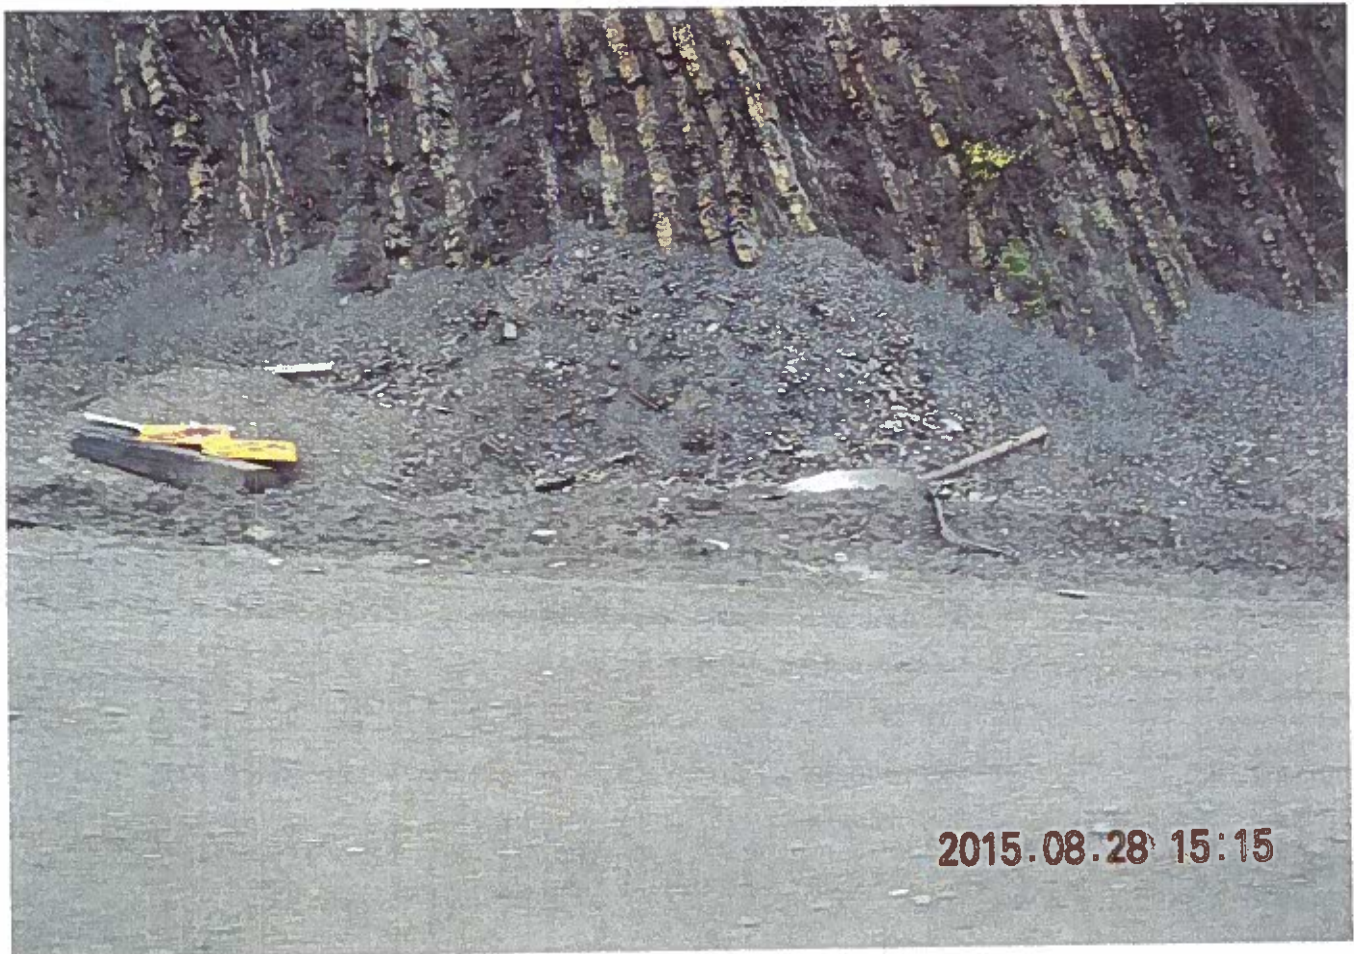
Figure 2

Debris at the site has not been cleaned up as stated in the last inspection report.

Debris at the site not cleaned up

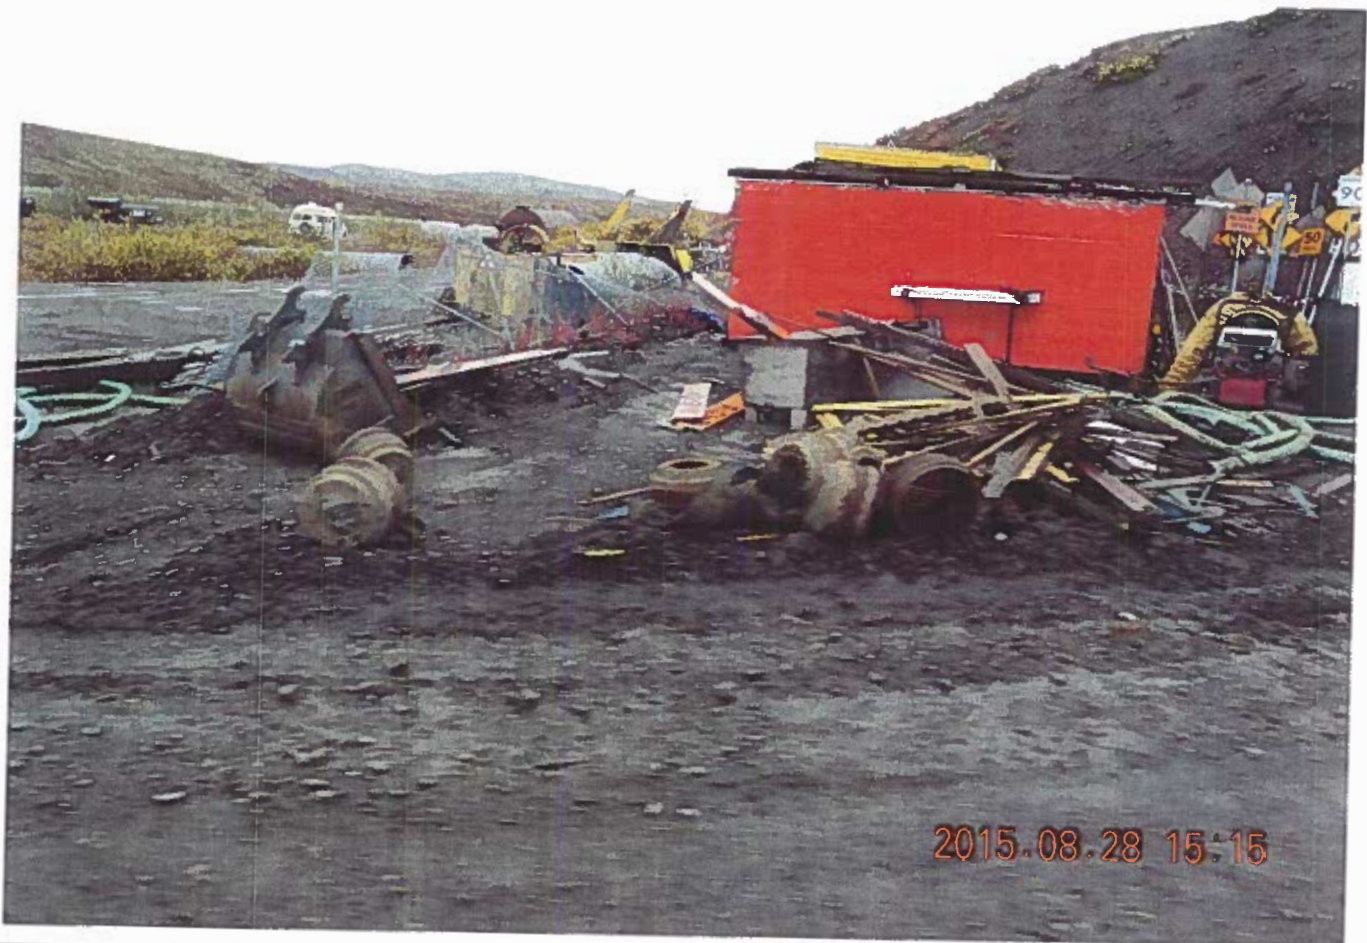
Figure 3

Debris at site not cleaned up

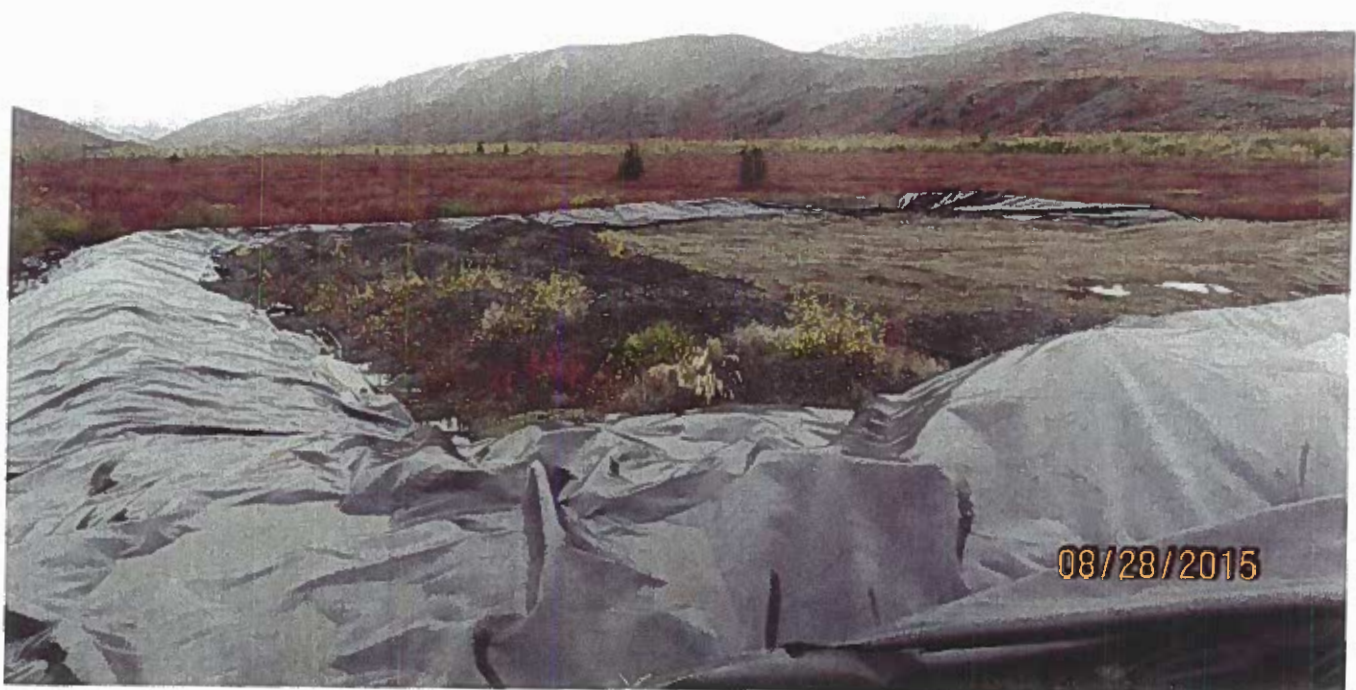
Figure 4

Contaminated soil in berm has not been turned

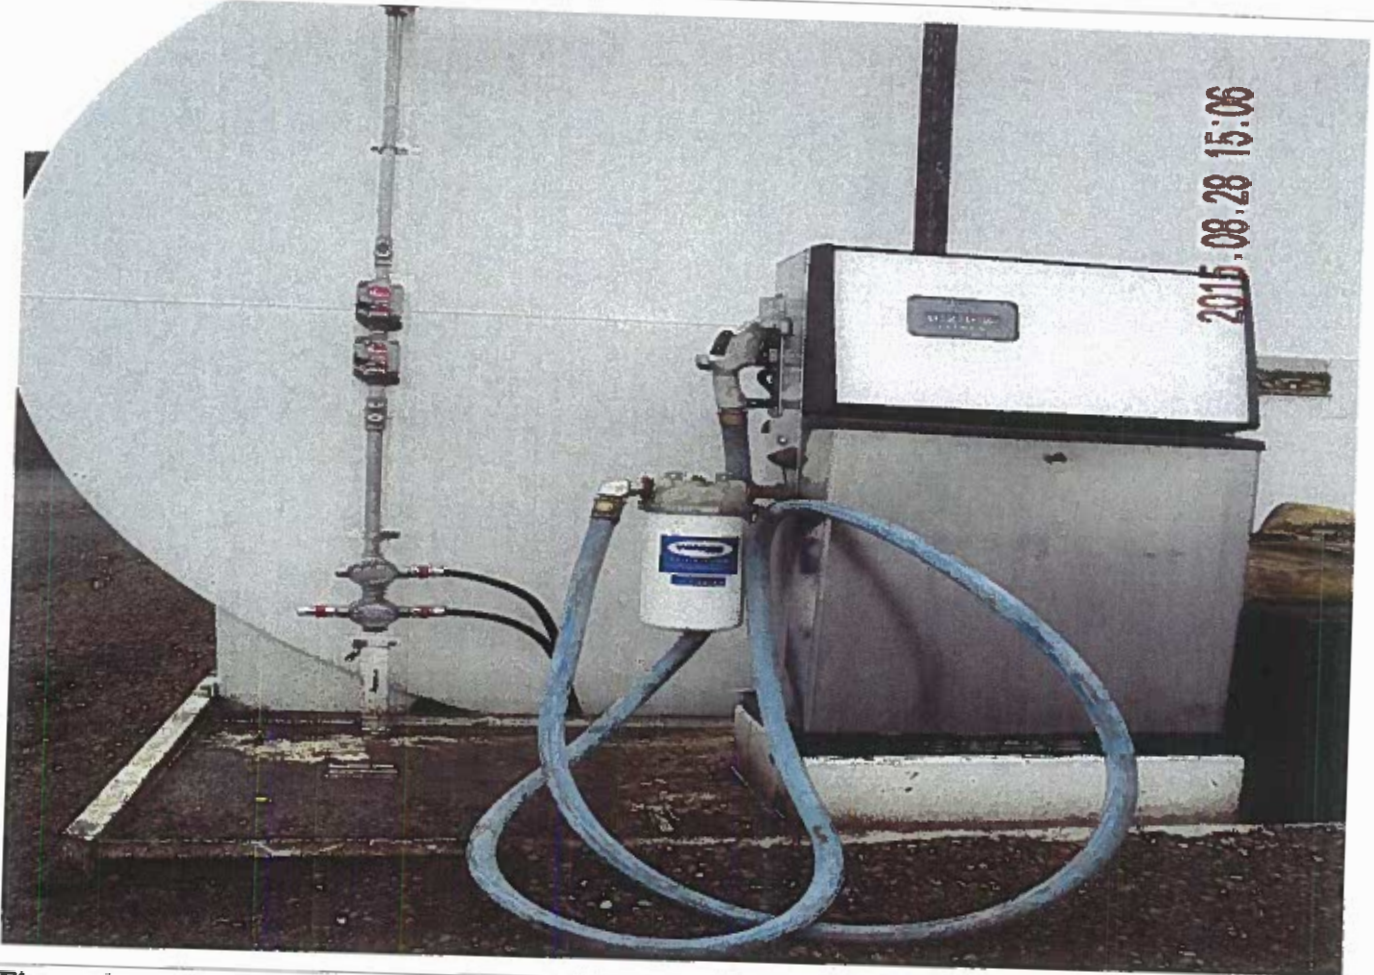
Figure 5

There is no secondary containment set up for the refueling.

22. The permittee shall set up all refuelling points with secondary containment.

No secondary containment at refueling station.

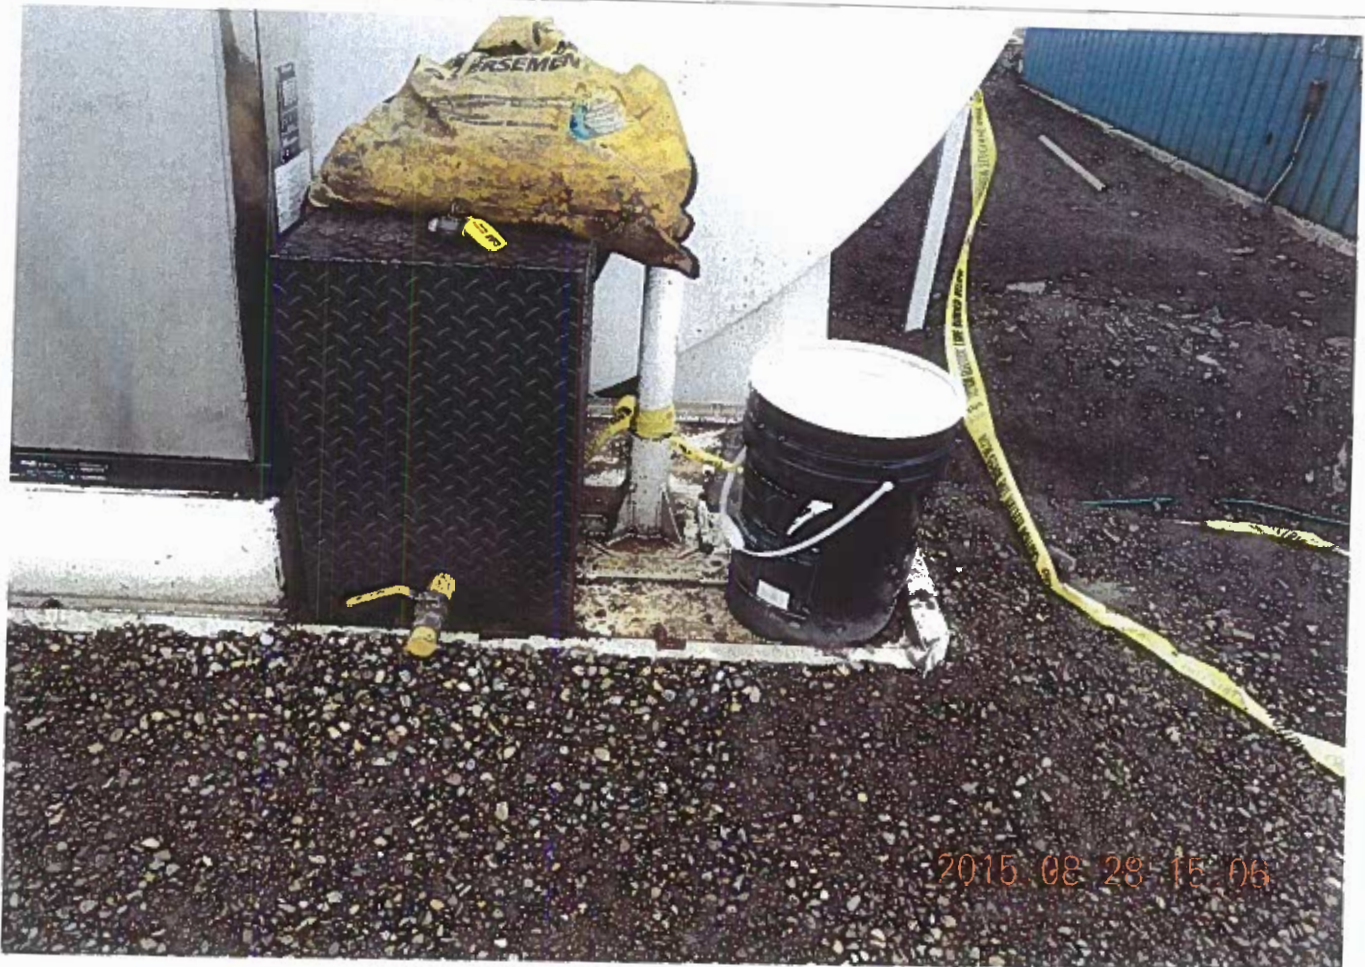
Figure 6

No secondary containment at refueling station.
