File Number: G13H004
Type of Operation: FUEL CACHES
Location: James Creek Km 14.2

ENVIRONMENTAL INSPECTION REPORT

Permittee:	GNWT Department of Infrastructure	Permit Expiry Date:	August 11, 2018
Land Use Permit No.	G13H004	Previous Inspection:	September 12, 2018
Quarrying Permit No.		Inspection Date:	September 25, 2018
Contractor:	DOI	Subcontractor:	
Location(s) Inspected:	James Creek Km 14.2		
Current Stage of Operation:	On-going		
Program Modifications Approved:

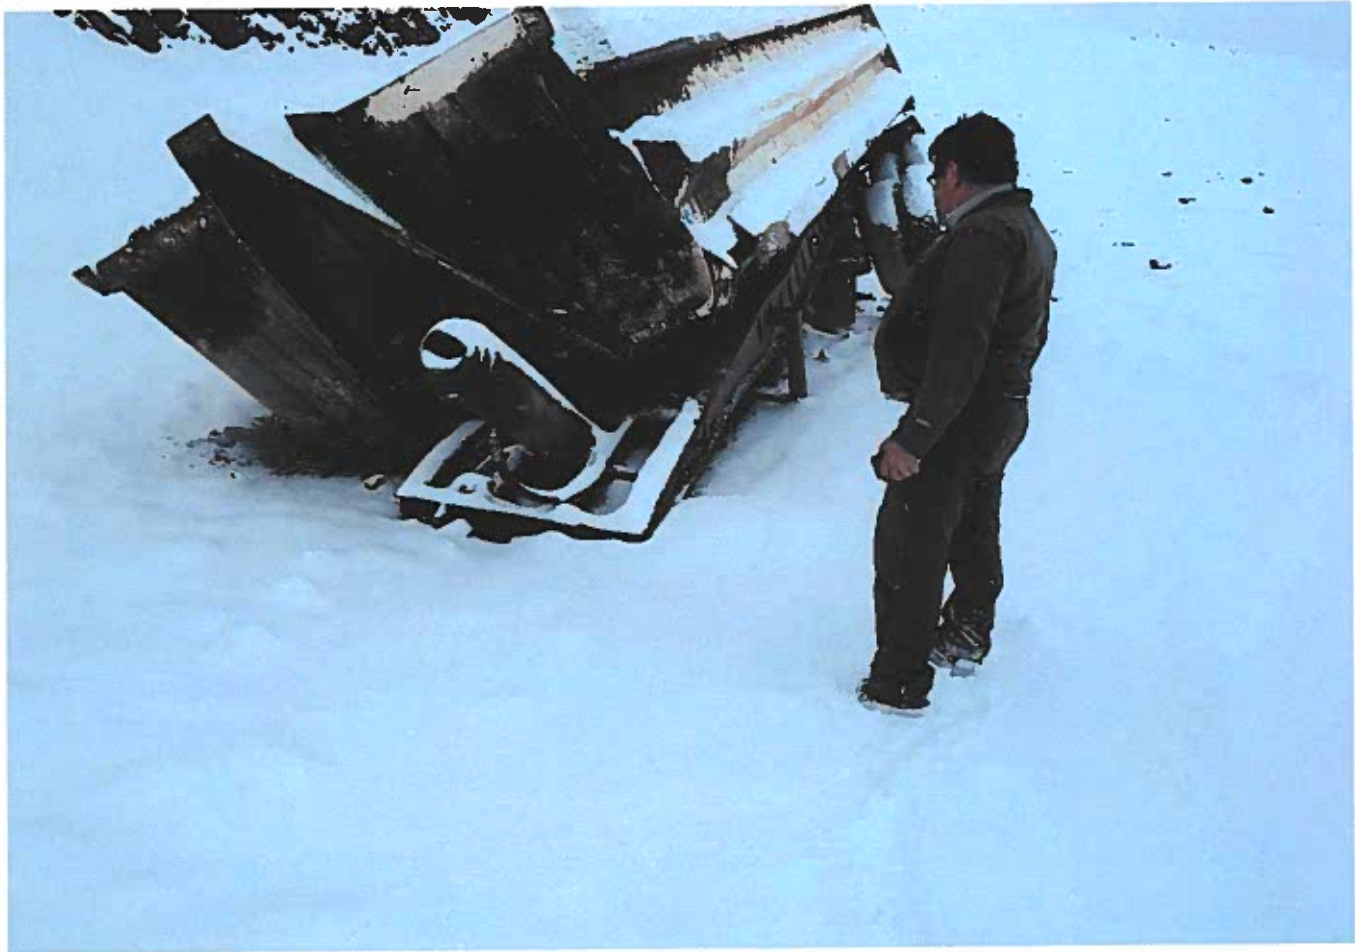
Figure 1

The hydraulic fluid in the end dump ram was not drained or capped and can still create a spill with snow displacement. With snow cover in the area, it is unknown if the spill on the ground under the ram was cleaned up. The canvas material beside the land farm was not removed as requested in the August 23, 2018 inspection report.
