File Number G13H004
Type of Operation FUEL CACHES
Location James Creek

ENVIRONMENTAL INSPECTION REPORT

Permittee:	GNWT Department of Infrastructure	Permit Expiry Date:	August 11, 2018
Land Use Permit No.	G13H004	Previous Inspection:	June 19, 2017
Quarrying Permit No.		Inspection Date:	July 12, 2017
Contractor:		Subcontractor:	
Location(s) Inspected:	James Creek		
Current Stage of Operation:	on going		
Program Modifications Approved:	NIL

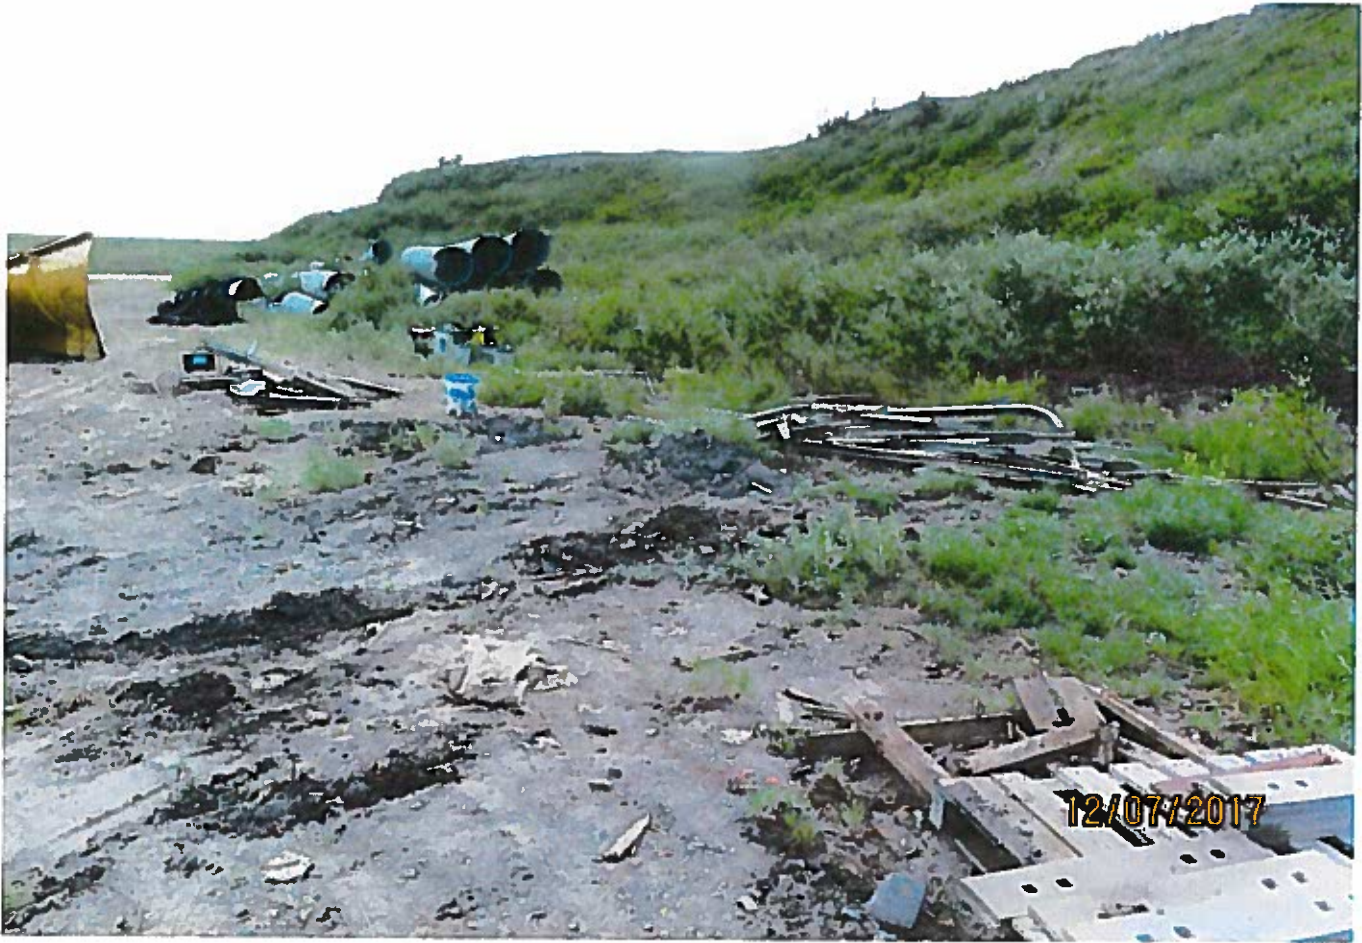
Figure 3
South entrance

It has been observed that at the fuel stage that a new hose and dispenser was recently installed since last inspection. The majority of previous inspection observations were dealt with accordingly, however at the southerly entrance area to the left the piping previously indicated is still at that location and should be removed as it is not being used. Also observed in this area was a single battery not contained and should be removed as well. On the other side of the road at the southerly end is more piping laying on the ground by the road and some garbage debri, these should be picked and removed as well. Aside from this location all other matters were satisfactory at the time of the inspection.
