File Number G13H004
Type of Operation FUEL CACHES
Location James Creek Km 14.2

ENVIRONMENTAL INSPECTION REPORT

Permittee:	GNWT Department of Infrastructure	Permit Expiry Date:	August 11, 2018
Land Use Permit No.	G13H004	Previous Inspection:	April 26, 2017
Quarrying Permit No.		Inspection Date:	June 19, 2017
Contractor:		Subcontractor:	
Location(s) Inspected:	James Creek Km 14.2		
Current Stage of Operation:	ongoing		
Program Modifications Approved:	NIL

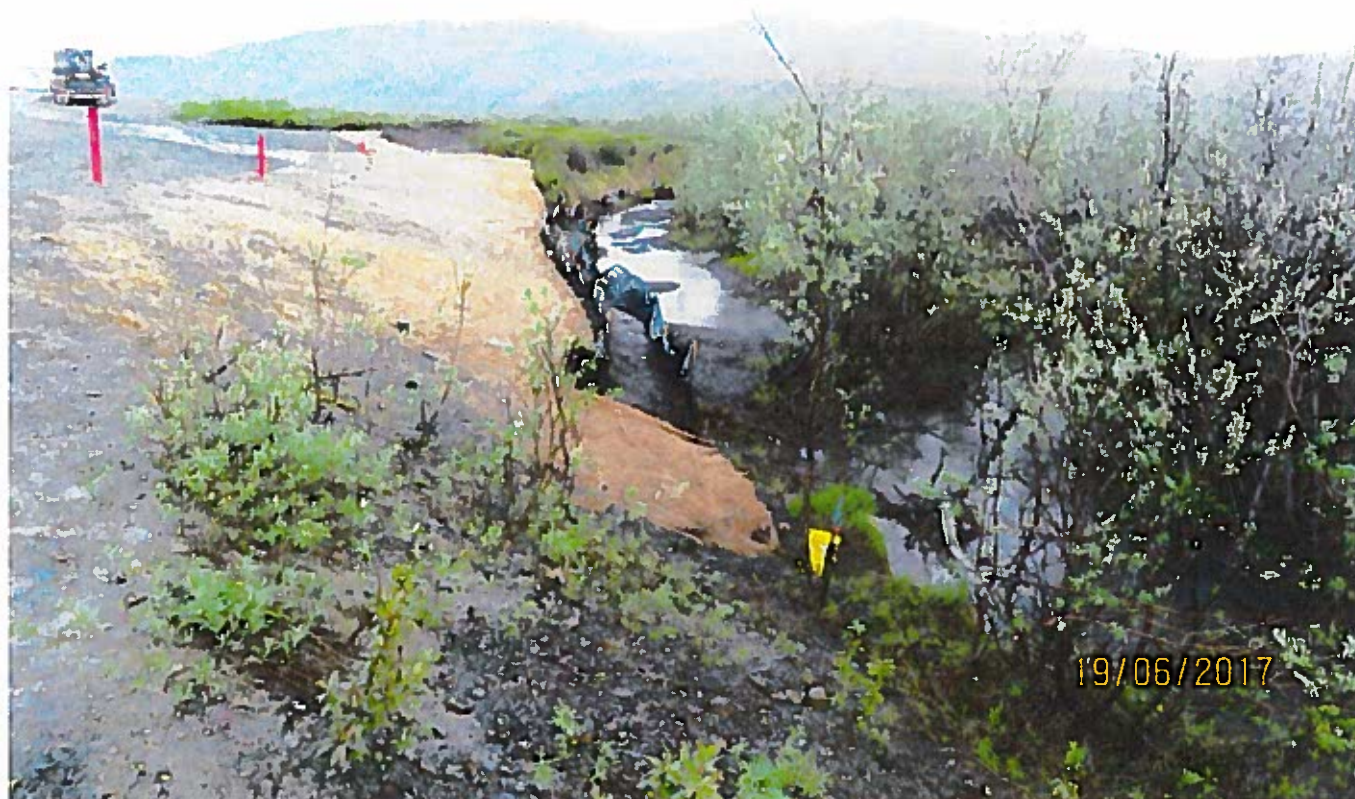
Figure 1

As the freshet is all done with the previous spill reclamation by the creek looks satisfactory, it was observed at the southerly entrance area there is numerous used tires piled as well some metal piping laying in the area, there was also more used tires by the land farm area. Beside the land farm by the hill a white plastic fender portion of the rigs that were involved in a earlier accident is still stored there, as well as some garbage debri in that area. In the land farm there are numerous zip-lock bags there. These items mentioned are in contravention of condition 26(1)(e) Keep work area clean.

Previous spill reclamation area

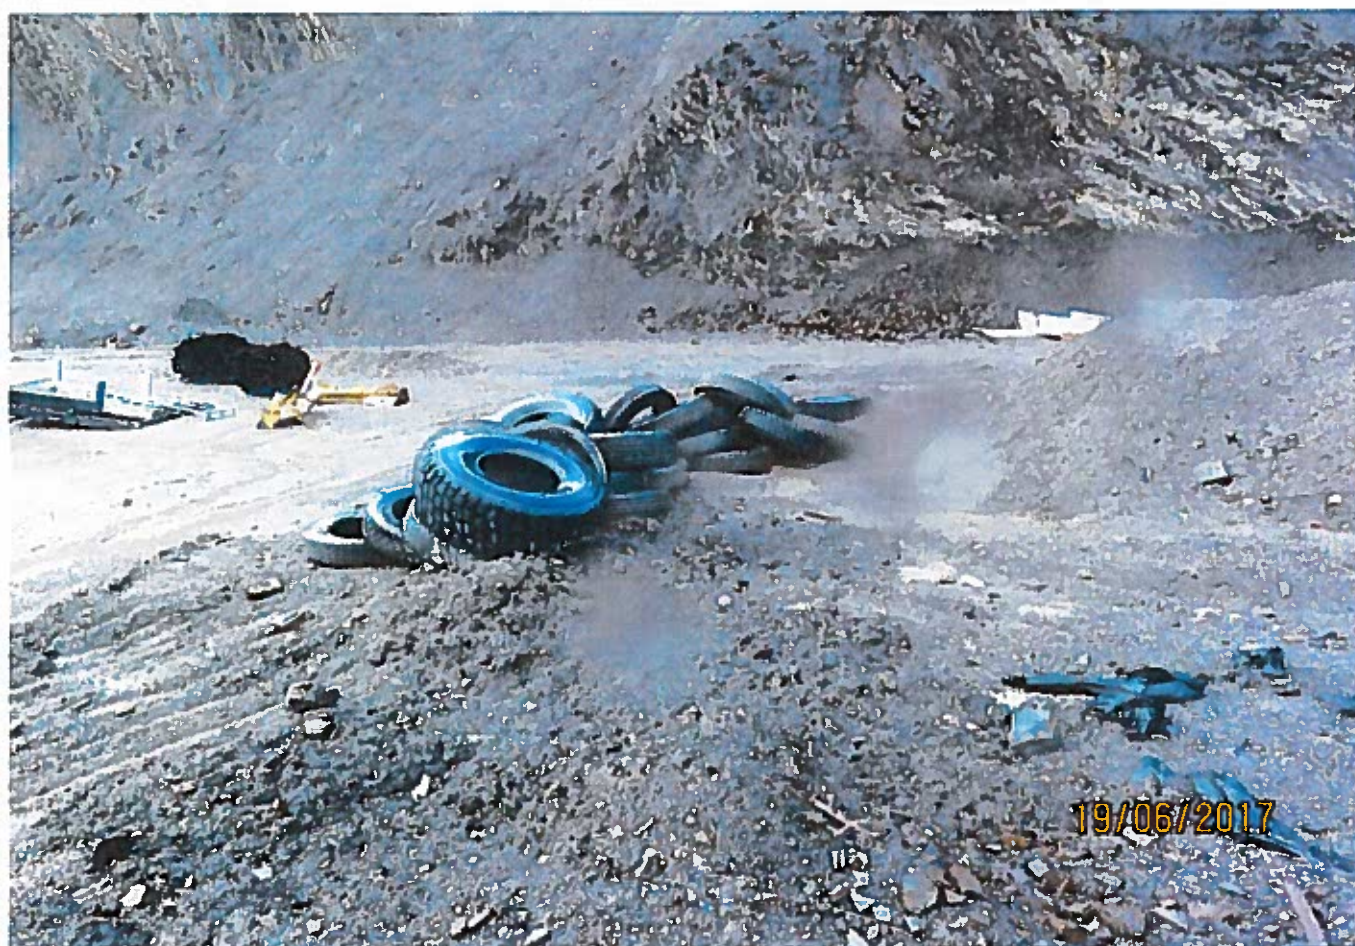
Figure 2

tires by land farm

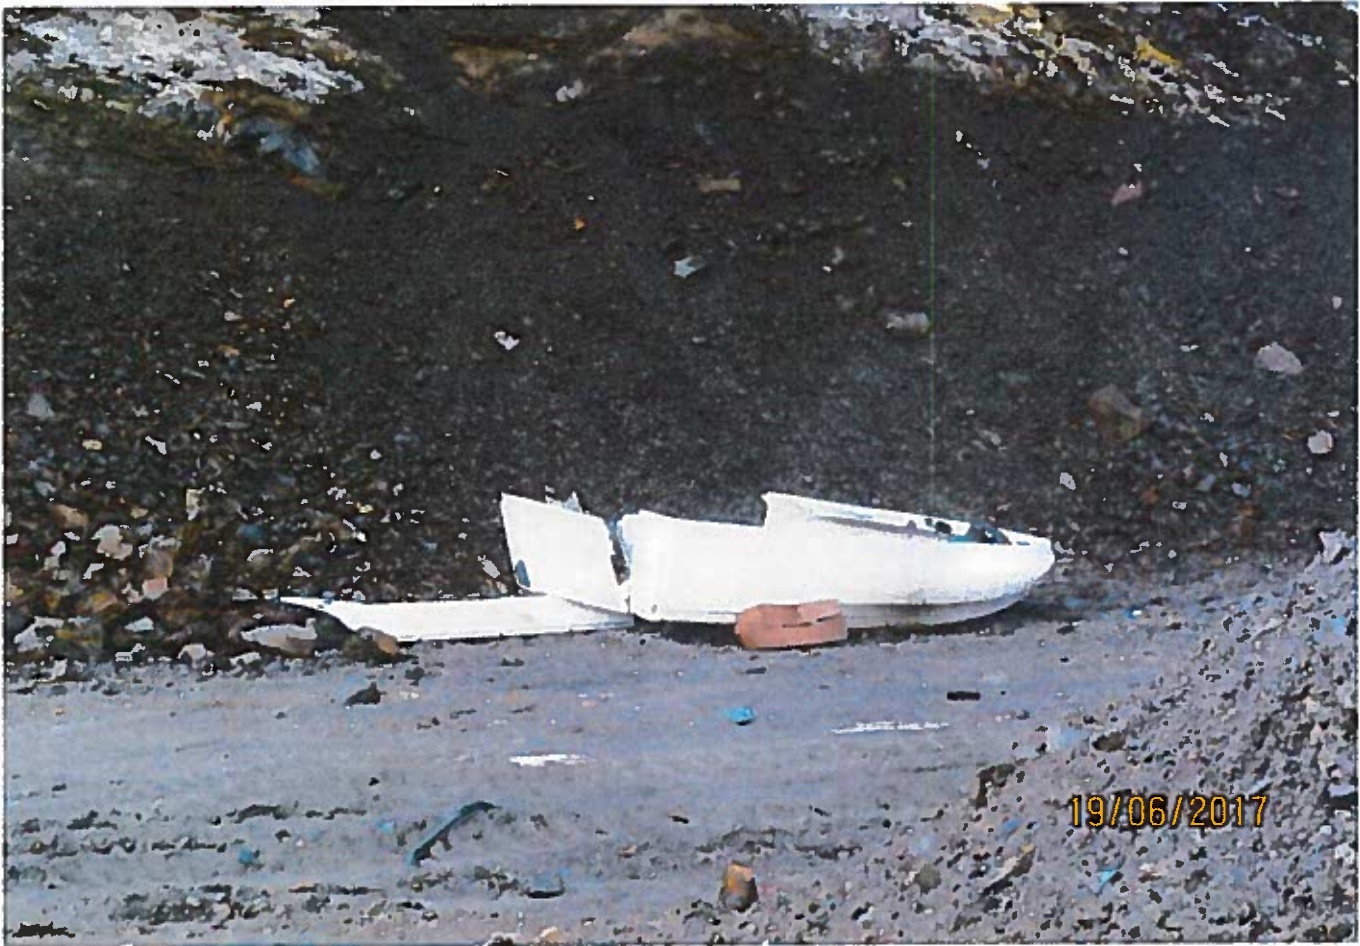
Figure 3
rig fender and debris near the land farm

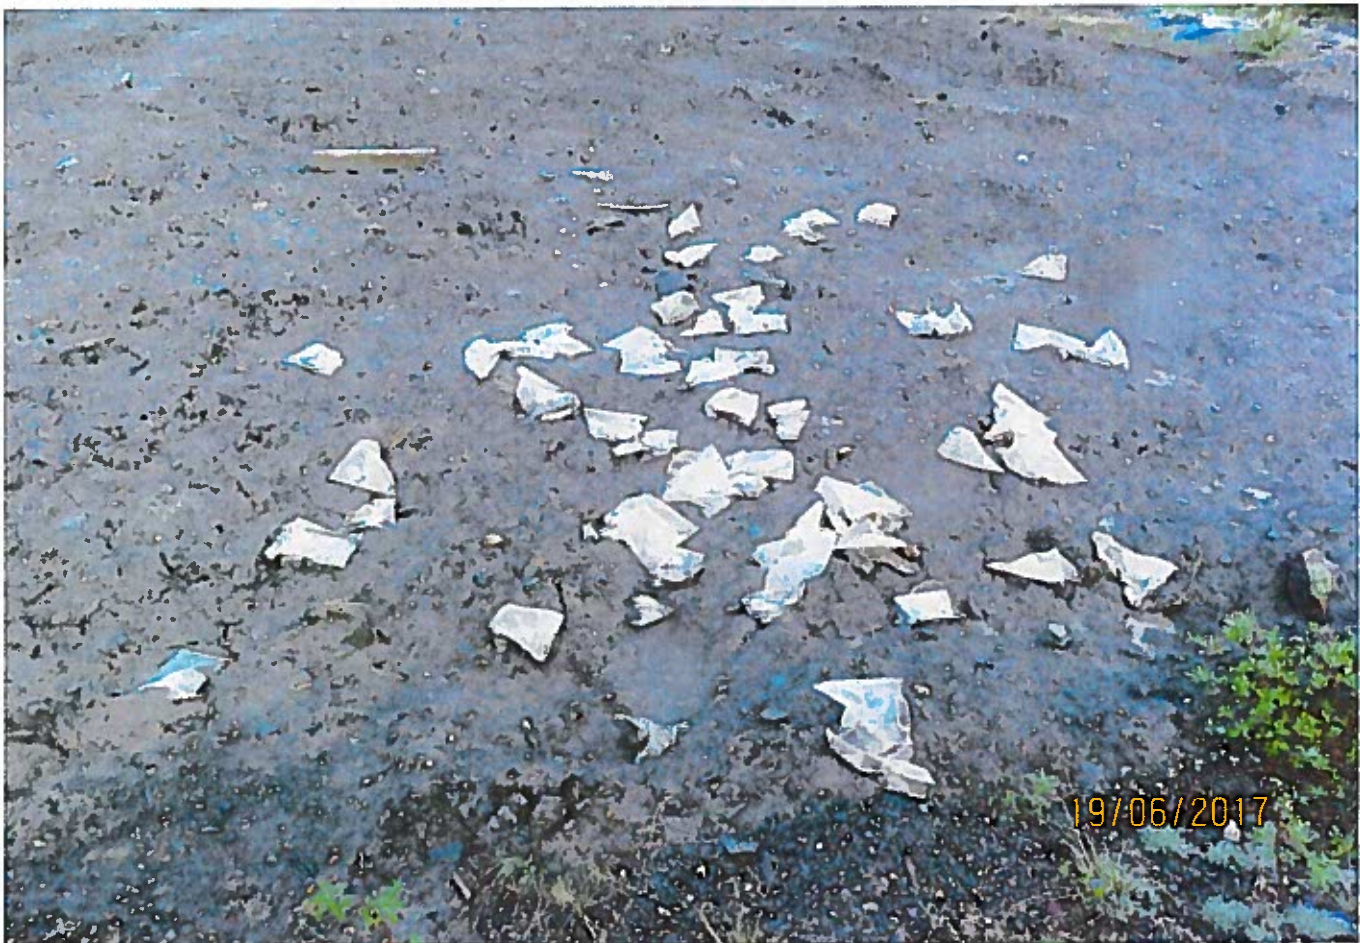
Figure 4
zip lock bags in land farm

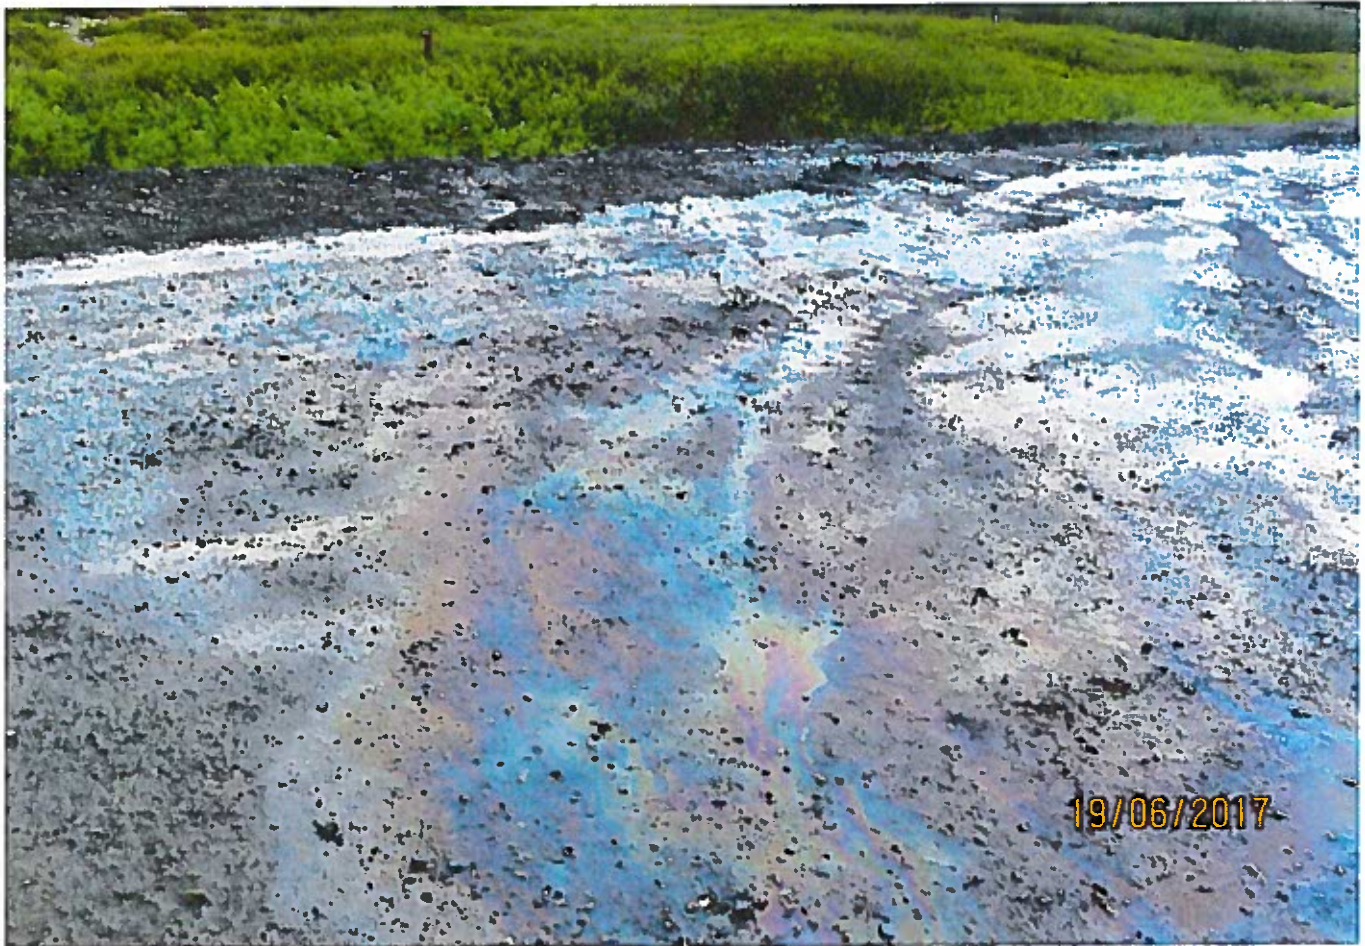
Outside the camp trailer it was observed that there is a spill that occurred and not reported to the spill line or cleaned up at the time of the occurrence. This was very evident with the fresh rain in the area, however the worker there indicated he will place absorbent pads there and place into a container. This was in contravention of condition 26(1)(m) fuel storage item 19 and 27.

Figure 5
sheen on ground not cleaned up

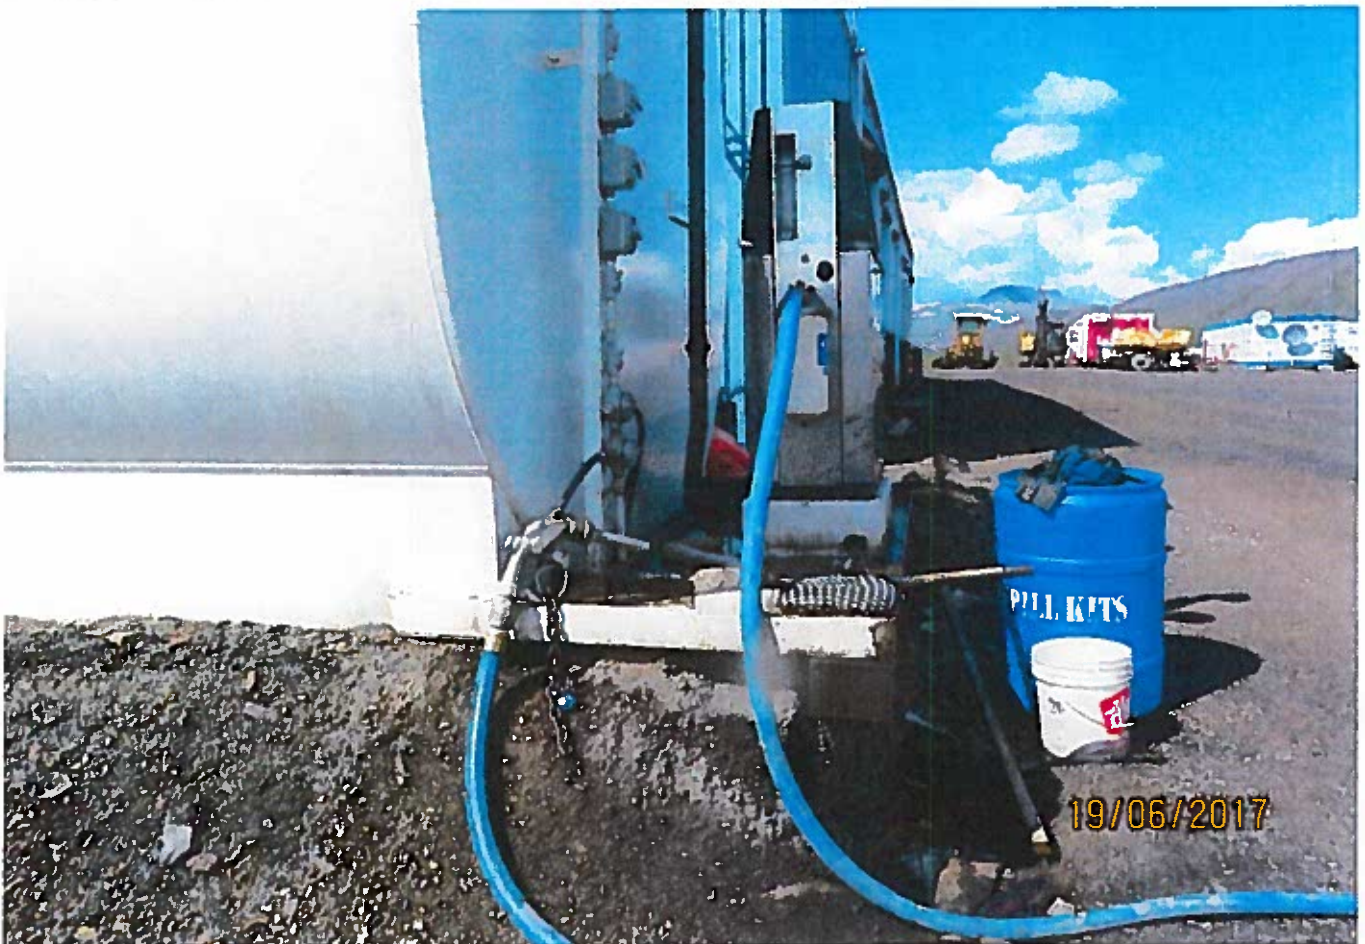
At the fuel storage area it was observed that the switches there are unlocked and the lock is placed on a chain to the nozzle handle which is not stored into a secondary containment. Further there was an odor of hydrocarbon in this area as well. These items was also mentioned in previous inspection reports and is an indicator that employees or contractors are not following or trained in any fuel storage handling procedures or fuel transfers. These items indicated are in violation of condition 26(1)(m) items 19, 22, 24 and 27.

Figure 6
Fuel storage and transfer area, with no secondary containment

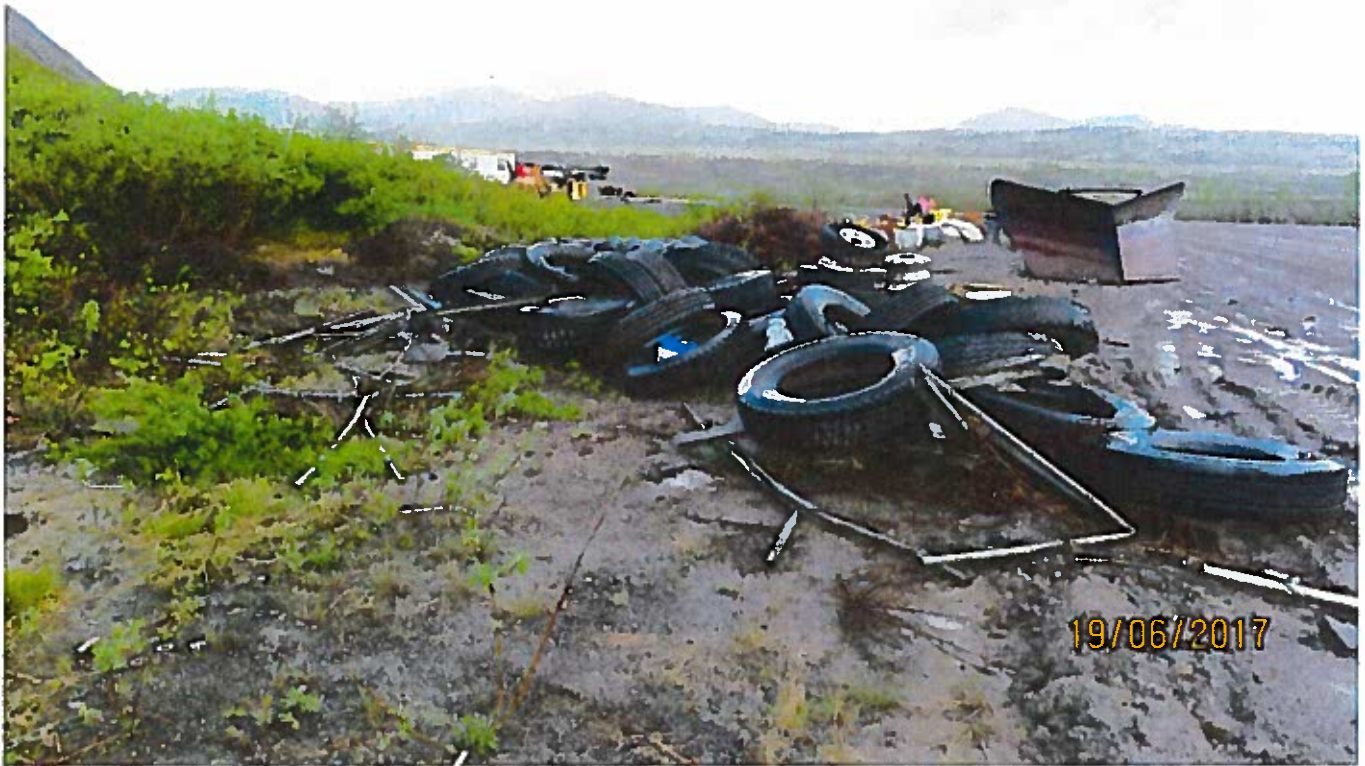
Figure 7
tires and metal by north end entrance.
