File Number: G13H004
Type of Operation: FUEL CACHES
Location: Km 14.2 James Creek

ENVIRONMENTAL INSPECTION REPORT

Permittee:	GNWT Department of Transportation	Permit Expiry Date:	August 11, 2018
Land Use Permit No.	G13H004	Previous Inspection:	October 06, 2016
Quarrying Permit No.		Inspection Date:	October 20, 2016
Contractor:		Subcontractor:	
Location(s) Inspected:	Km 14.2 James Creek		
Current Stage of Operation:	ongoing		
Program Modifications Approved:	NIL

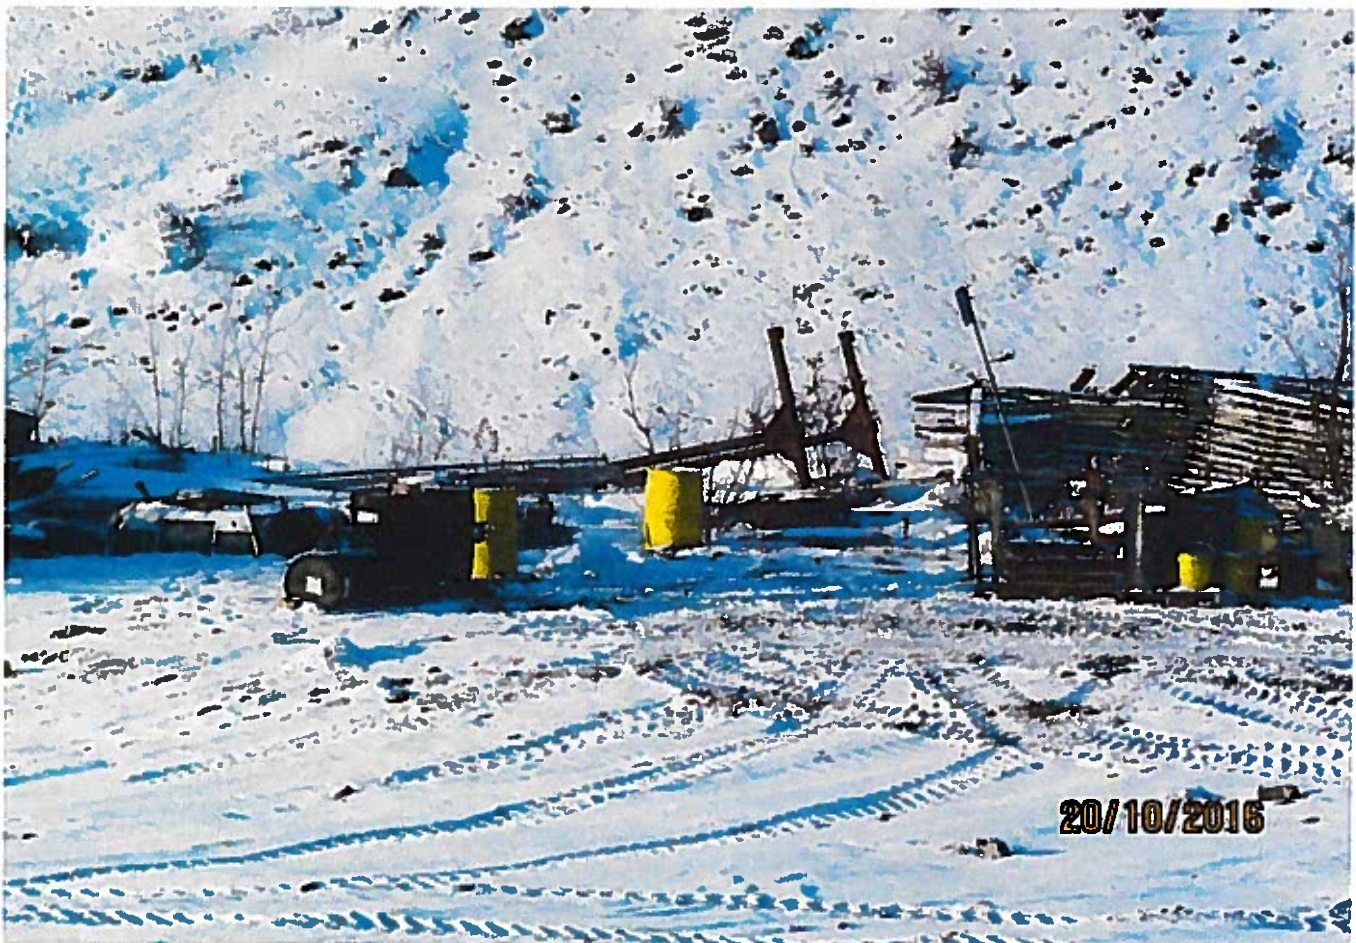
Figure 2

waste area

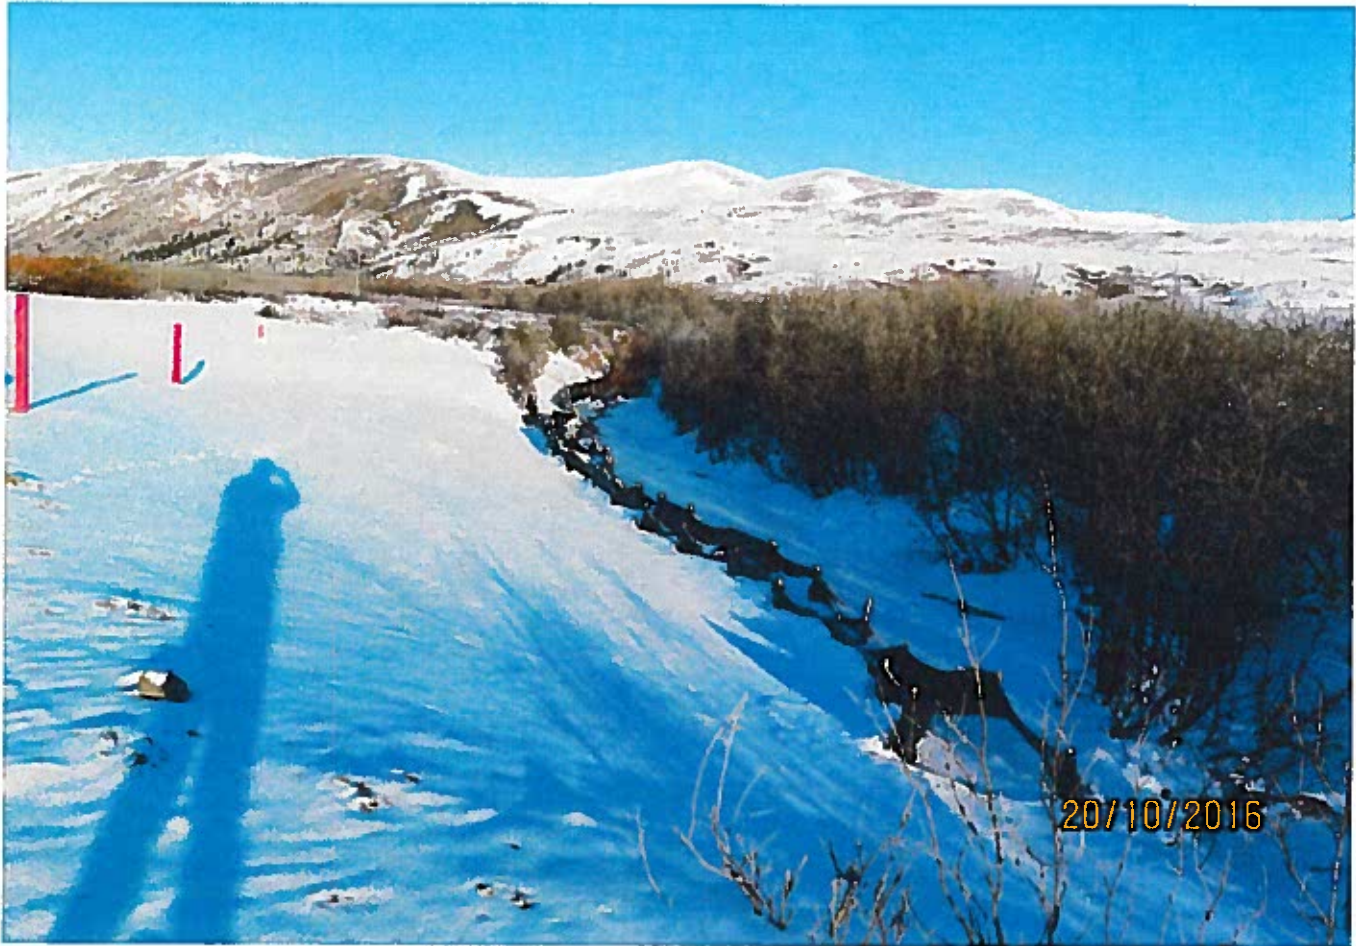
Figure 3
silt fence

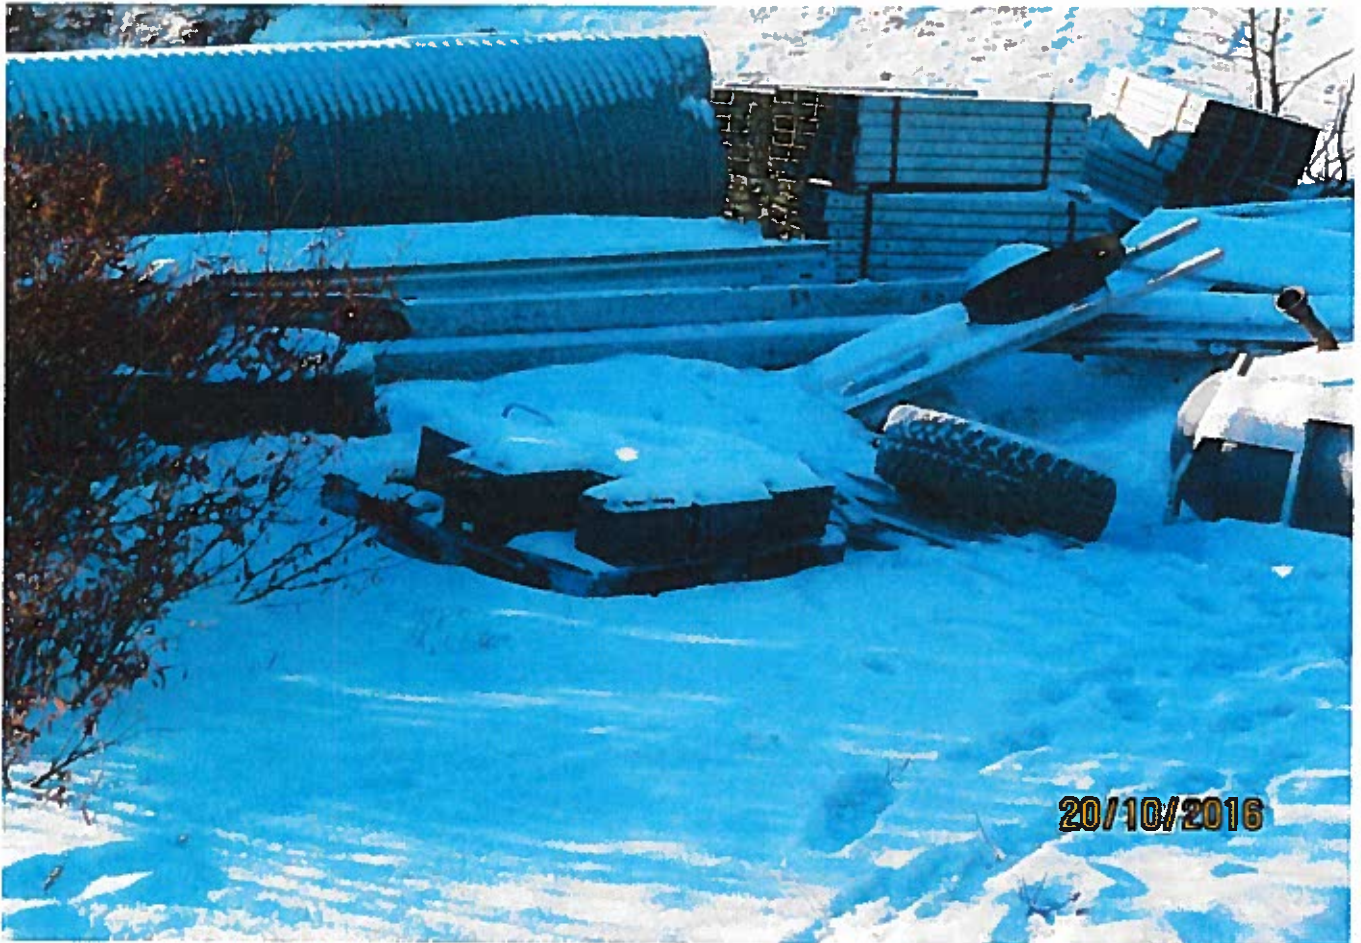
Figure 4
old battery storage to be removed

During this inspection it was observed that some of the concerns from the previous inspection report have been dealt with in regards to the garbage at the back end of the site have been removed. It was also observed that some of the waste oil pails had also been removed. It is recommend that these smaller items of concern such as the waste oil pails and batteries be dealt A.S.A.P. prior to freeze up of which will be more difficult to remove.

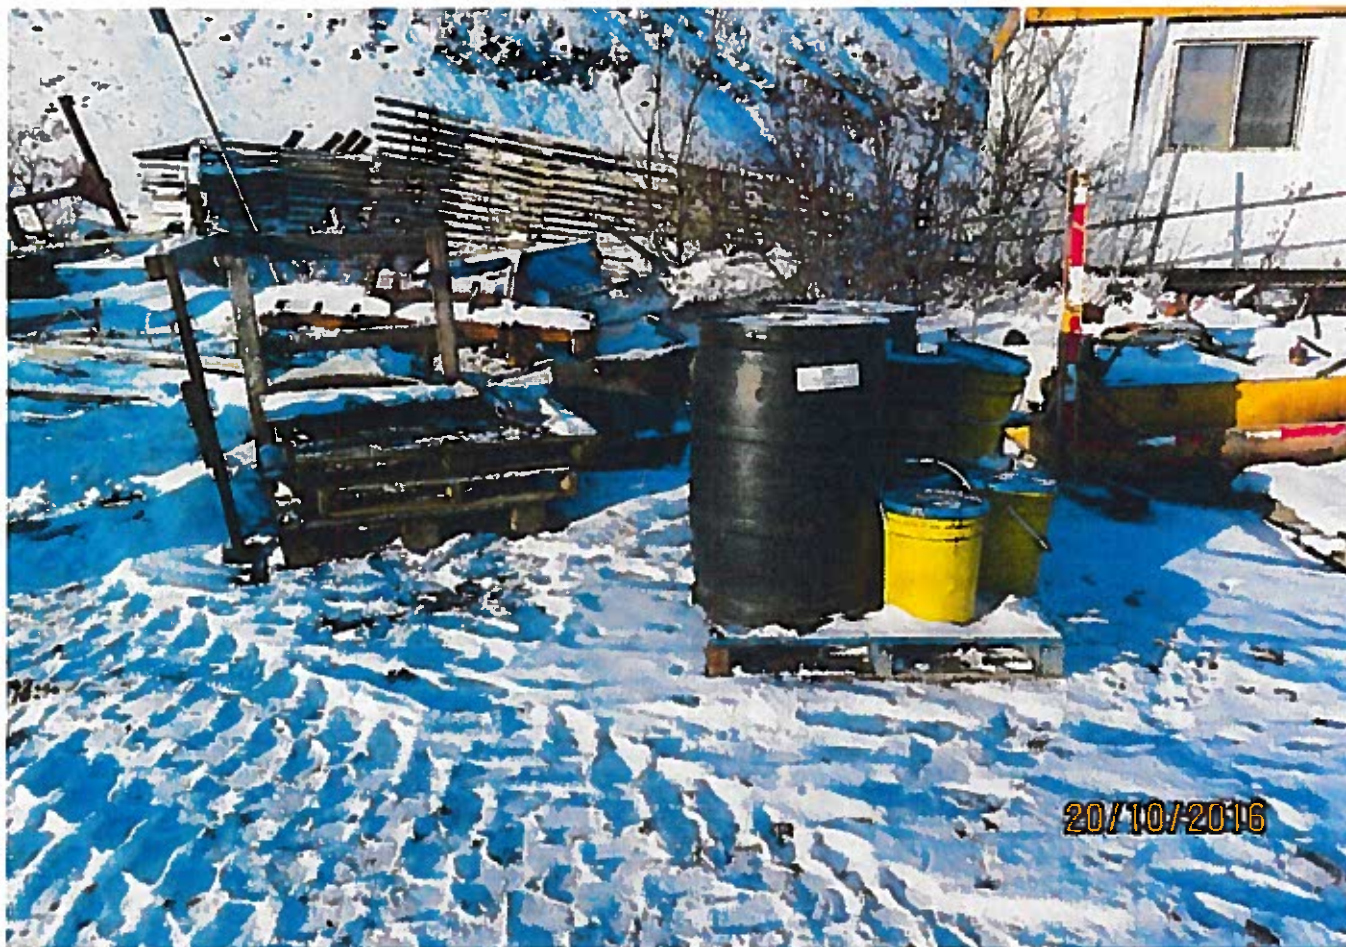
Figure 5
waste oil to be removed

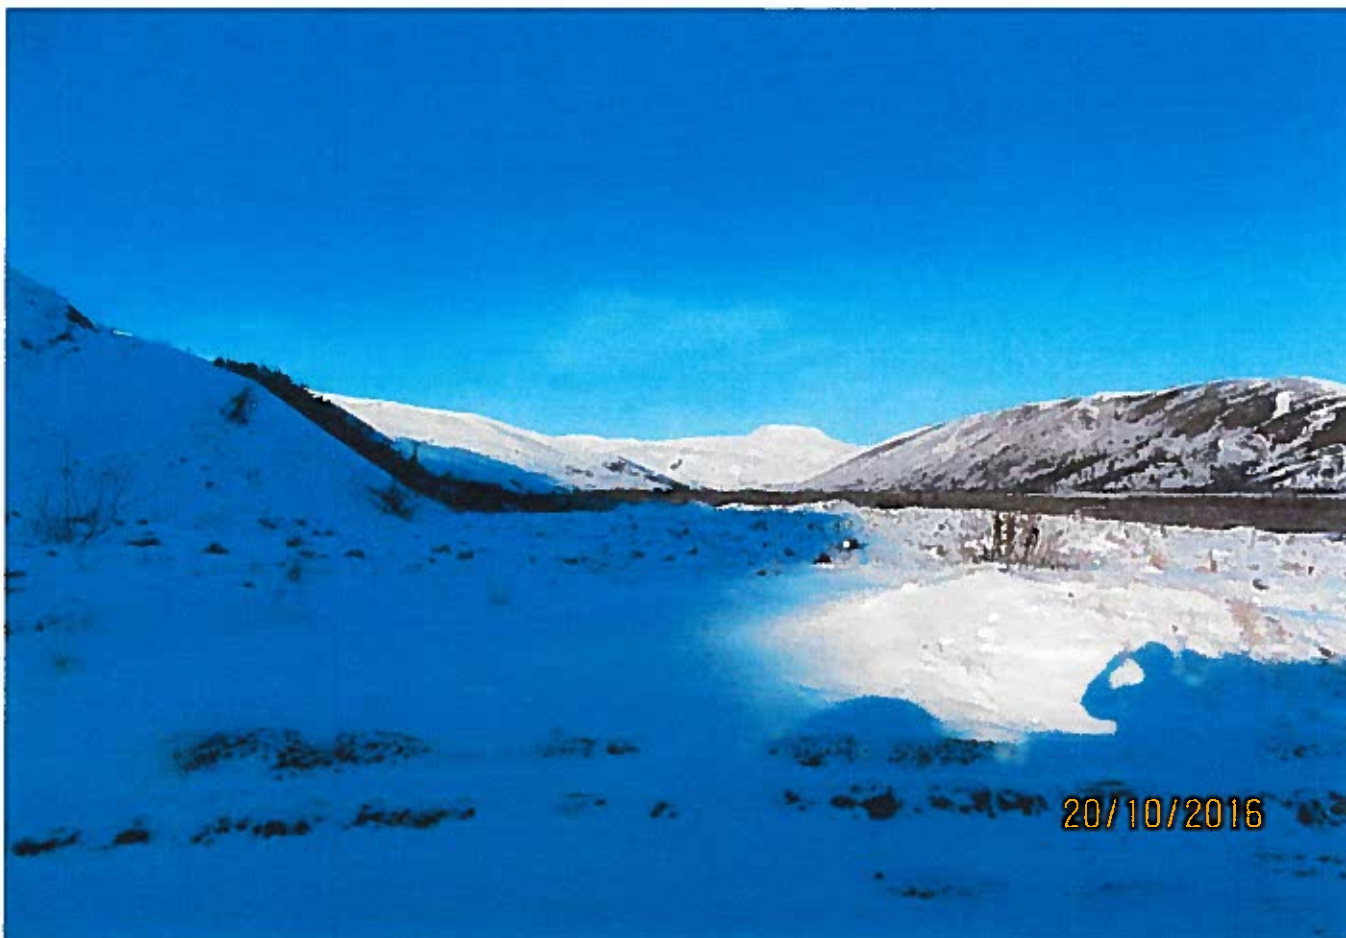
Figure 6
land farm
