July 29, 2016

Remedial Action Plan: Impacted Areas proximate to James Creek - DRAFT

Please find below a proposed remedial action plan for the Government of the Northwest Territories Department of Transportation (DOT) highway maintenance yard located at kilometer 14 on the Dempster Highway.

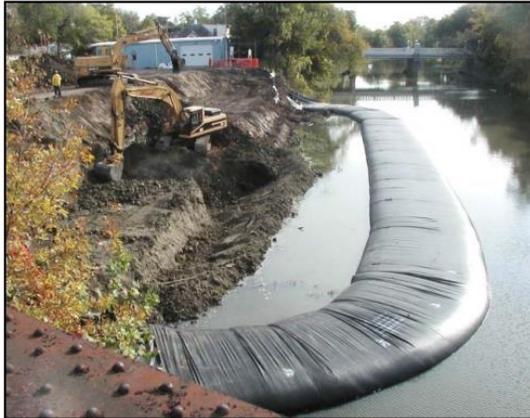
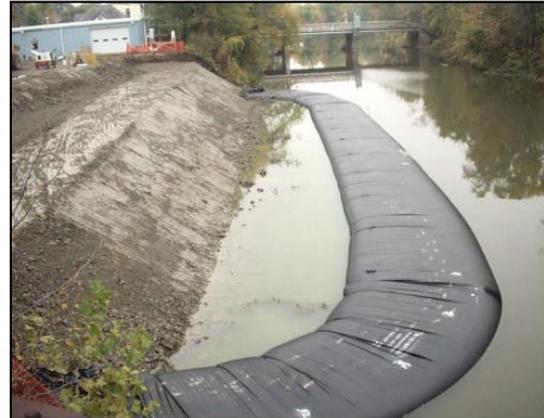
Photo: Example of Aquadam use

- Two test pits will be excavated up gradient of groundwater flow to confirm that no free product is present above groundwater prior to excavation;
- A portable containment dam will be installed in the creek near impacted area 2. The dam will run parallel to the creek bank and perpendicular up and down stream of the spill area (A drawing of the proposed excavation area is shown in Figure 3; photos of the dam are located below);
