ENVIRONMENTAL INSPECTION REPORT

Permittee:	Department of Transportation	Permit Expiry Date:	May 24, 2019
Land Use Permit No.	G14E002	Previous Inspection:	October 02, 2014
Quarrying Permit No.		Inspection Date:	September 28, 2015
Contractor:		Subcontractor:	
Location(s) Inspected:	Km 141		
Current Stage of Operation:	Access Road repairs and culvert replacement		
Program Modifications Approved:

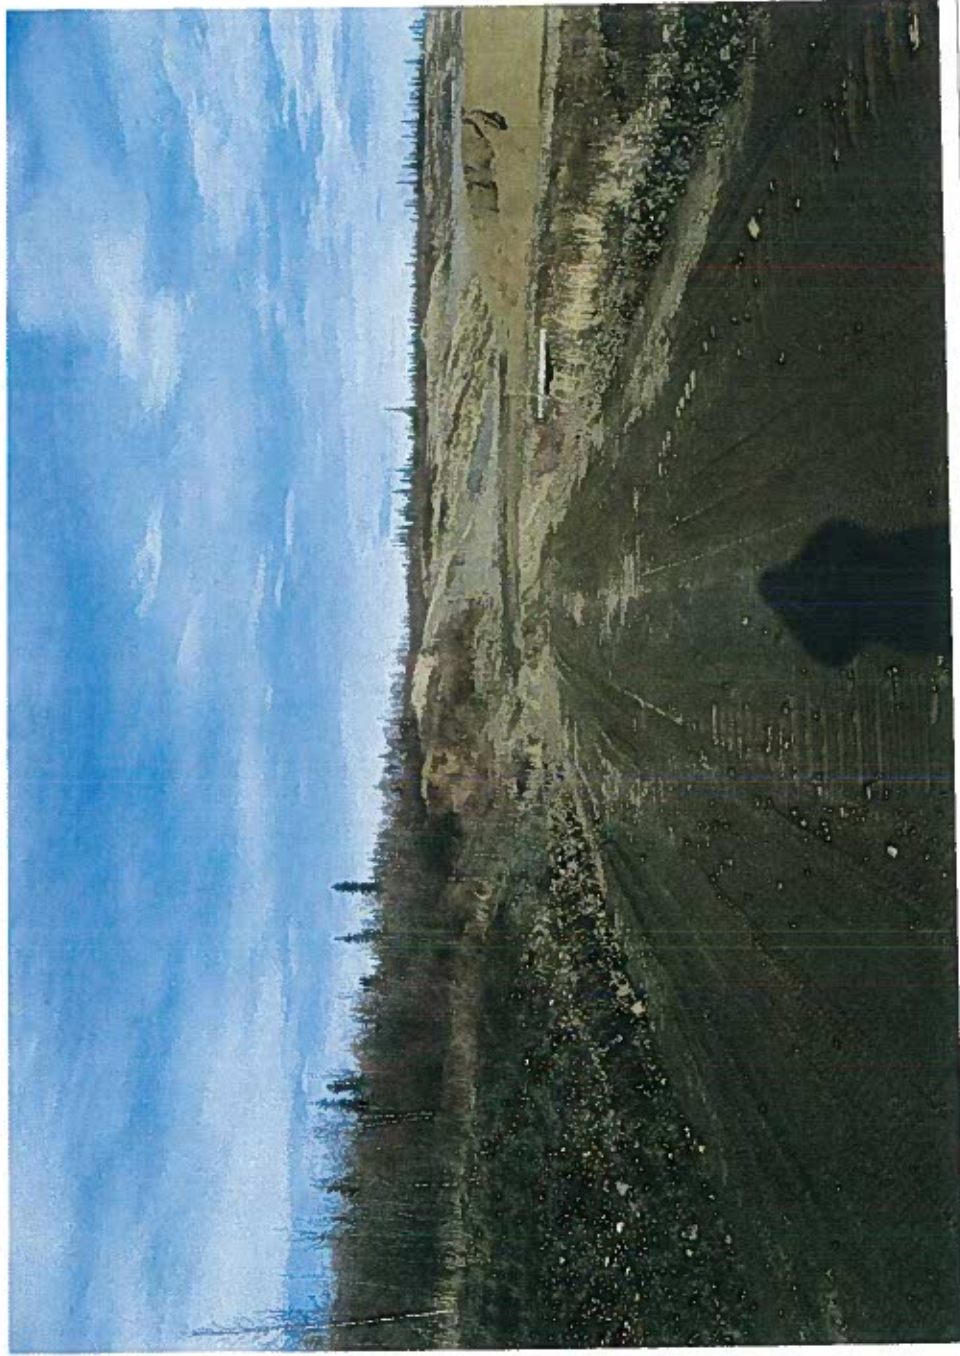
Figure 1

Access Road Repair and culvert replacement:
 access road into Km 141 has been repaired and a culvert replaced that had been washed out. More material on road may be required to accommodate heavy equipment.

Access Road into Km 141

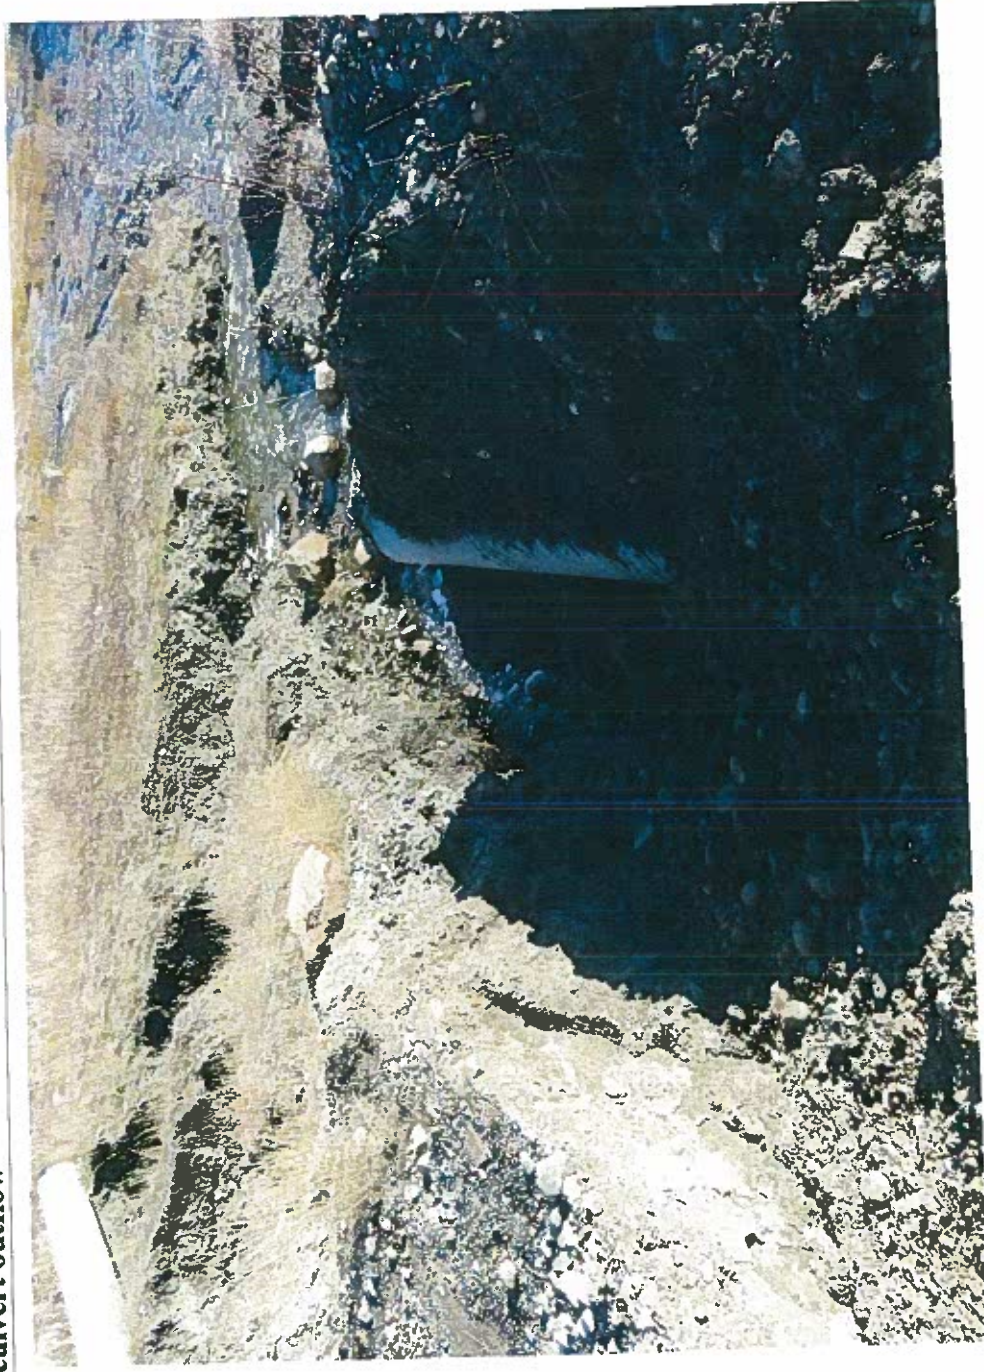
Figure 2
culvert outflow

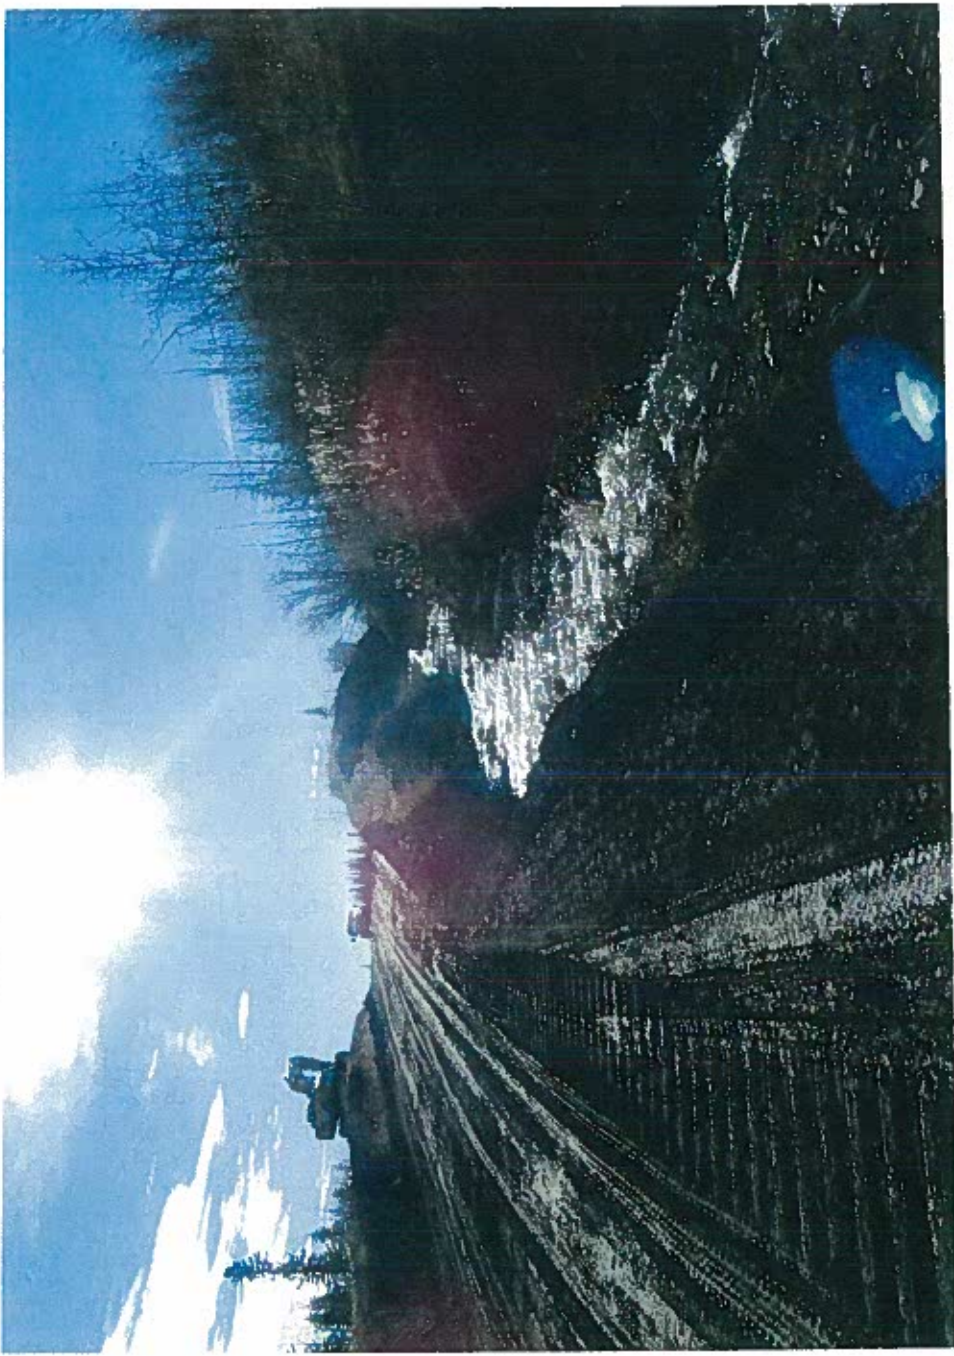
Figure 3
runoff along access road to culvert
