File Number	G14E002
Type of Operation	QUARRY SITE - Existing
Location	Wrangling River (178.7)

ENVIRONMENTAL INSPECTION REPORT

Permittee:	GNWT Department of Infrastructure	Permit Expiry Date:	May 24, 2019
Land Use Permit No.	G14E002	Previous Inspection:	March 28, 2018
Quarrying Permit No.		Inspection Date:	April 09, 2018
Contractor:		Subcontractor:	
Location(s) Inspected:	Wrangling River (178.7)		
Current Stage of Operation:	Stock piling completed		
Program Modifications Approved:

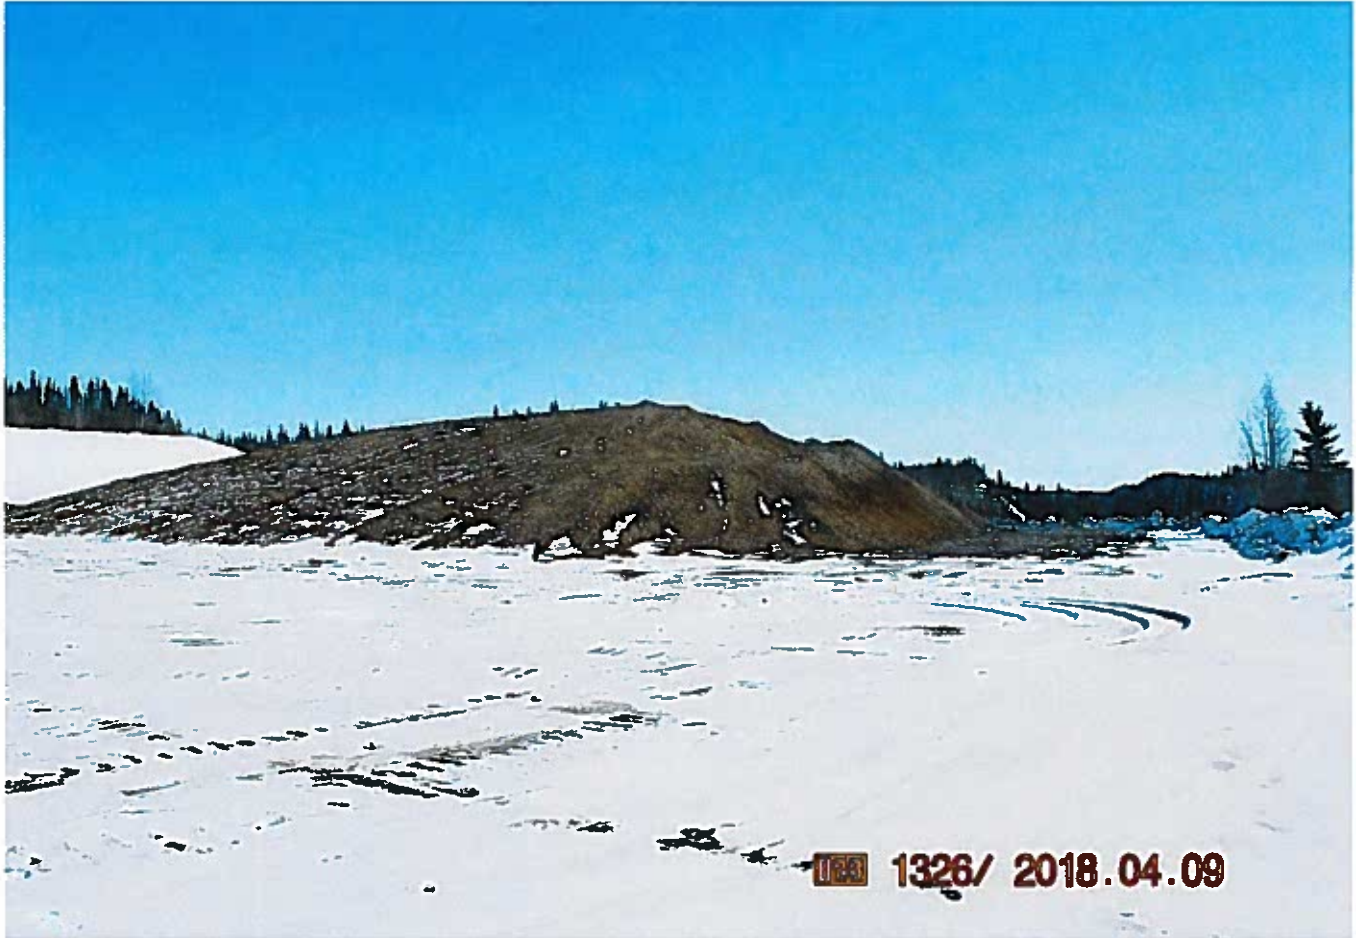
Figure 1

The material that was stored close to the bank to the river was pushed back to a satisfactory distance. The site was left clean and there were no concerns from the inspector.

Gravel near the edge of the bank to the creek is moved to a greater distance

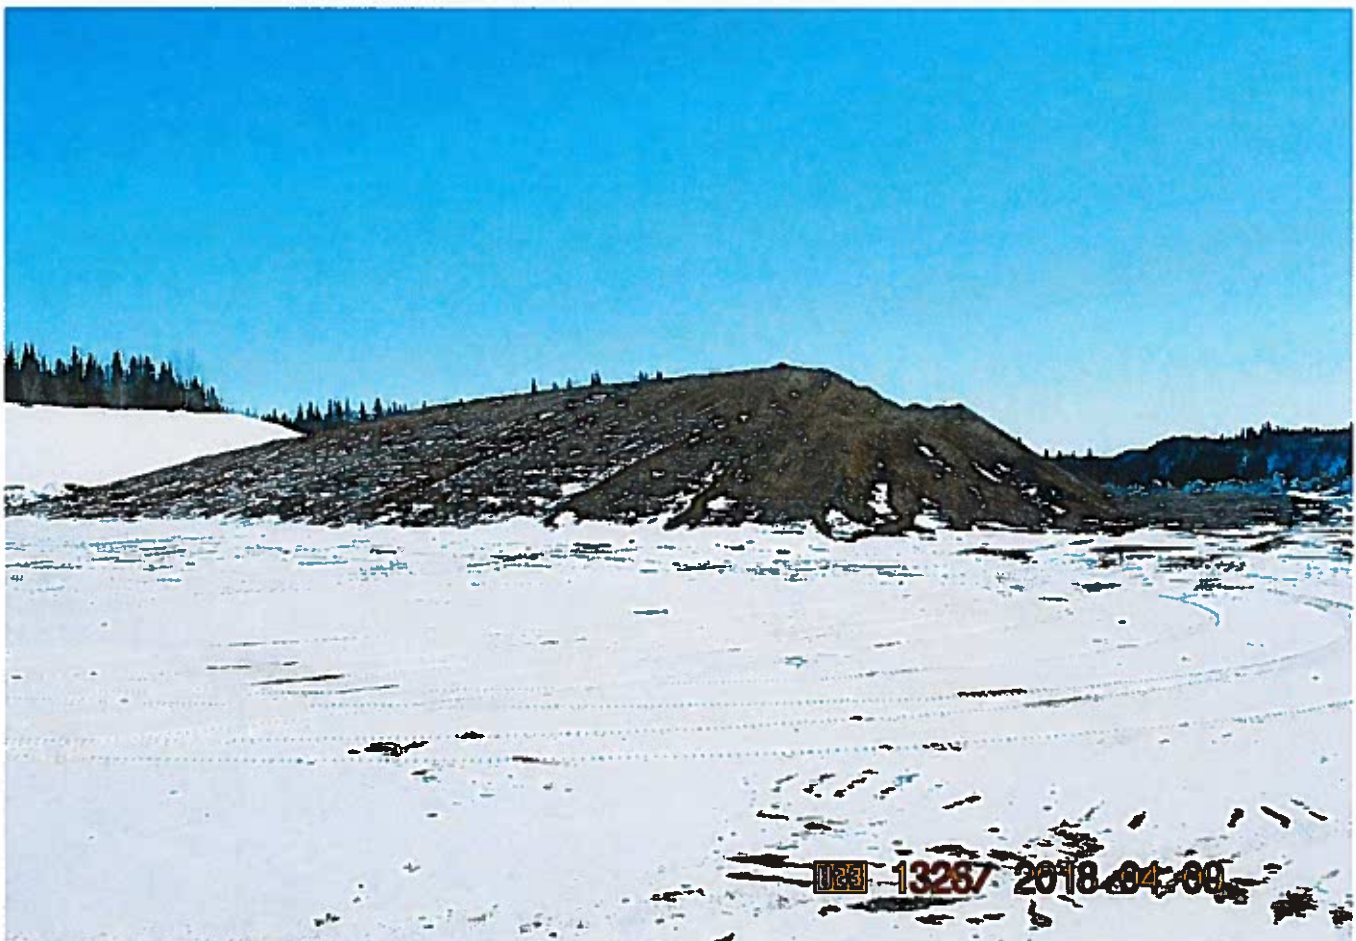
Figure 2

Viewing east

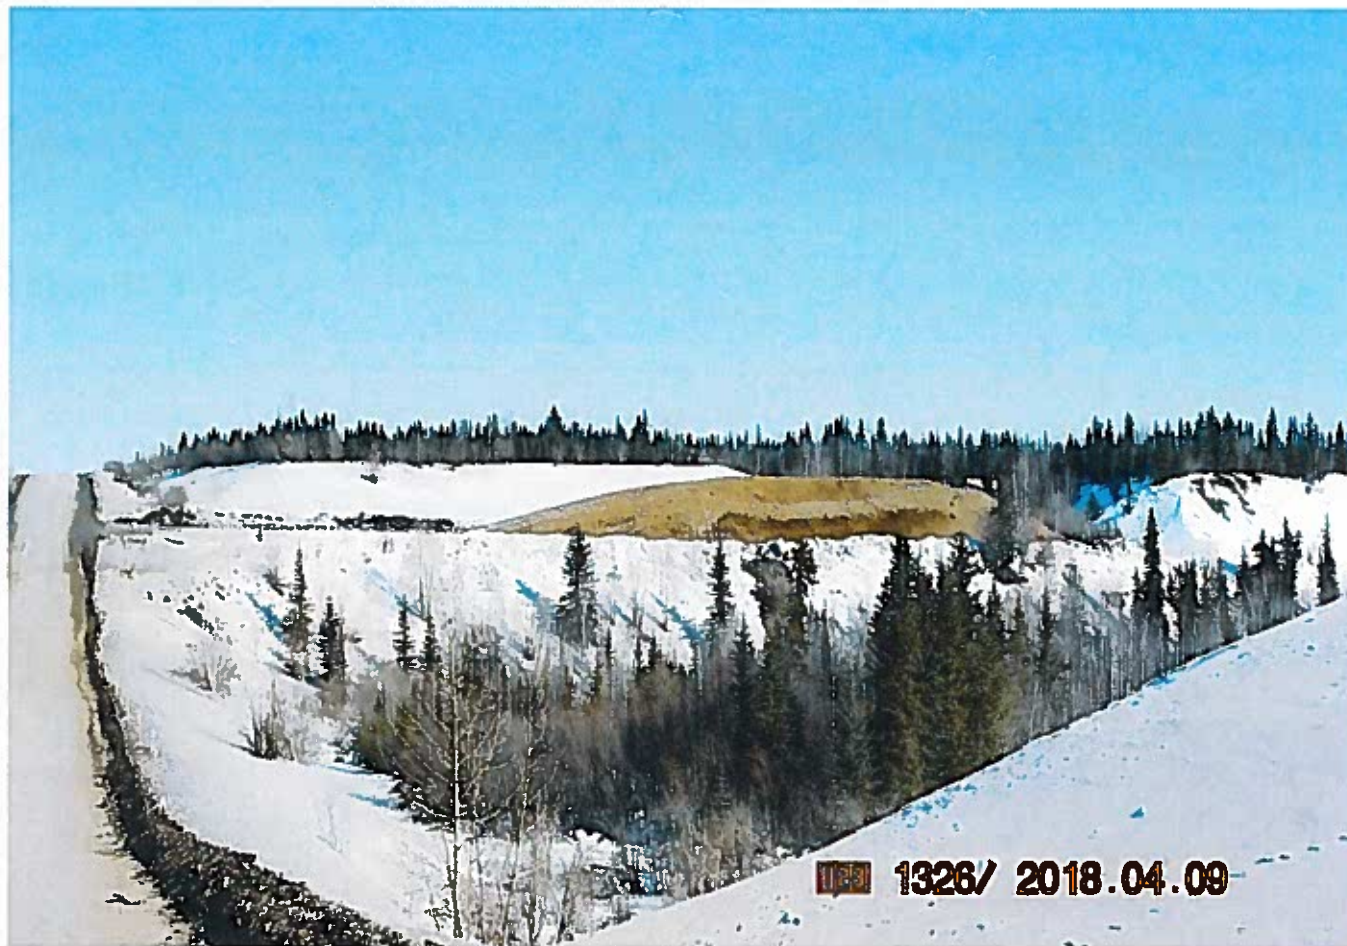
Figure 3
Viewing north

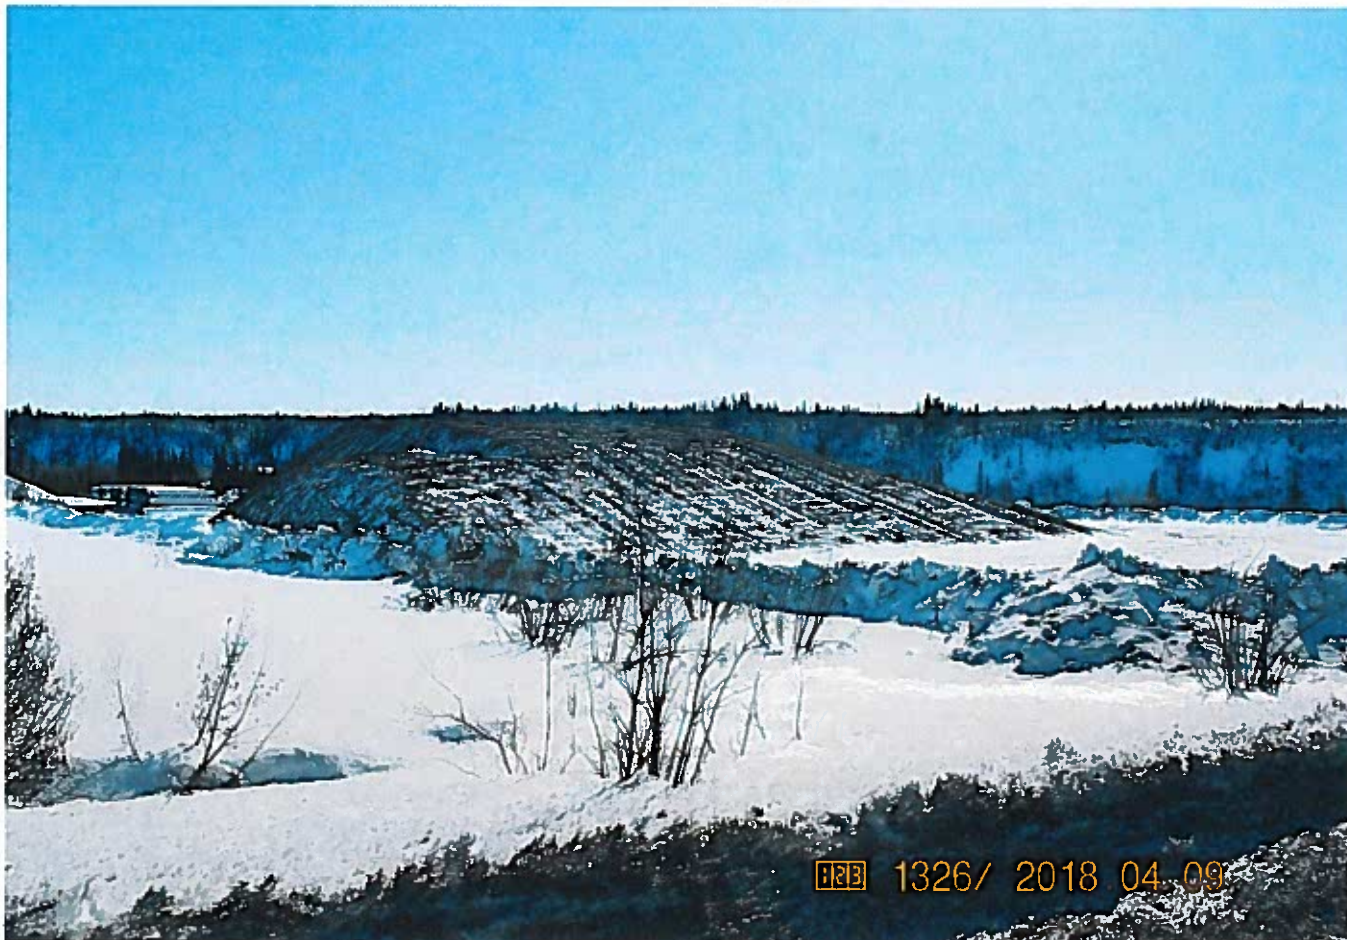
Figure 4
Viewing south
