File Number G14E002
Type of Operation QUARRY SITE - Existing
Location Km 178.1

ENVIRONMENTAL INSPECTION REPORT

Permittee:	GNWT Department of Infrastructure	Permit Expiry Date:	May 24, 2019
Land Use Permit No.	G14E002	Previous Inspection:	July 25, 2018
Quarrying Permit No.		Inspection Date:	July 31, 2018
Contractor:	DOI	Subcontractor:	
Location(s) Inspected:	Km 178.1		
Current Stage of Operation:			
Program Modifications Approved:

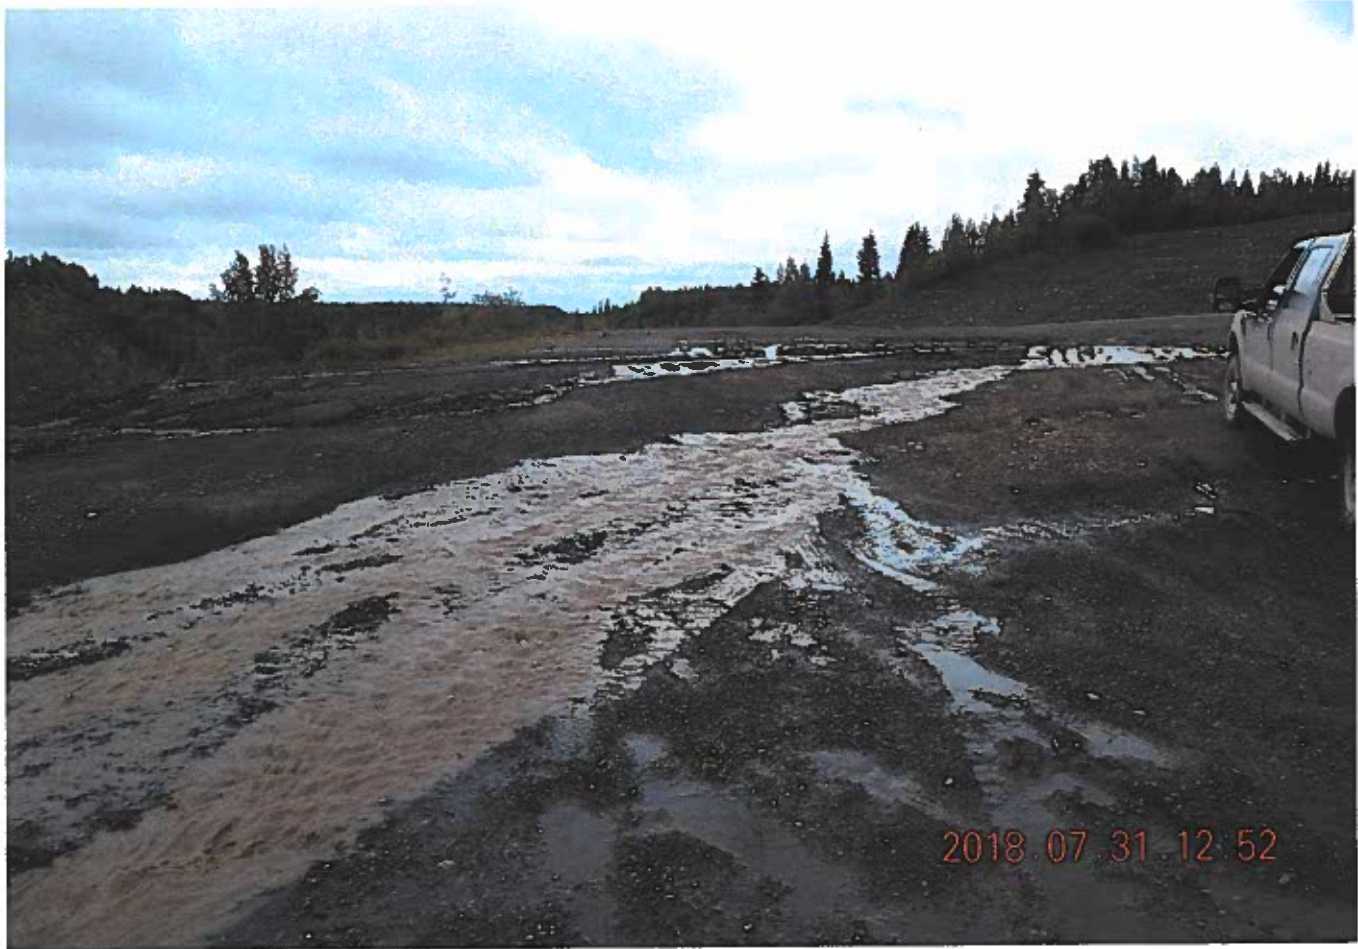
Inspection Images:
Figure 1

During the inspection on July 31, 2018 at Km 178.1 there is concern that the stream flowing between the entrance and the gravel pile has not been addressed as requested numerous times in the previous inspection reports.

There has been a bit of rain in the area in the last few days and the water flowing through the site is significantly more than what was viewed in the last inspection dated July 25, 2018. The stream is creating more channels over the edge of the bank of the staging area and is getting deeper along the main channel.

Department of Lands recommends that this matter be dealt with immediately to prevent further actions with legal legislations for non-compliance.
