File Number: G14E002
Type of Operation: QUARRY SITE - Existing
Location: Km 178.1

ENVIRONMENTAL INSPECTION REPORT

Permittee:	GNWT Department of Infrastructure	Permit Expiry Date:	May 24, 2019
Land Use Permit No.	G14E002	Previous Inspection:	July 31, 2018
Quarrying Permit No.		Inspection Date:	August 08, 2018
Contractor:	DOI	Subcontractor:	
Location(s) Inspected:	Km 178.1		
Current Stage of Operation:	On-going		
Program Modifications Approved:

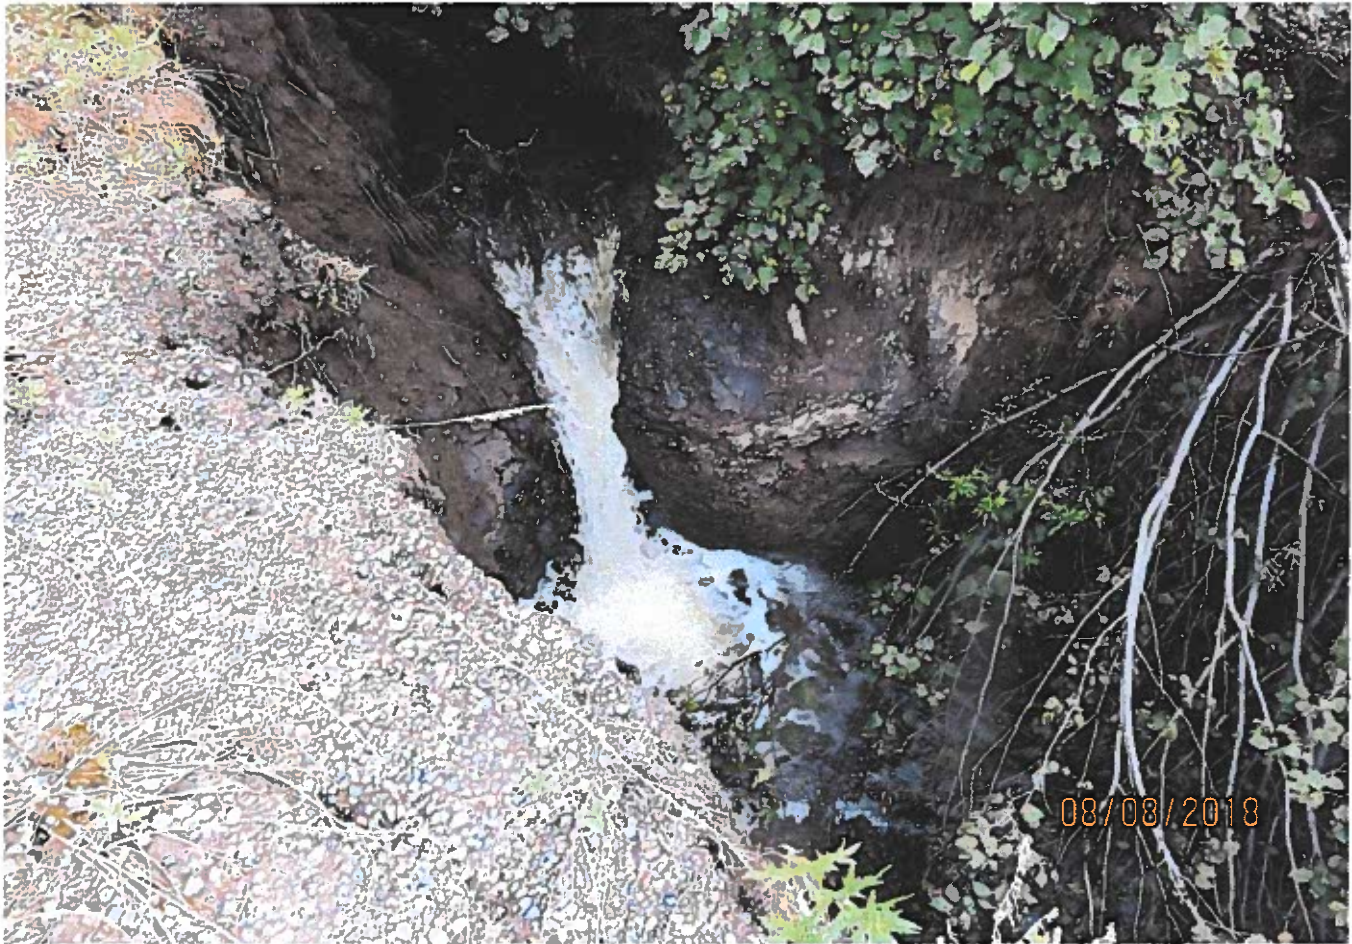
Figure 1

Along side the Dempster highway above the staging area

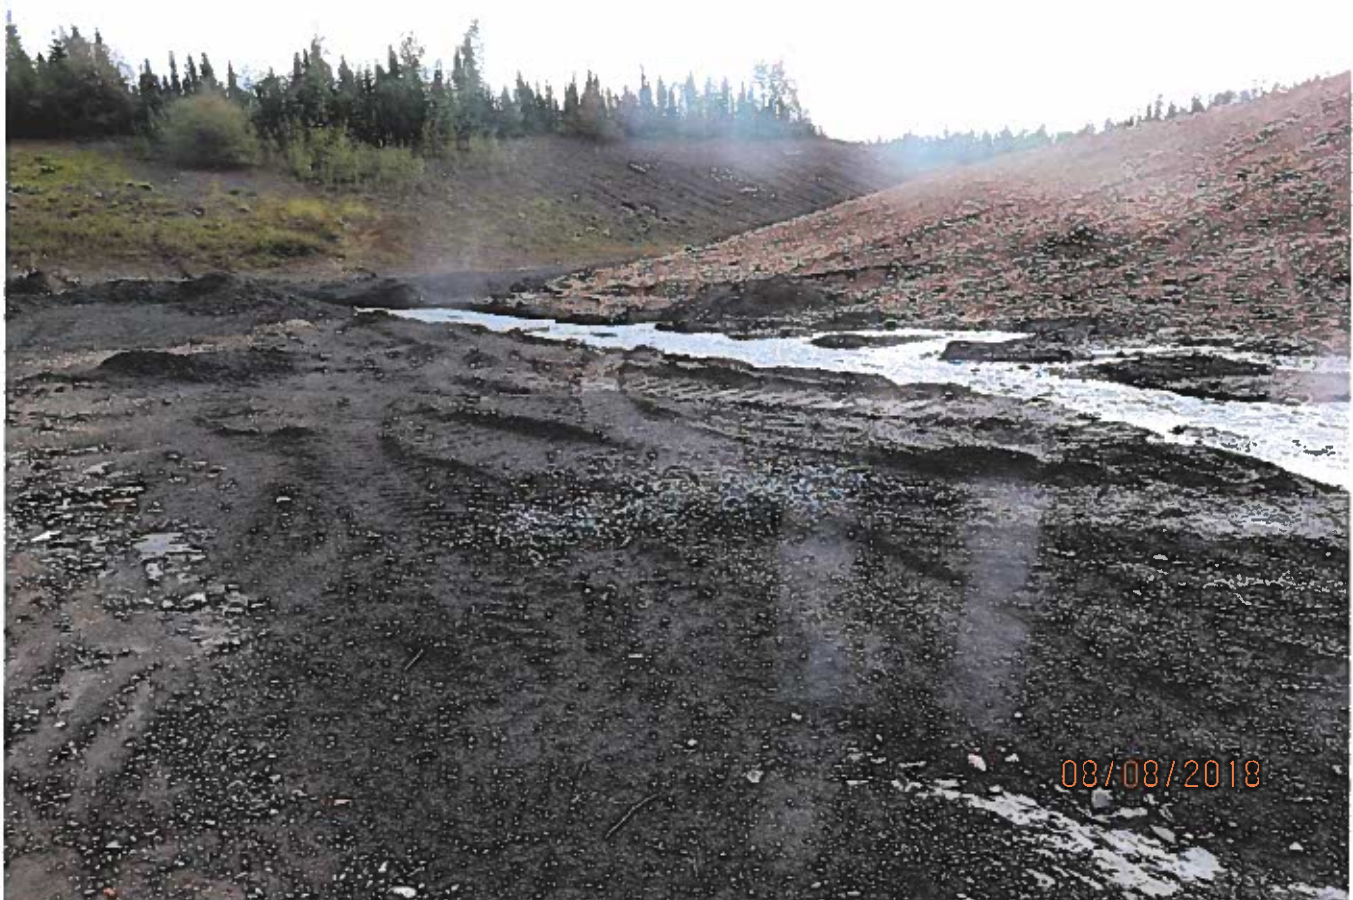
Figure 2

In front of the stock pile

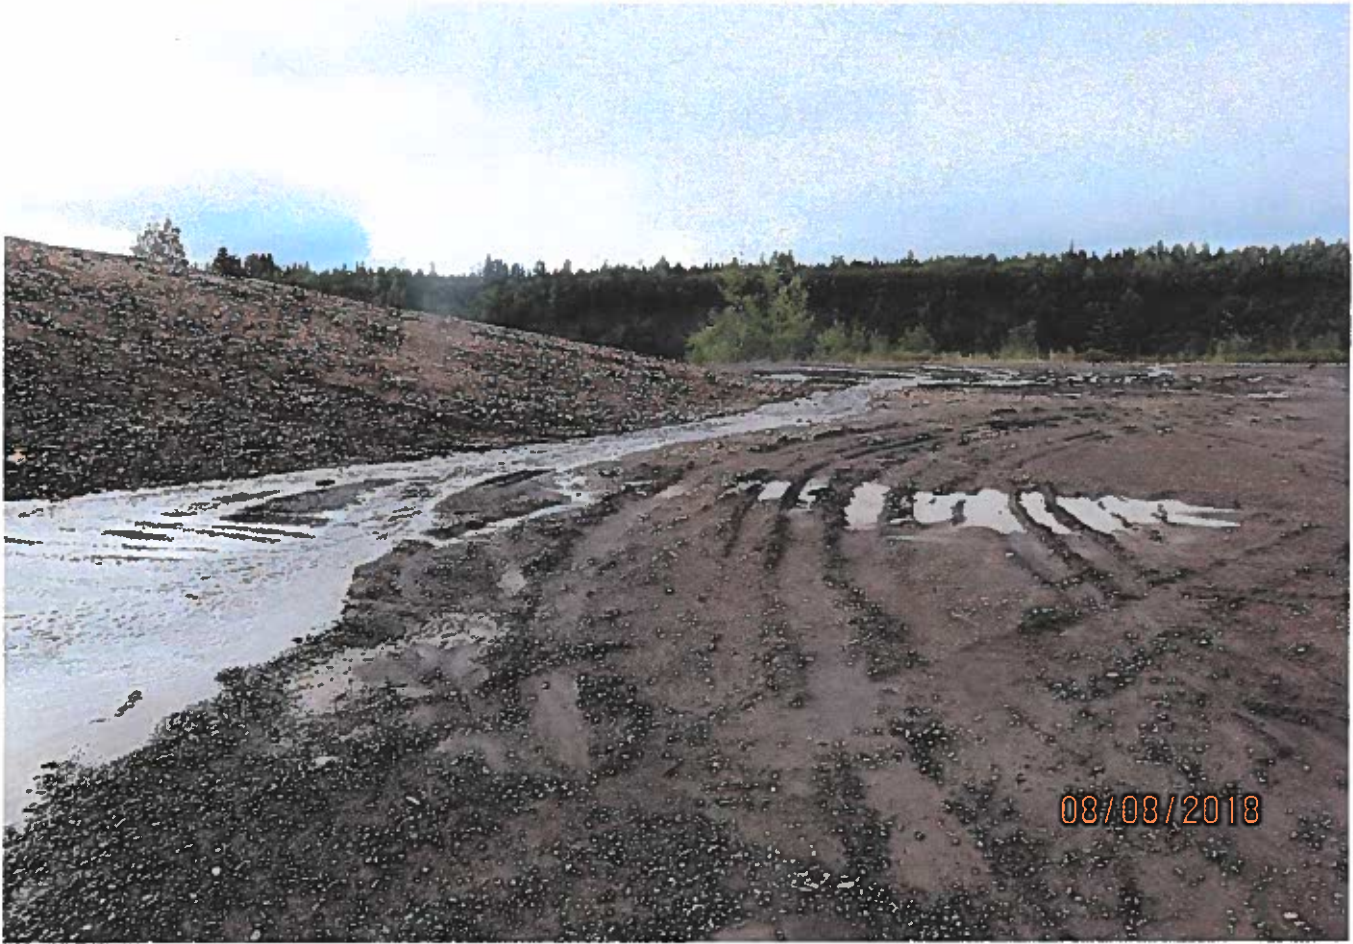
Figure 3
In front of the stock pile
