File Number G14E002
Type of Operation QUARRY SITE - Existing
Location Km 235, Km 178.1, Km 141 and Km 6

ENVIRONMENTAL INSPECTION REPORT

Permittee:	GNWT Department of Infrastructure	Permit Expiry Date:	September 21, 2019
Land Use Permit No.	G14E002	Previous Inspection:	November 29, 2018
Quarrying Permit No.		Inspection Date:	December 05, 2018
Contractor:		Subcontractor:	
Location(s) Inspected:	Km 235, Km 178.1, Km 141 and Km 6		
Current Stage of Operation:	On going		
Program Modifications Approved:

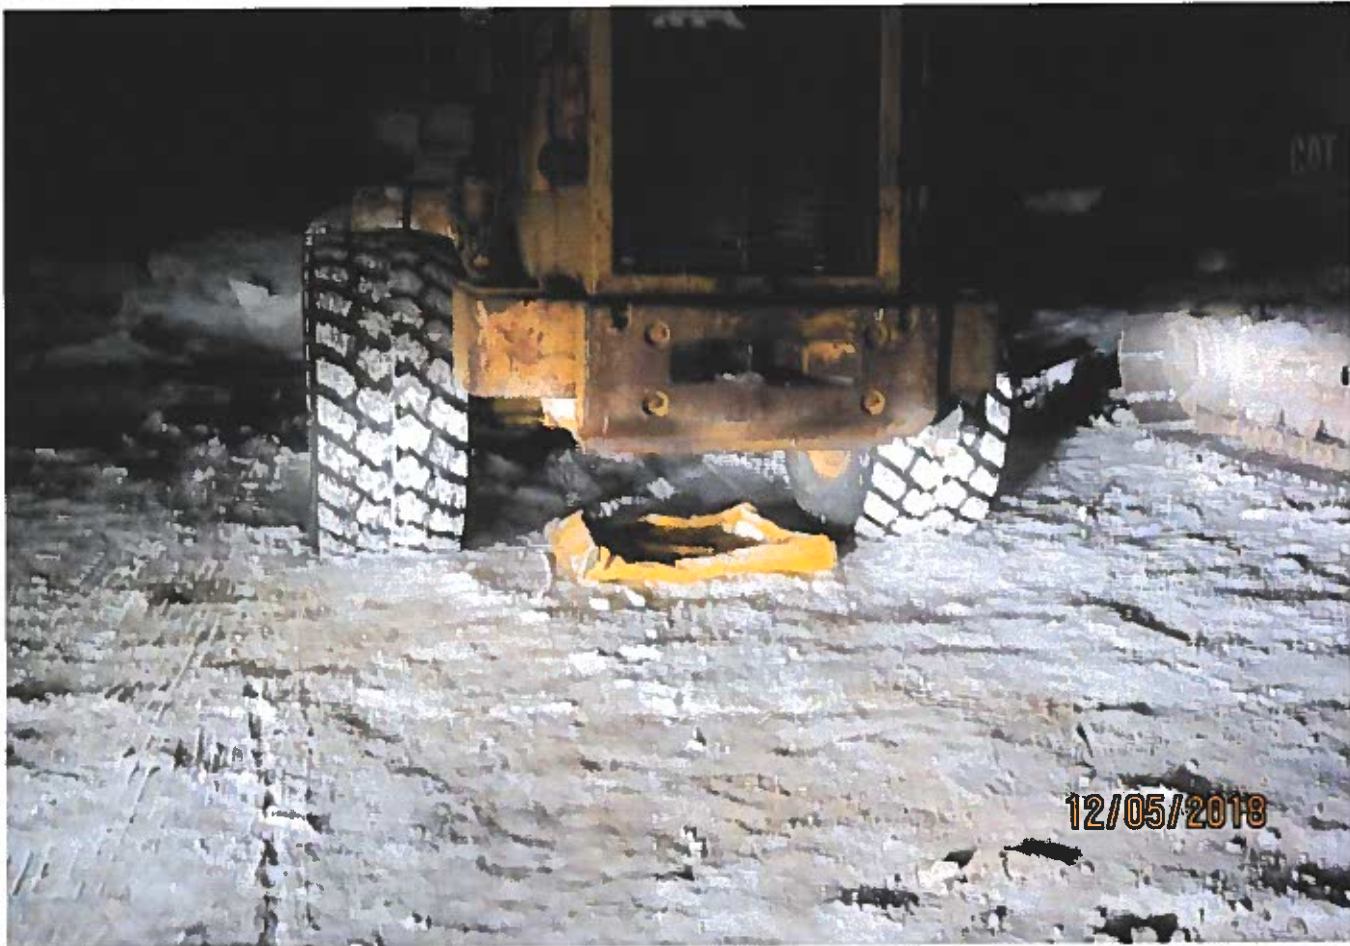
Figure 2
drip tray put in place

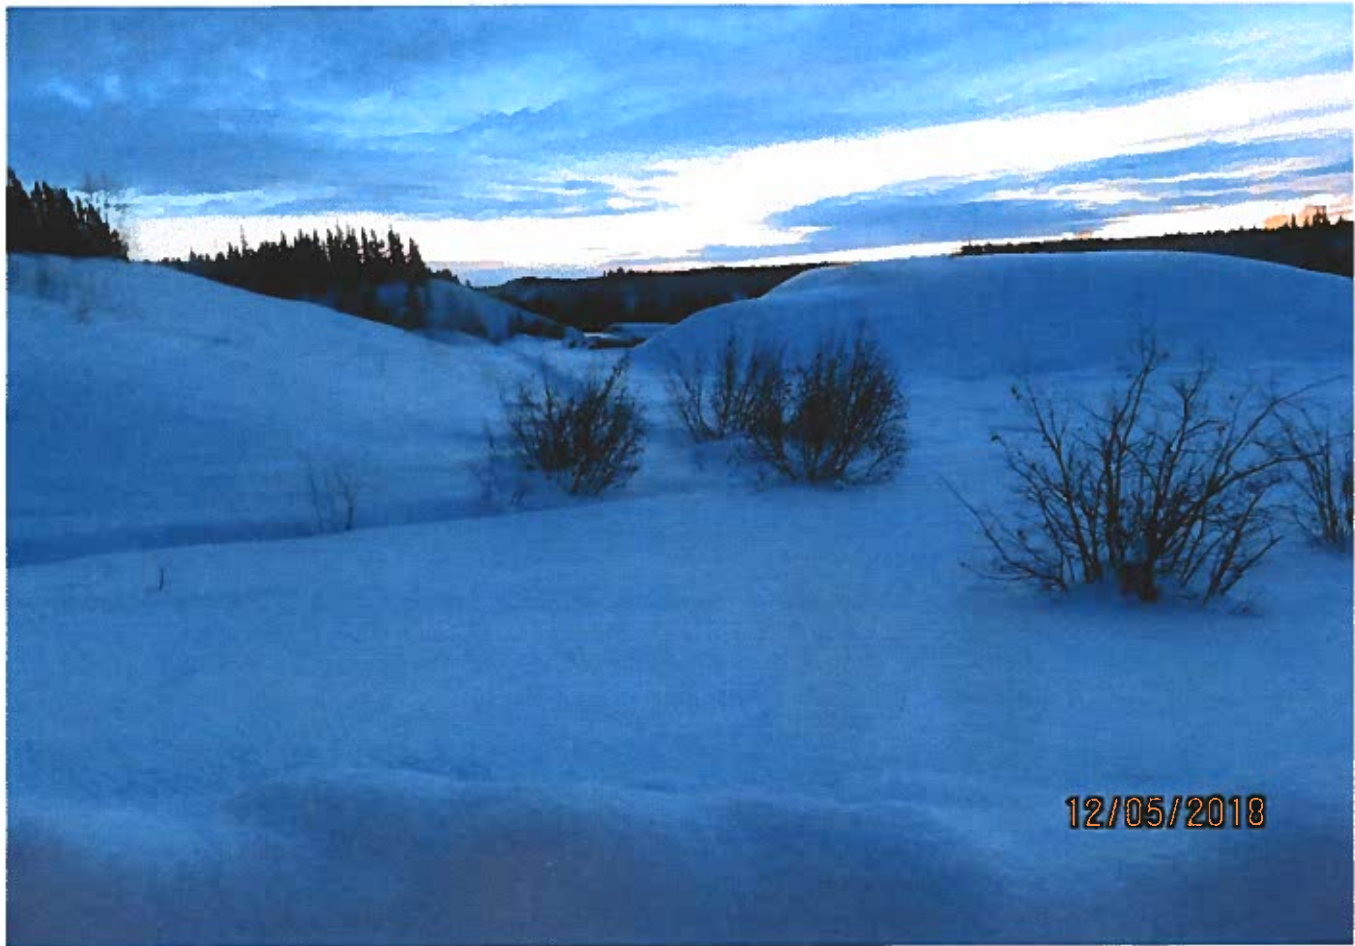
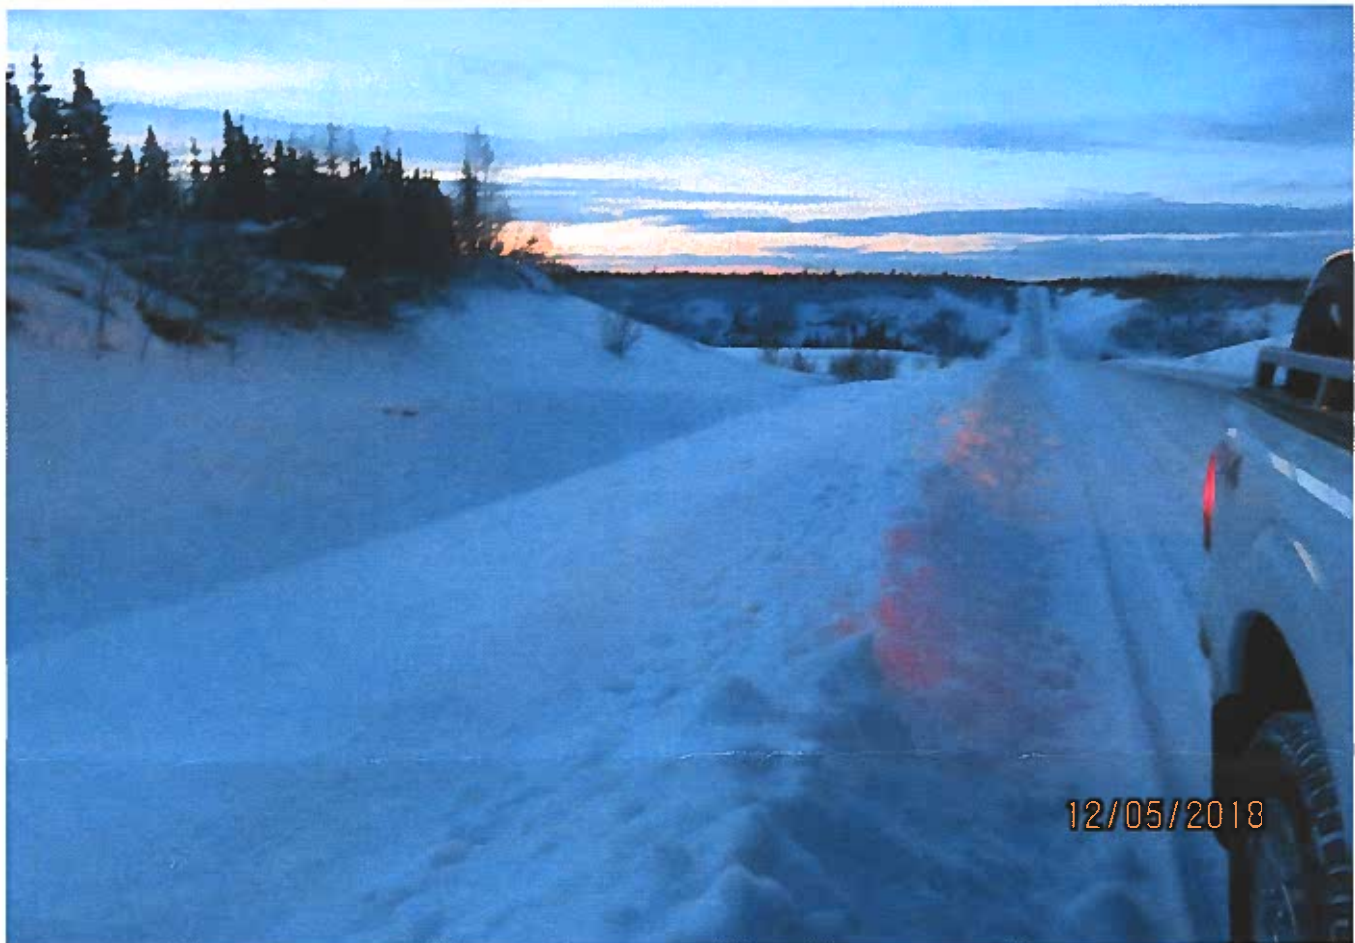
Figure 4
Km 178.1

During the inspection at Km 178.1 on December 5, 2018 there was no activity occurring at the time of the inspection.

There is still a section at the edge of the bank on the south side of the staging area that needs to be remediated before the spring run off starts.

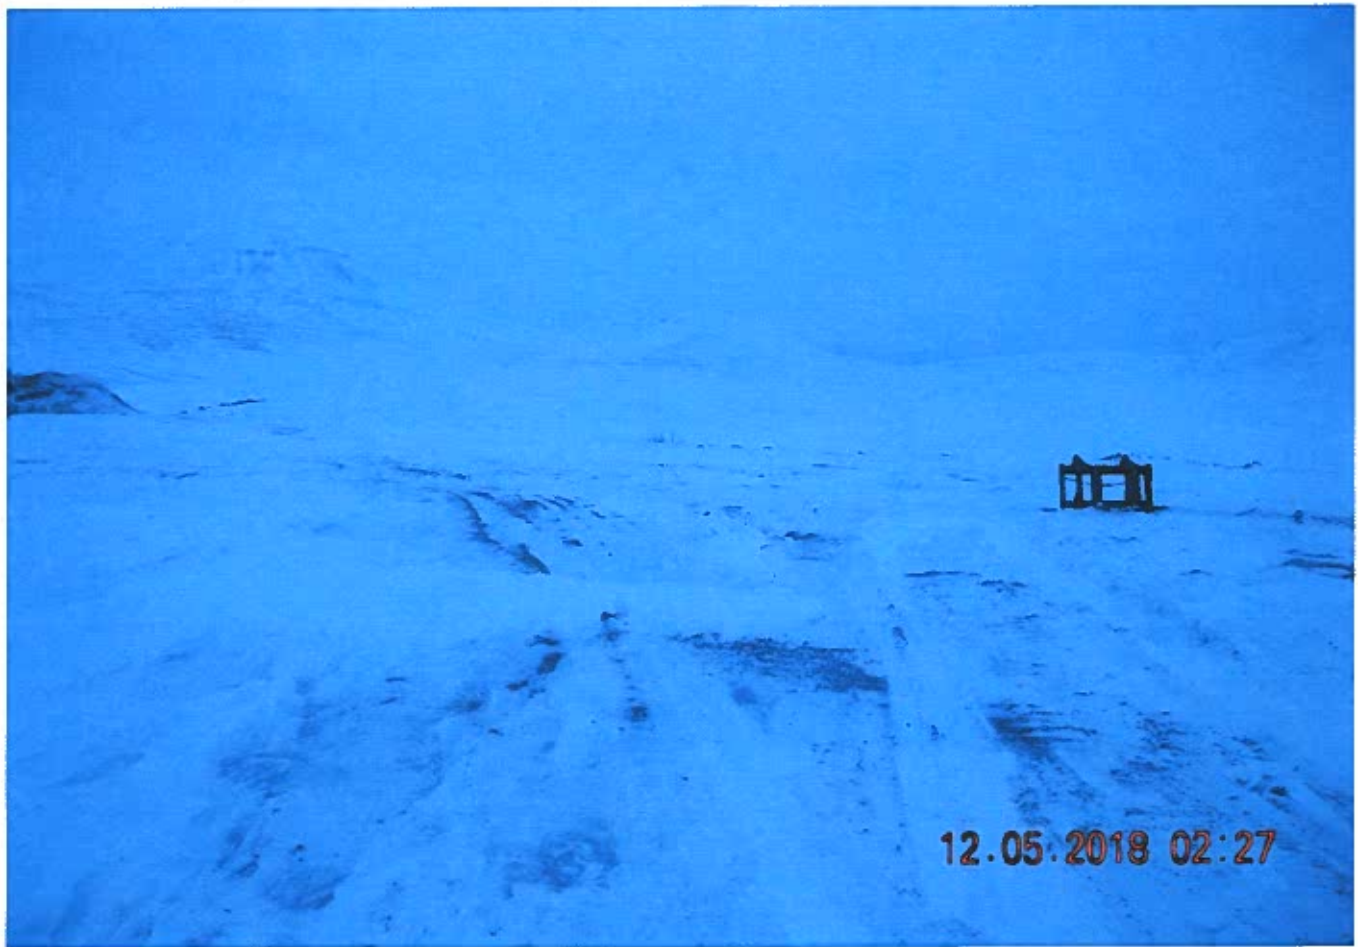
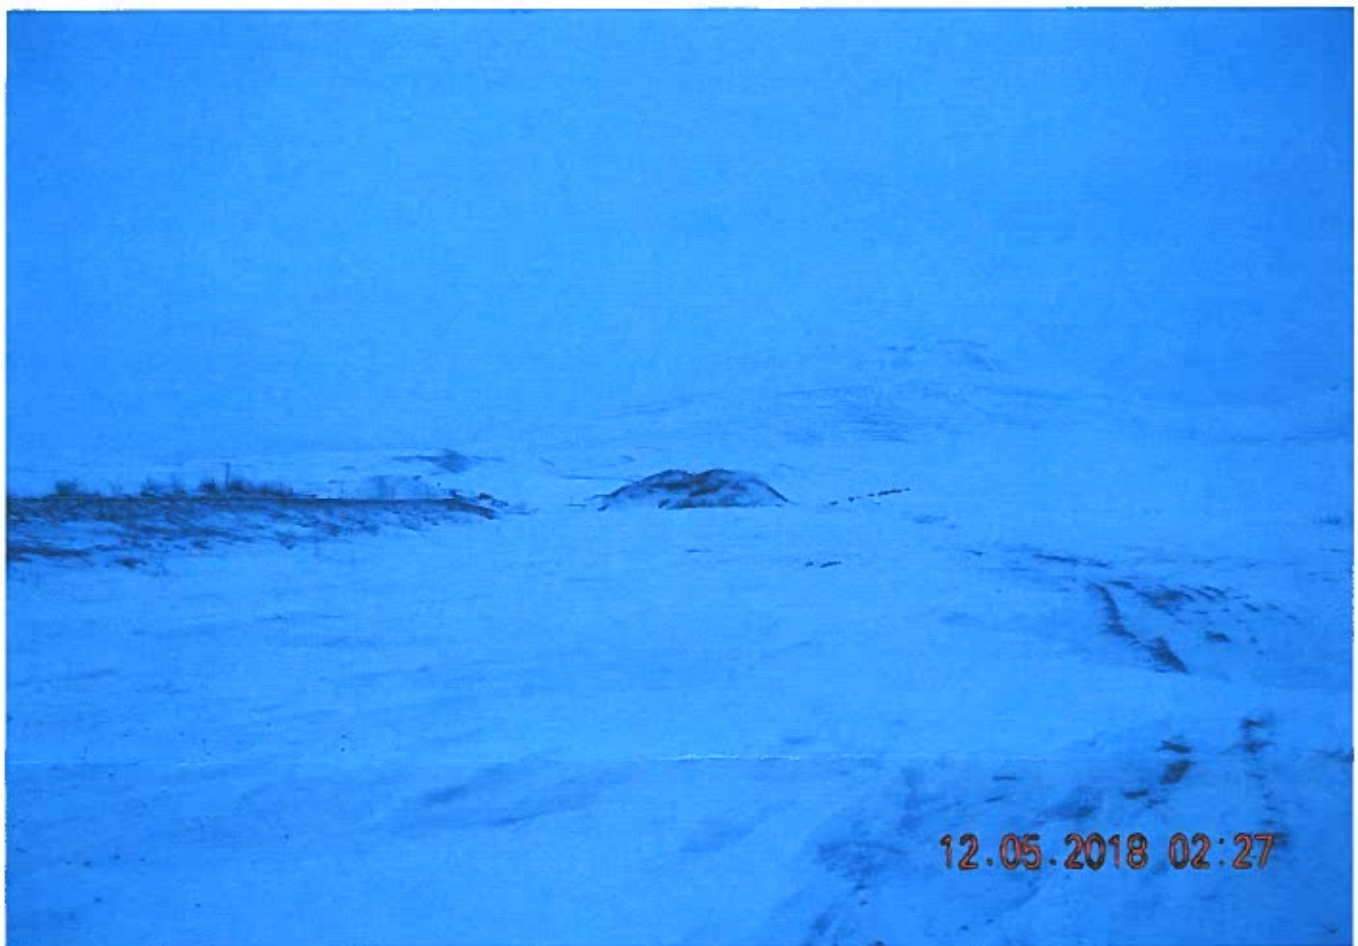
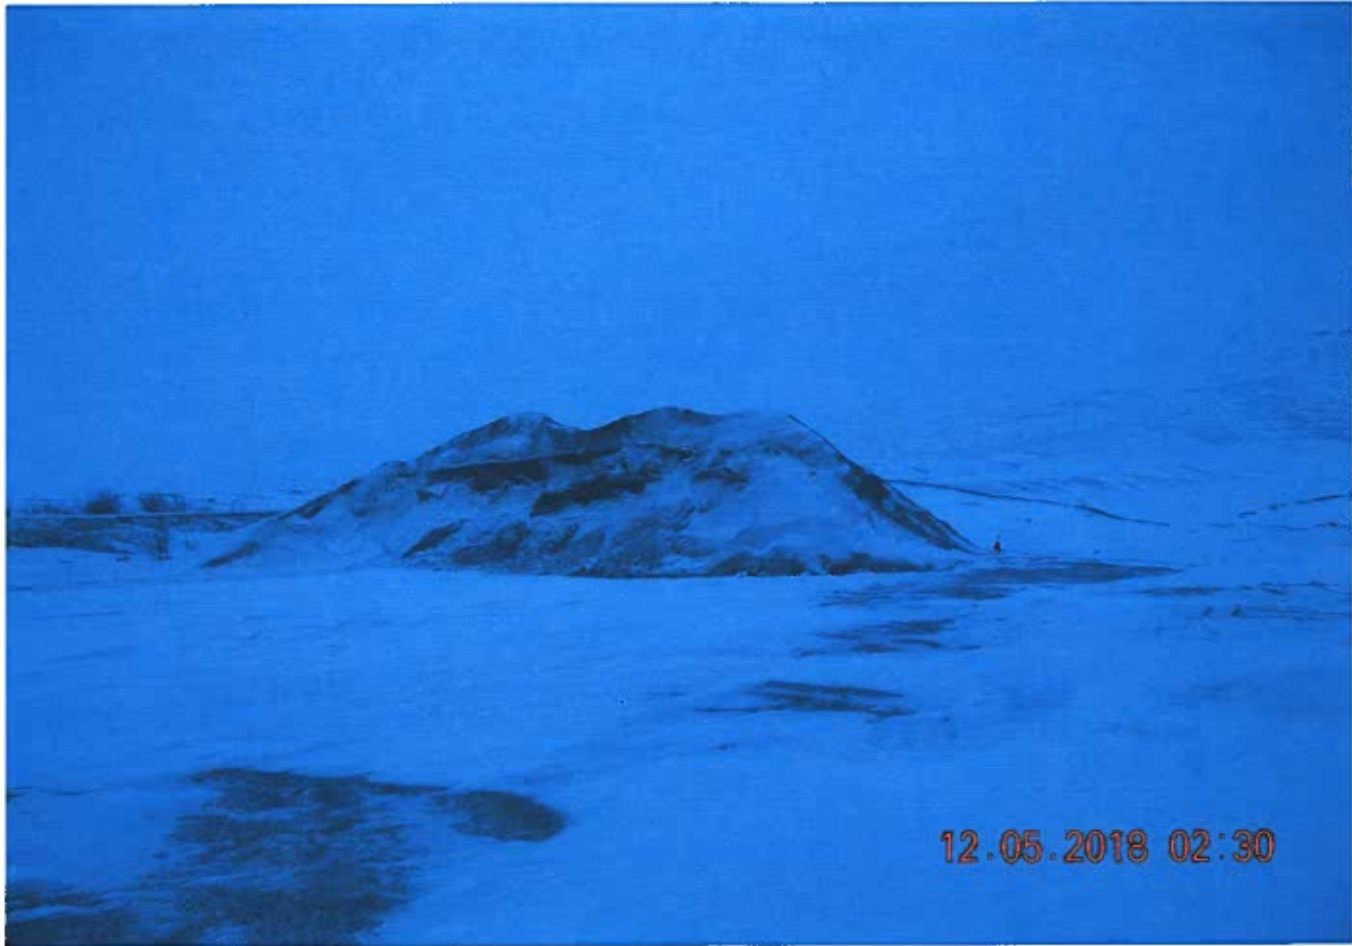
Figure 7
Km 6

At km 6 there was no concerns at the time of the inspection, the gravel stock pile is getting smaller since the last inspection and there was a set loader forks at the site.
