File Number: G14E002
Type of Operation: QUARRY SITE - Existing
Location: Km 6 & Km 178.1

ENVIRONMENTAL INSPECTION REPORT

Permittee:	GNWT Department of Infrastructure	Permit Expiry Date:	May 24, 2019
Land Use Permit No.	G14E002	Previous Inspection:	July 17, 2018
Quarrying Permit No.		Inspection Date:	July 25, 2018
Contractor:	DOI	Subcontractor:	
Location(s) Inspected:	Km 6 & Km 178.1		
Current Stage of Operation:	ongoing		
Program Modifications Approved:

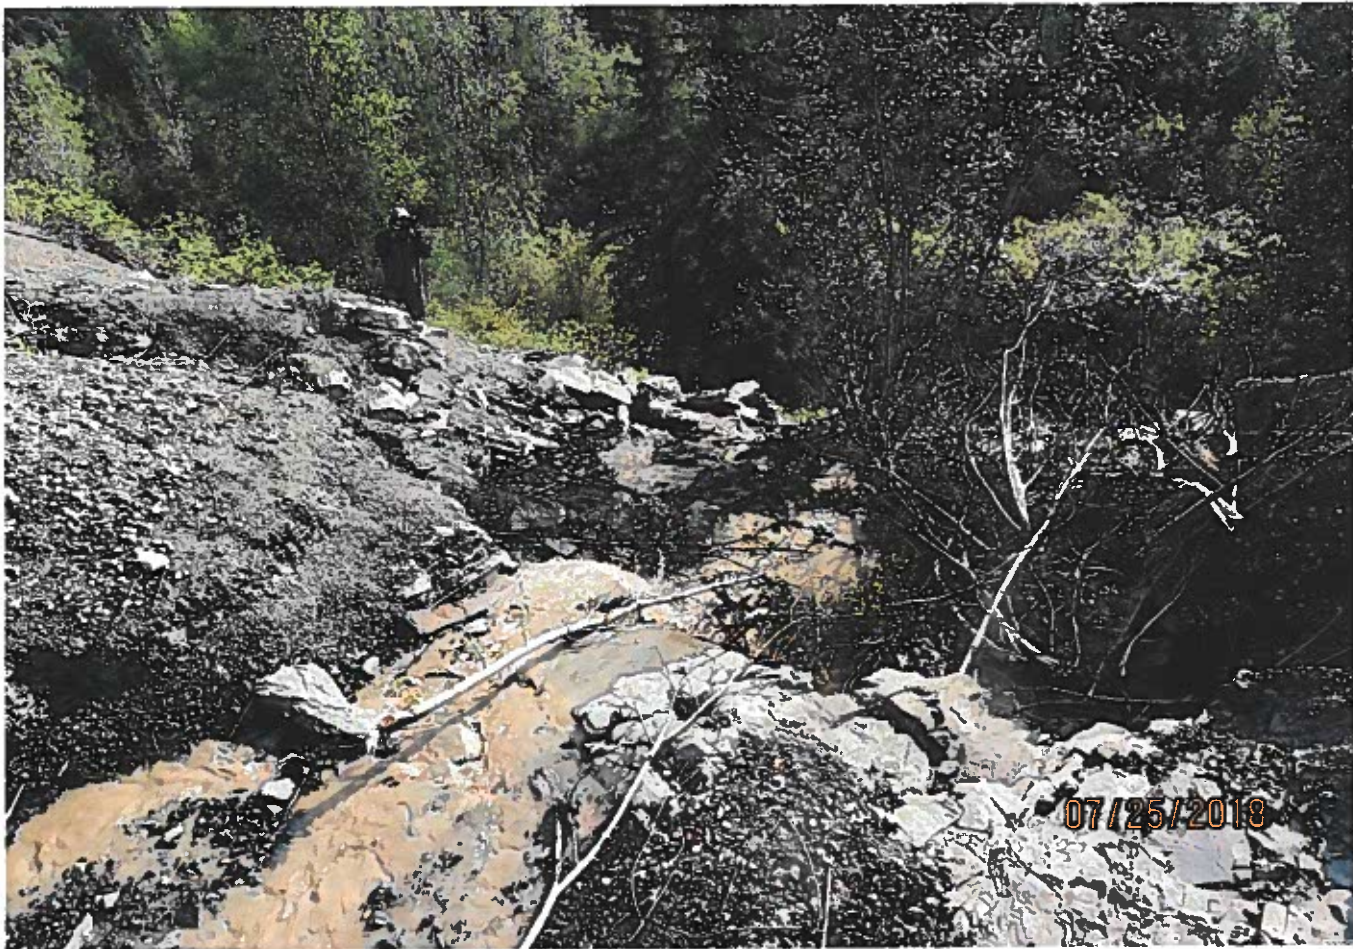
Figure 1, Km 178.1

During the inspection on July 25, 2018 at Km 178.1 there is still a concern that the stream flowing through the site between the entrance and the gravel pile is eroding the bank of the staging area. This stream seems to be flowing nonstop since spring freshet and one pass over the stream with a small truck created a lot of sediment flowing down the stream and it is flowing into the fish bearing river below that may trigger Department of Fisheries and Oceans involvement.

It was stated in the previous inspection reports dated May 30, 2018, July 5, 2018, July 10, 2018 and July 17, 2018 that this issue should be dealt with but nothing is done at this time.

If this matter is not dealt with as requested, Department of Lands will consider further actions with legal legislations for non-compliance.

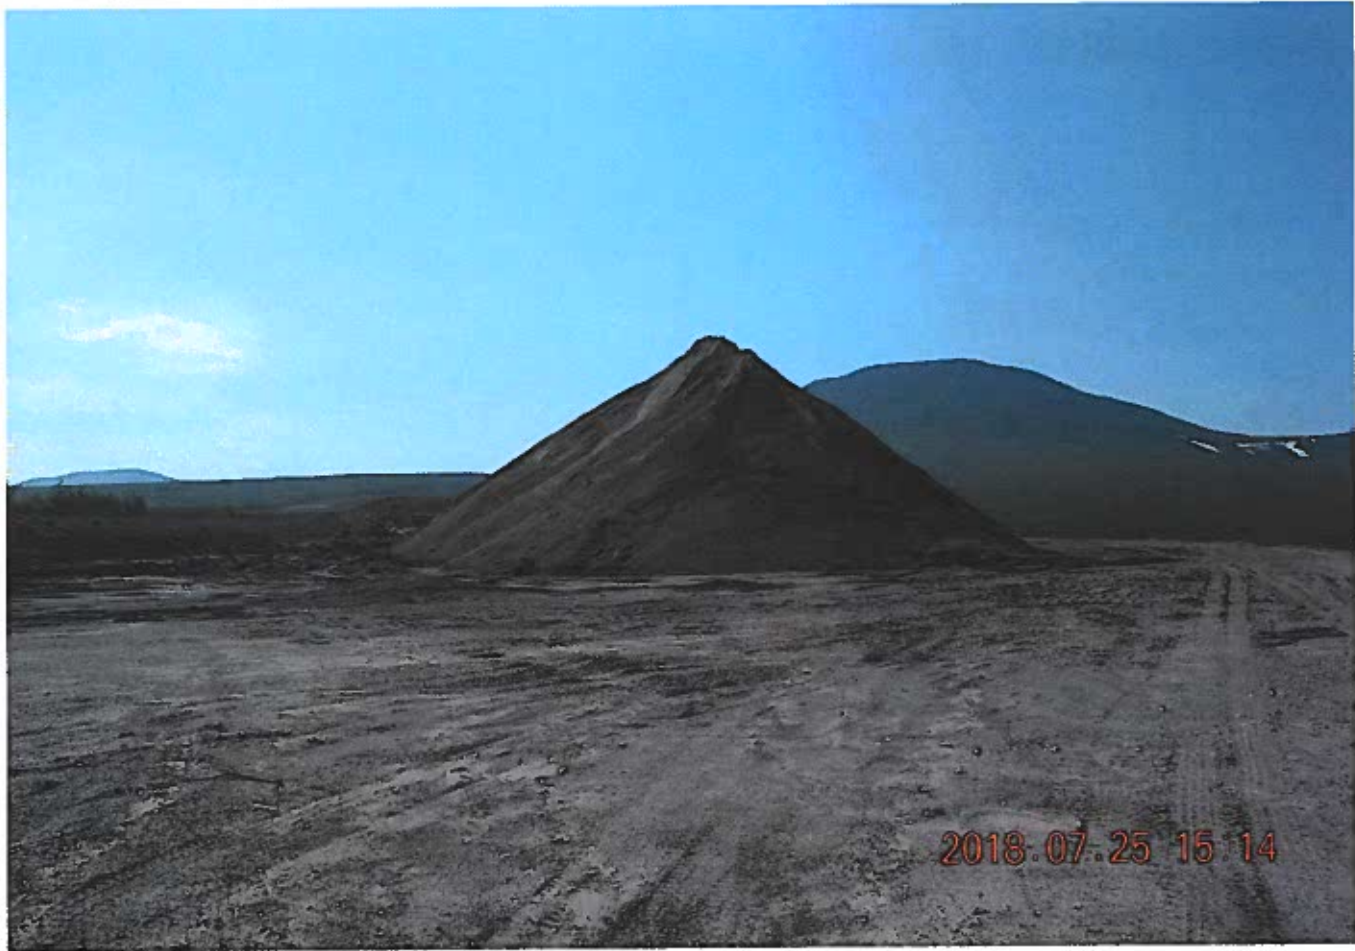
Figure 5, km 6

During the inspection on July 25, 2018 there were no concerns observed by the inspectors at km 6 at this time.
