File Number G14E002
Type of Operation QUARRY SITE - Existing
Location Km 251

ENVIRONMENTAL INSPECTION REPORT

Permittee:	GNWT Department of Infrastructure	Permit Expiry Date:	May 24, 2021
Land Use Permit No.	G14E002	Previous Inspection:	October 17, 2019
Quarrying Permit No.		Inspection Date:	October 30, 2019
Contractor:	DOI	Subcontractor:	
Location(s) Inspected:	Km 251		
Current Stage of Operation:	No work at this time		
Program Modifications Approved:

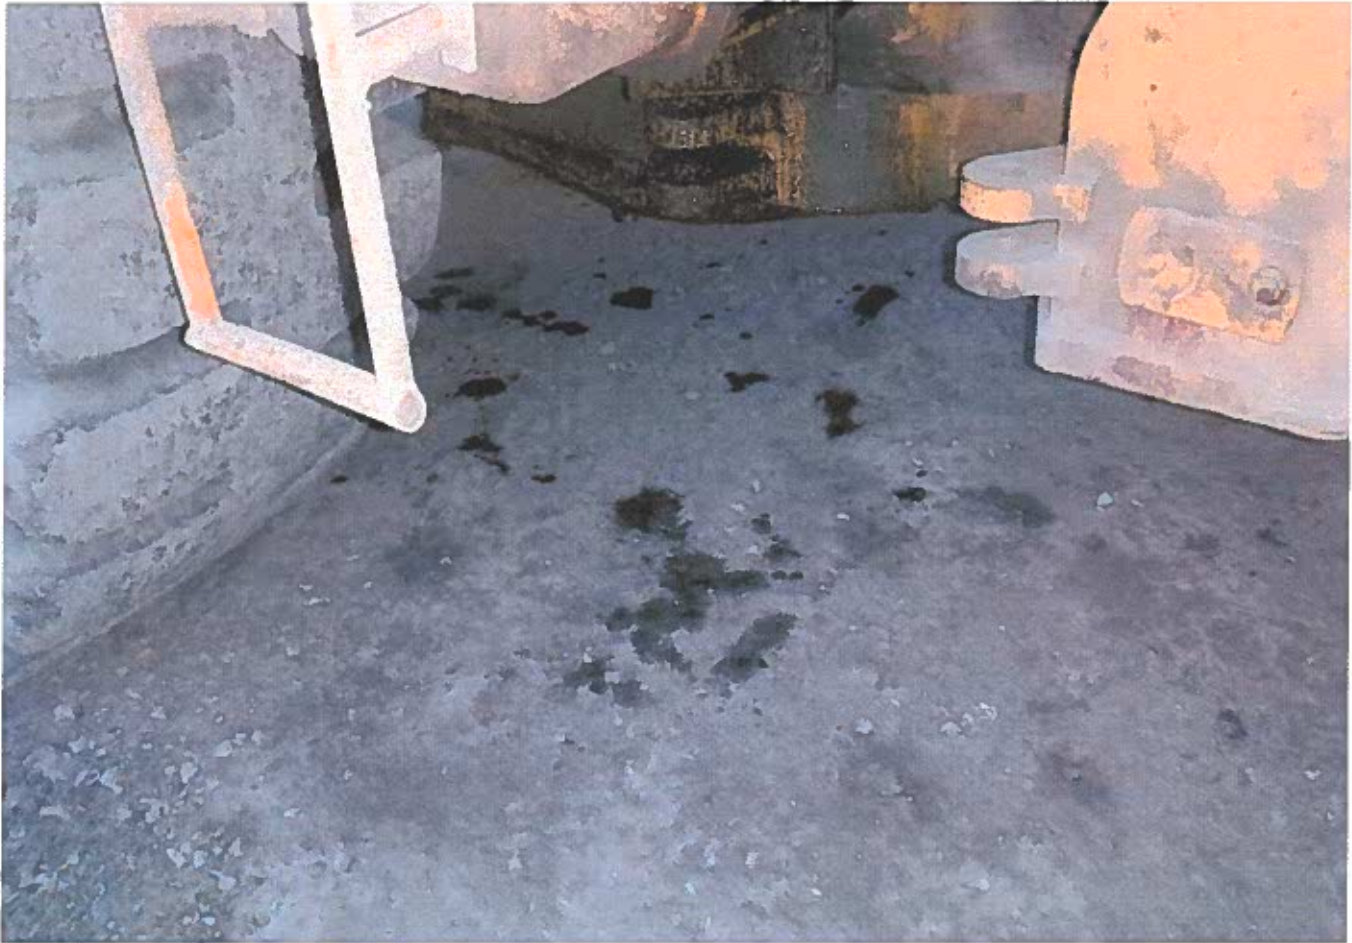
Figure 1

There is oil leaks under all the loaders that are parked at the site, there is a puddle of hydraulic oil under the cone crusher and other leaks in different sections of the crusher. The rest of the site is in good order and there is no activity occurring at this time.

Please ensure these spills are cleaned up asap.
