File Number	G16Q004
Type of Operation	QUARRY SITE - Existing
Location	Km 251

ENVIRONMENTAL INSPECTION REPORT

Permittee:	Bob's Welding Ltd.	Permit Expiry Date:	May 25, 2021
Land Use Permit No.	G16Q004	Previous Inspection:	November 24, 2020
Quarrying Permit No.		Inspection Date:	December 04, 2020
Contractor:		Subcontractor:	
Location(s) Inspected:	Km 251		
Current Stage of Operation:	ongoing		
Program Modifications Approved:	New Quarry permit issued for removal of material

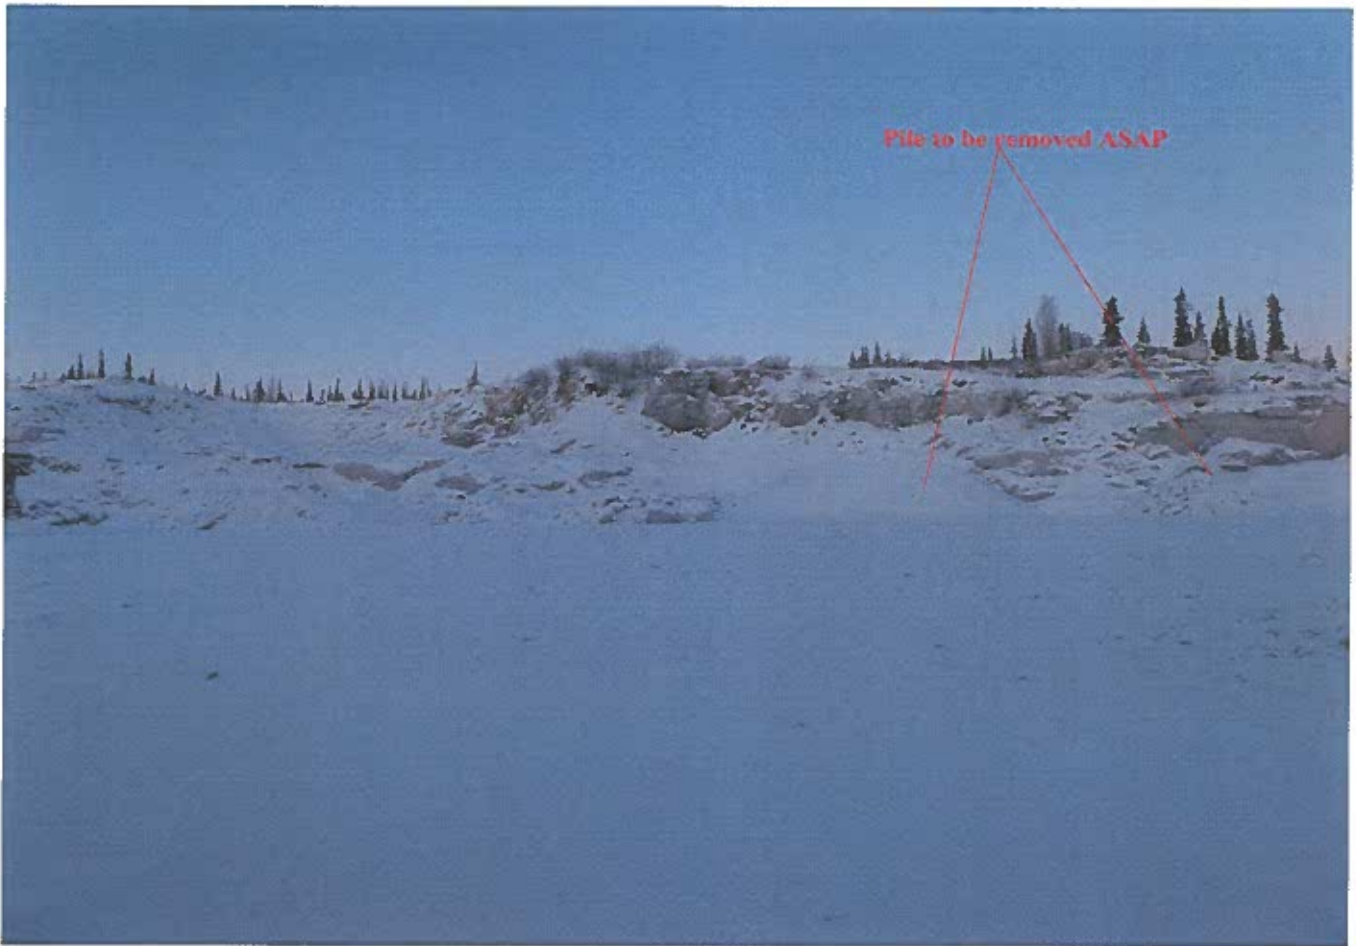
Figure 1

Please note that some material was removed however it is recommended that material by the north wall be removed first as other contractors need to get to their work locations provided to them, this has been previously mentioned in past inspection reports in regards to other contractors to work in the area and that this is a multi user pit/source. It is highly recommended that the materials mentioned be removed ASAP.

Ensure material by north side wall is removed as previously indicated.
