File Number G16Q004
Type of Operation QUARRY SITE - Existing
Location KM 251 Quarry

ENVIRONMENTAL INSPECTION REPORT

Permittee:	Bob's Welding Ltd.	Permit Expiry Date:	May 25, 2021
Land Use Permit No.	G16Q004	Previous Inspection:	July 17, 2018
Quarrying Permit No.		Inspection Date:	September 05, 2018
Contractor:		Subcontractor:	
Location(s) Inspected:	KM 251 Quarry		
Current Stage of Operation:	On-going		
Program Modifications Approved:

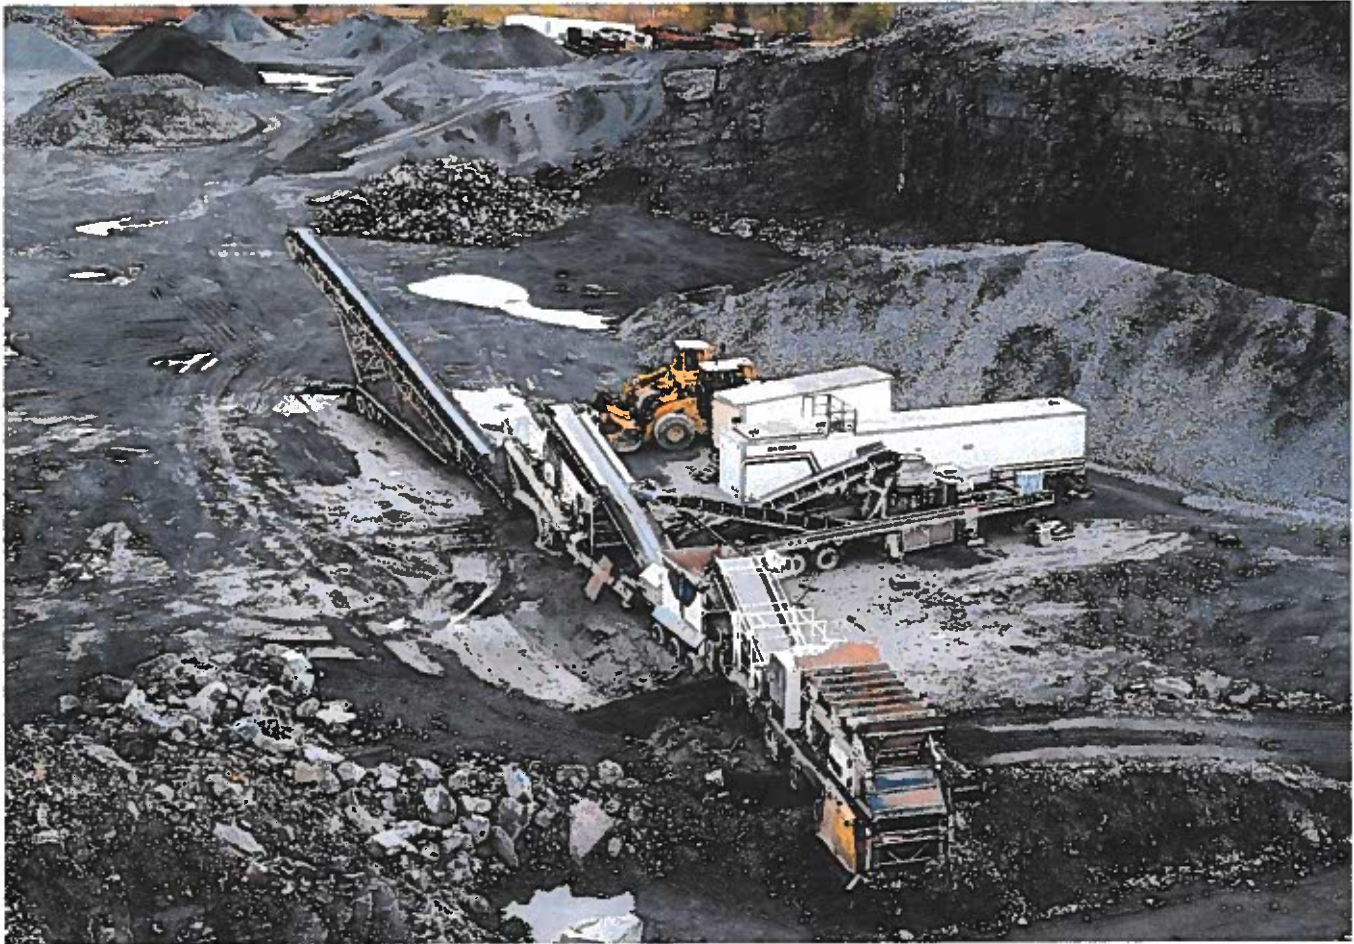
Figure 1

The crusher parked in the middle of the pit floor.

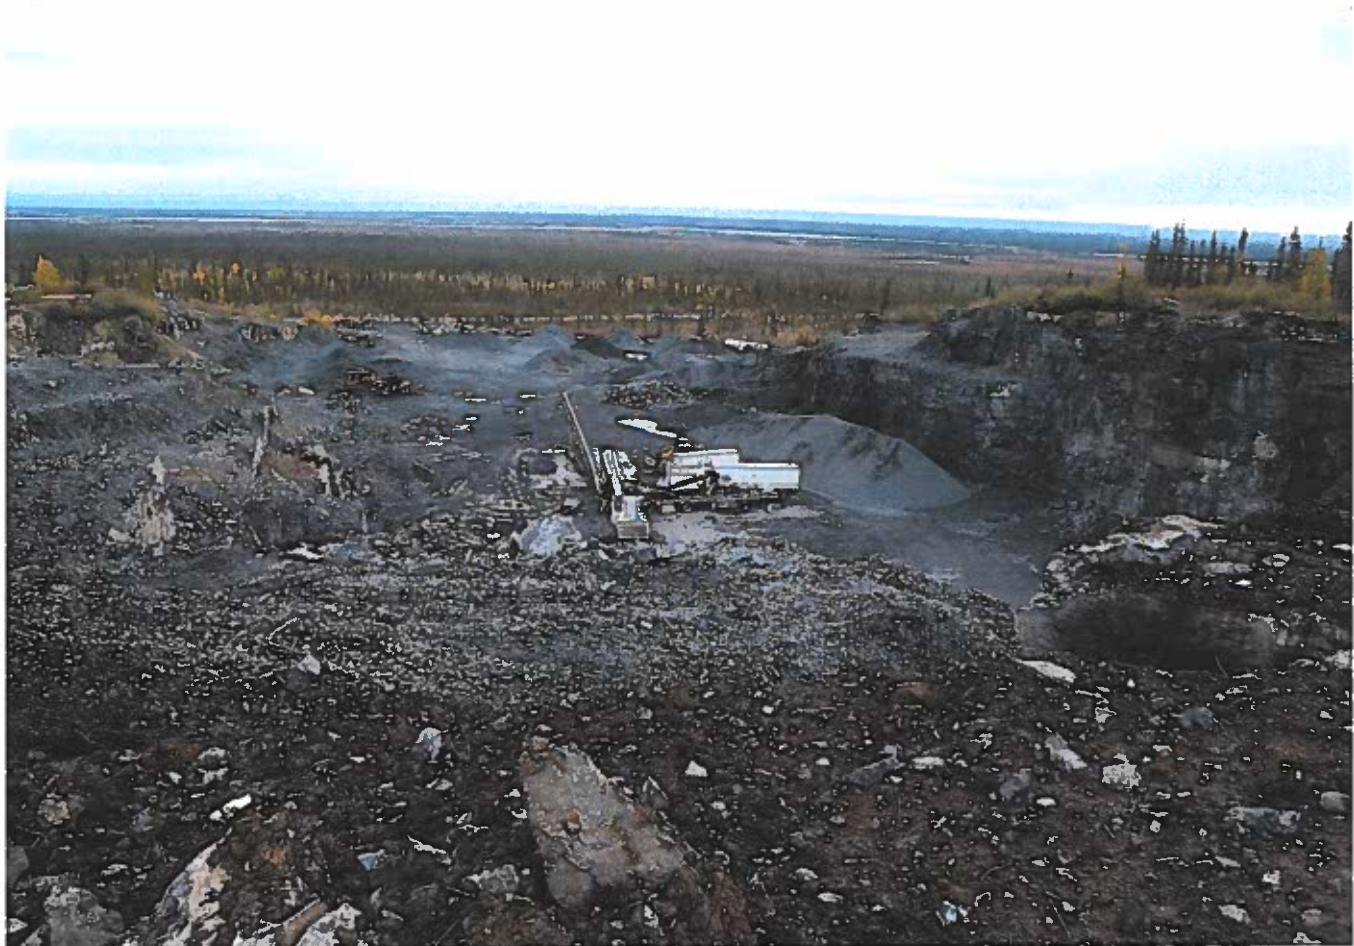
Figure 2

A general photo overlooking the entire pit.

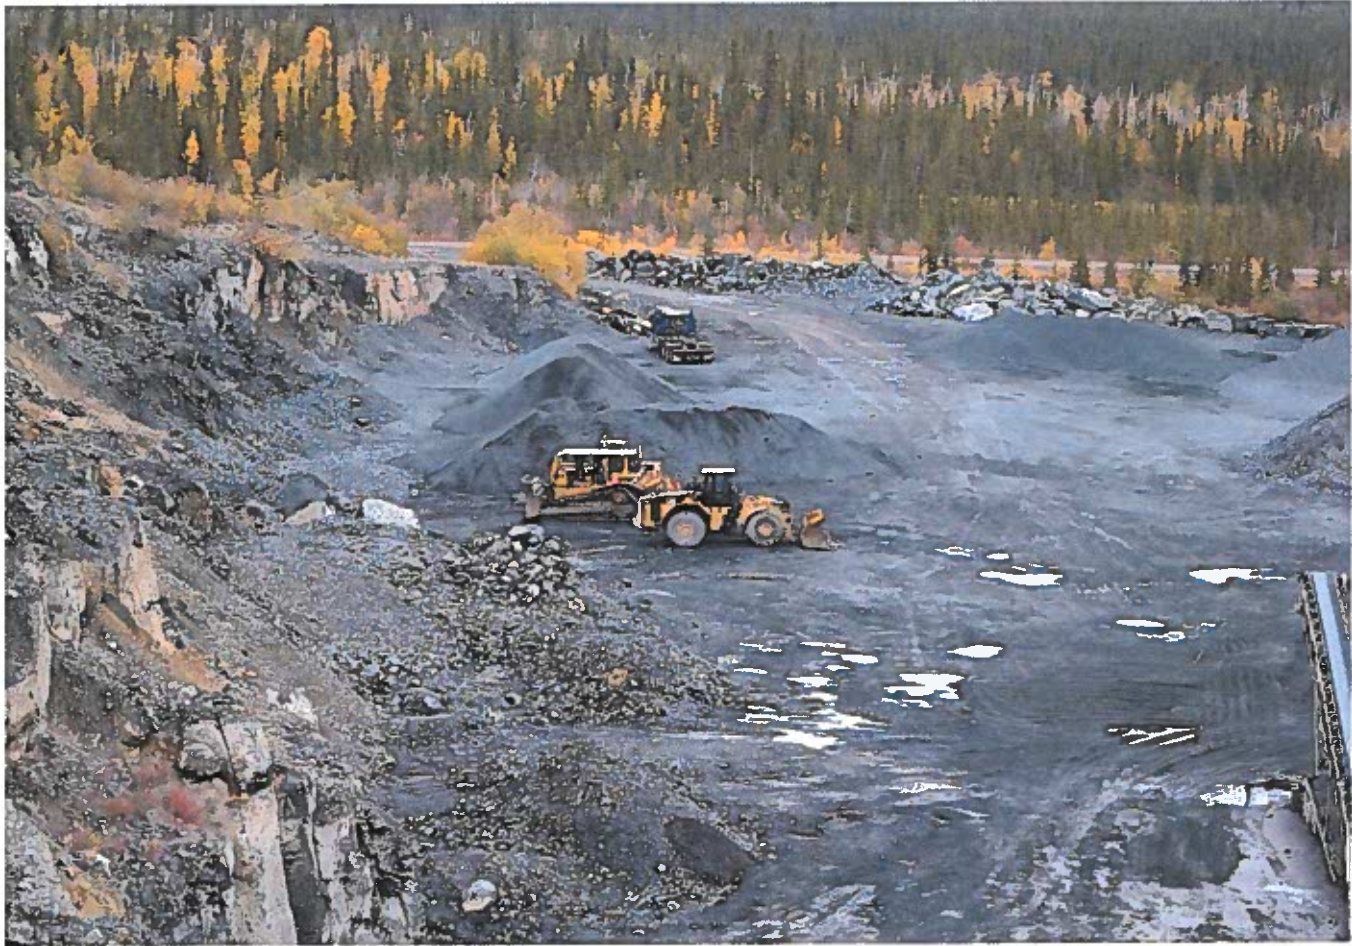
Figure 3
Some of the equipment used for the operation of the pit.

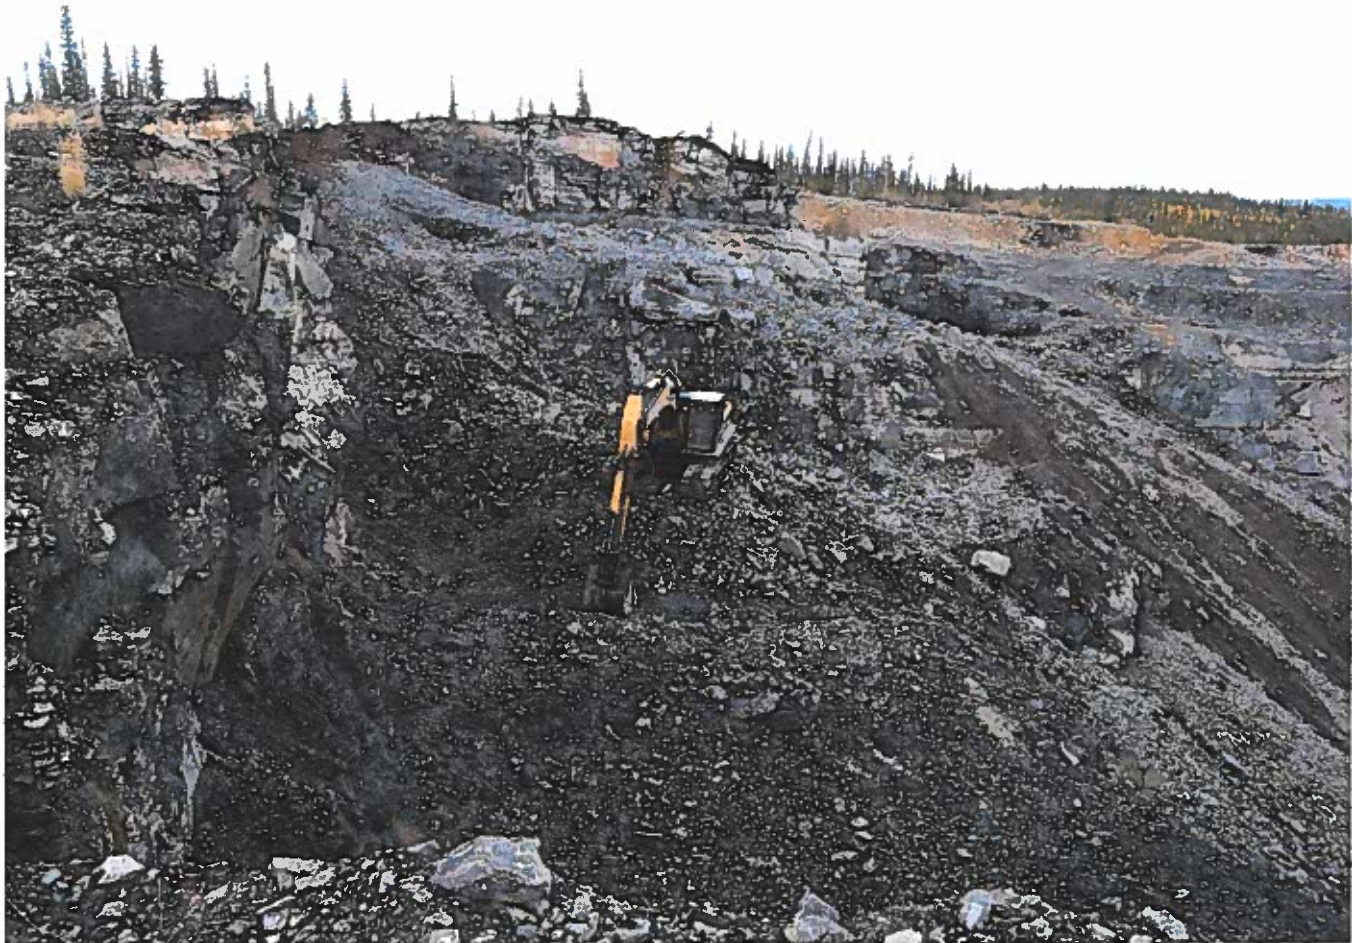
Figure 4
An excavator sitting amongst the blast material.

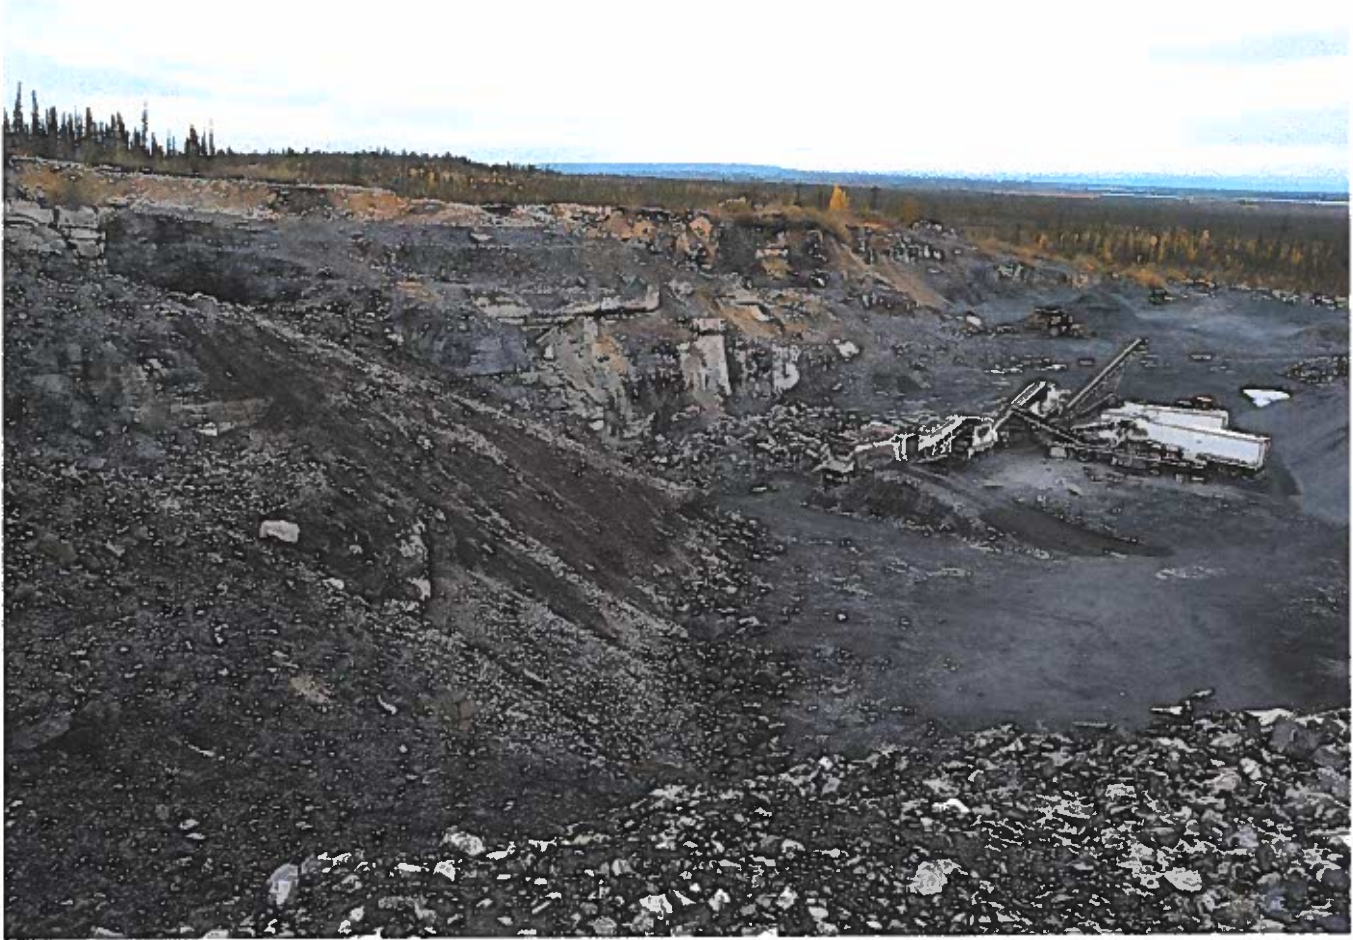
Figure 5

Some of the blast material sloped towards the crusher, ready for processing.
