File Number	G17Q005
Type of Operation	QUARRY SITE - Existing
Location	Km 66 on the Dempster Highway

ENVIRONMENTAL INSPECTION REPORT

Permittee:	L.J.'s Septic Services & Contracting Ltd.	Permit Expiry Date:	March 28, 2022
Land Use Permit No.	G17Q005	Previous Inspection:	August 24, 2017
Quarrying Permit No.		Inspection Date:	September 07, 2017
Contractor:	L.J.'s Septic Services & Contracting Ltd.	Subcontractor:	
Location(s) Inspected:	Km 66 on the Dempster Highway		
Current Stage of Operation:	hauling crushed gravel from the site		
Program Modifications Approved:

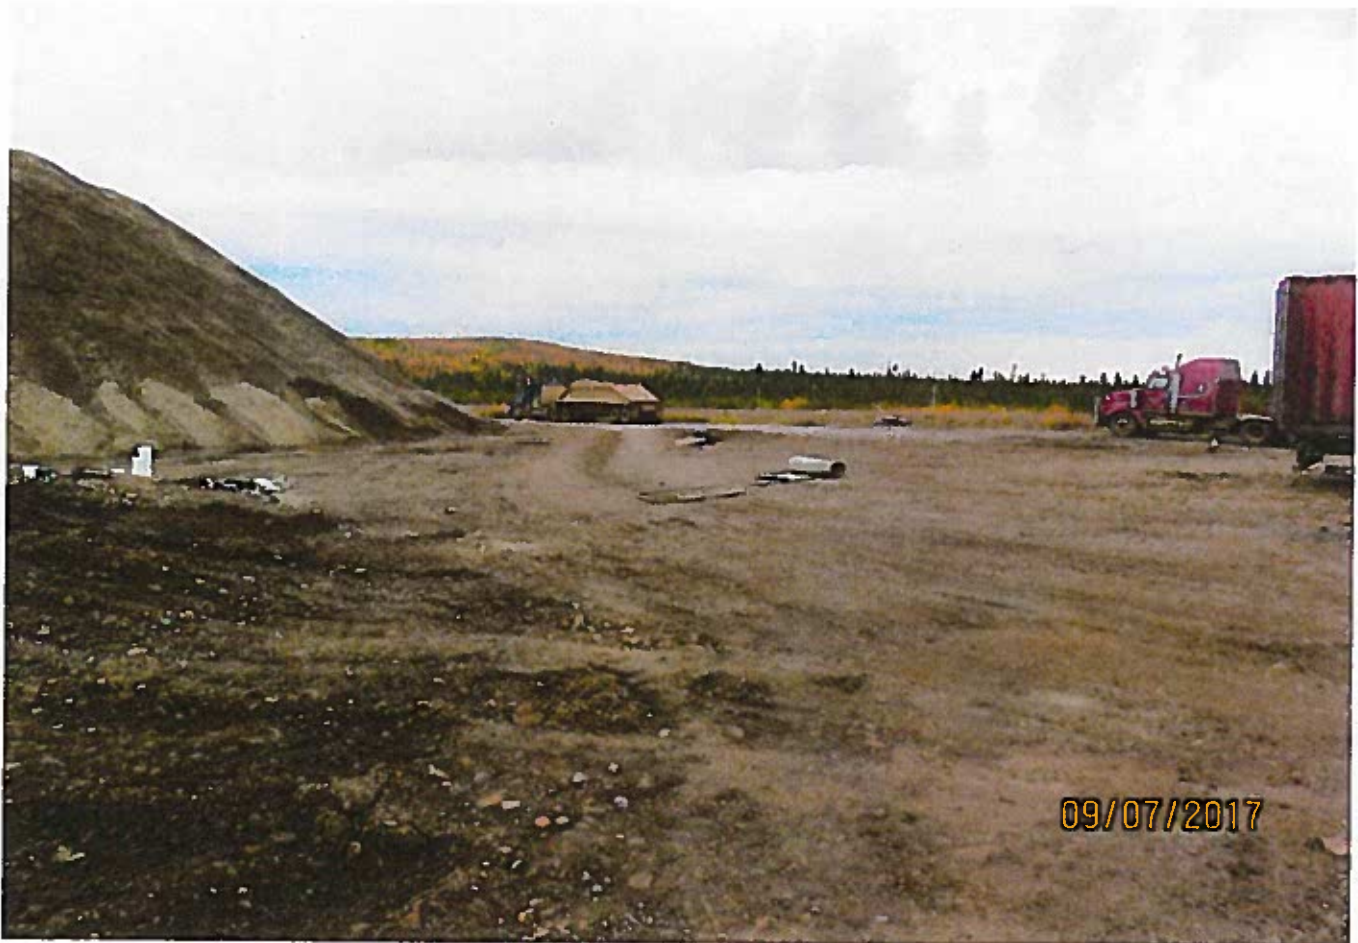
Figure 1

L.J.'s crew were busy hauling away the crushed gravel from the site for the road maintenance on the Dempster Highway. The rock crushers were removed from the site except for one, it is parked at the back of the gravel pile on the east side.

Gravel truck in line for load of gravel

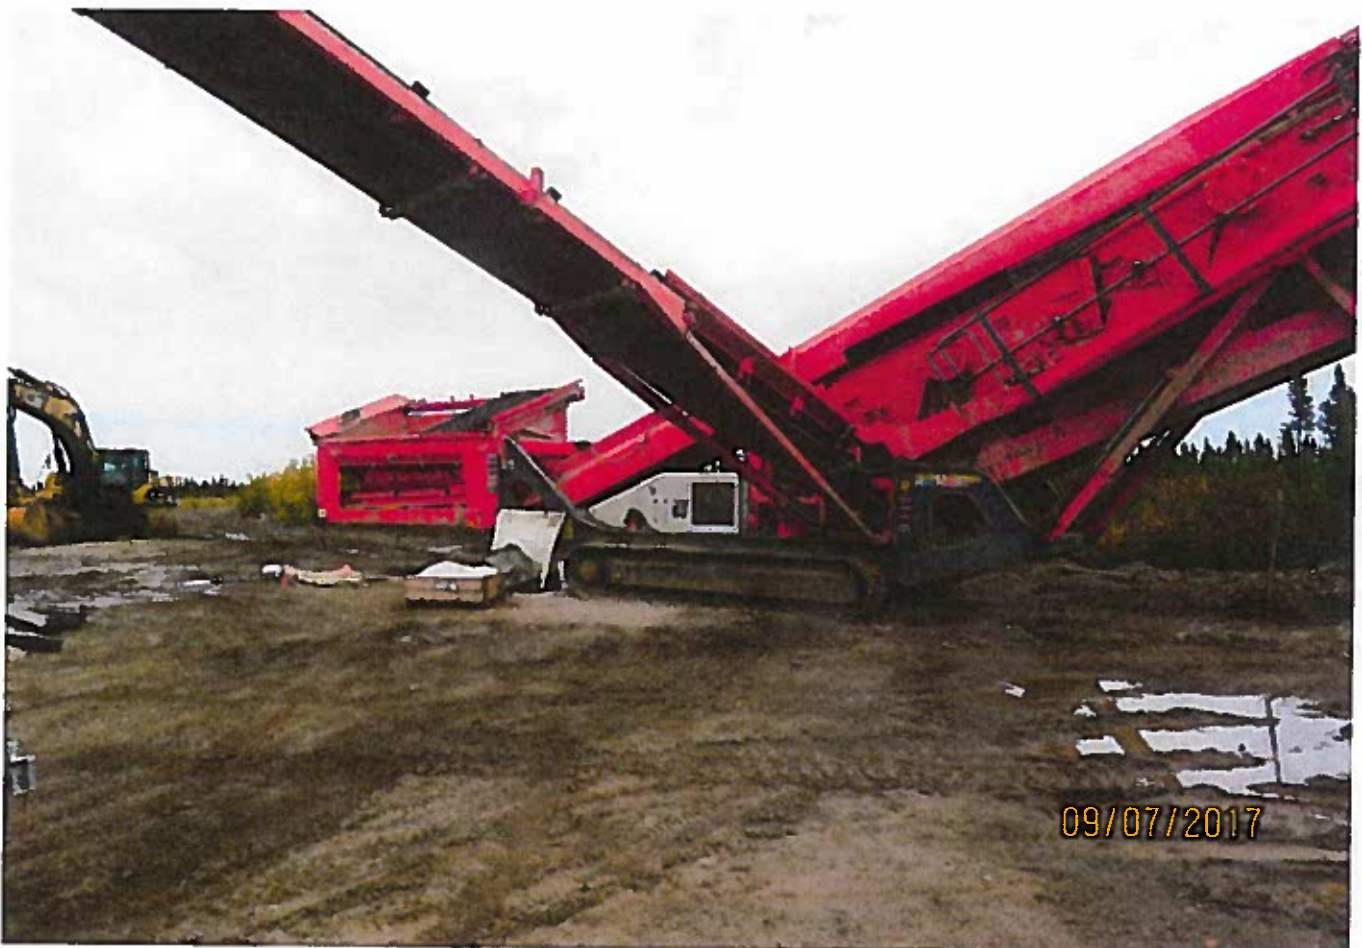
Figure 2

One rock crusher remaining at the site

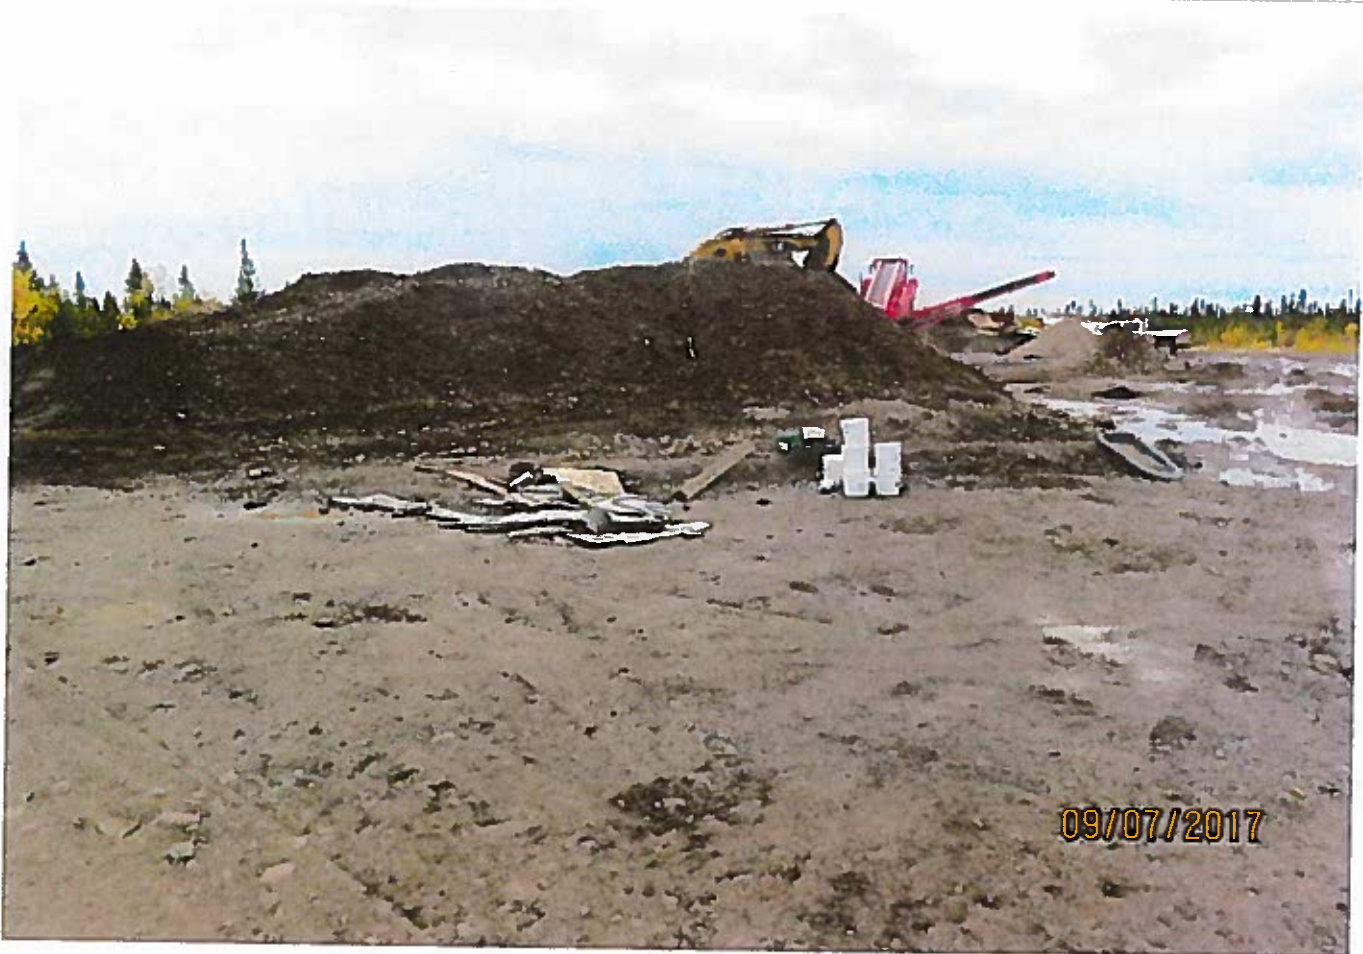
The garbage from around the area was gathered up and placed in piles at the site and some garbage was put in a sea can. The oil that was in the puddle by the crusher indicated in the last inspection report was cleaned up from the area.

Figure 3
Garbage on site

Please ensure there is no oil leaks on the equipment that is parked at the site and all the garbage and scrap material is removed before the snow falls.

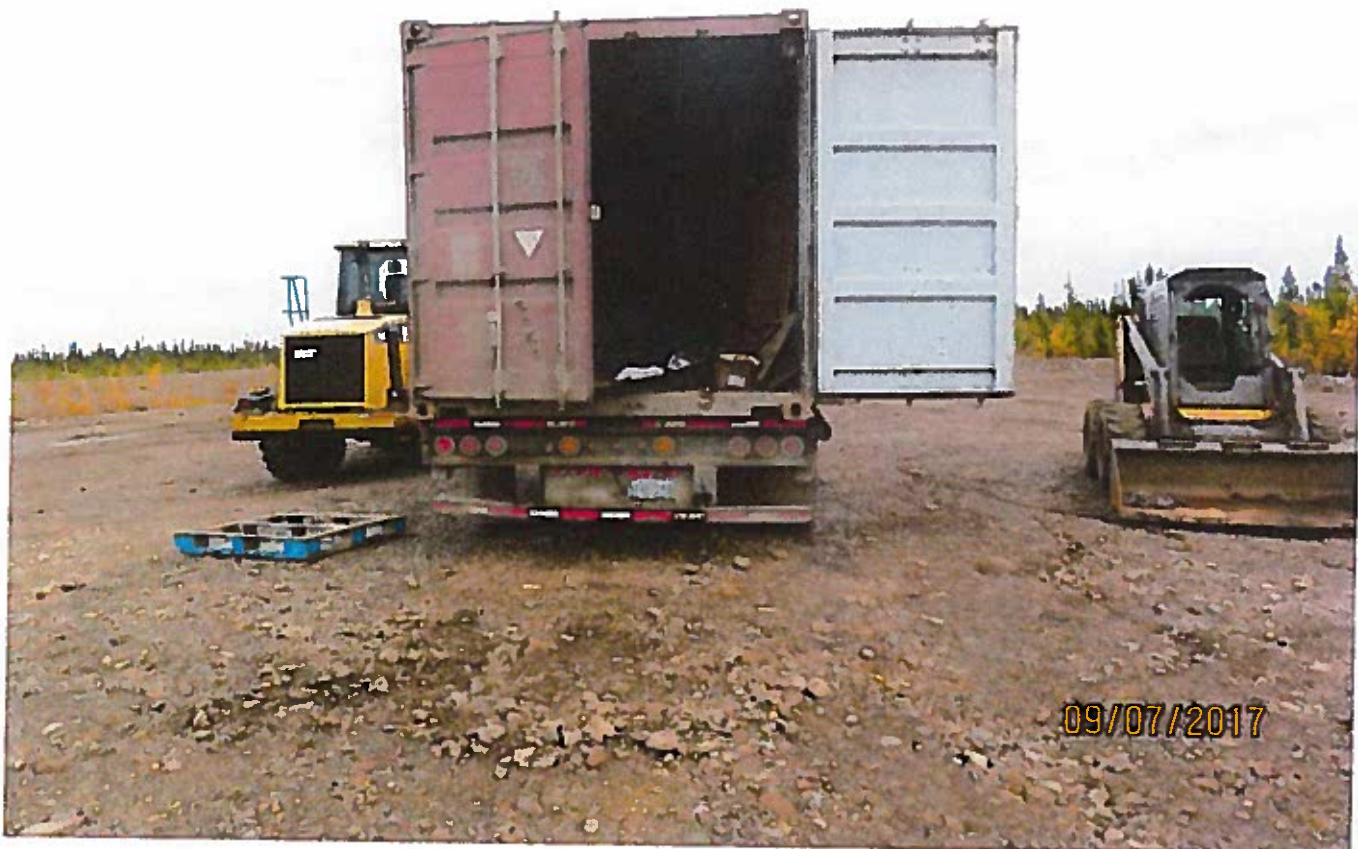
Figure 4
garbage in sea can

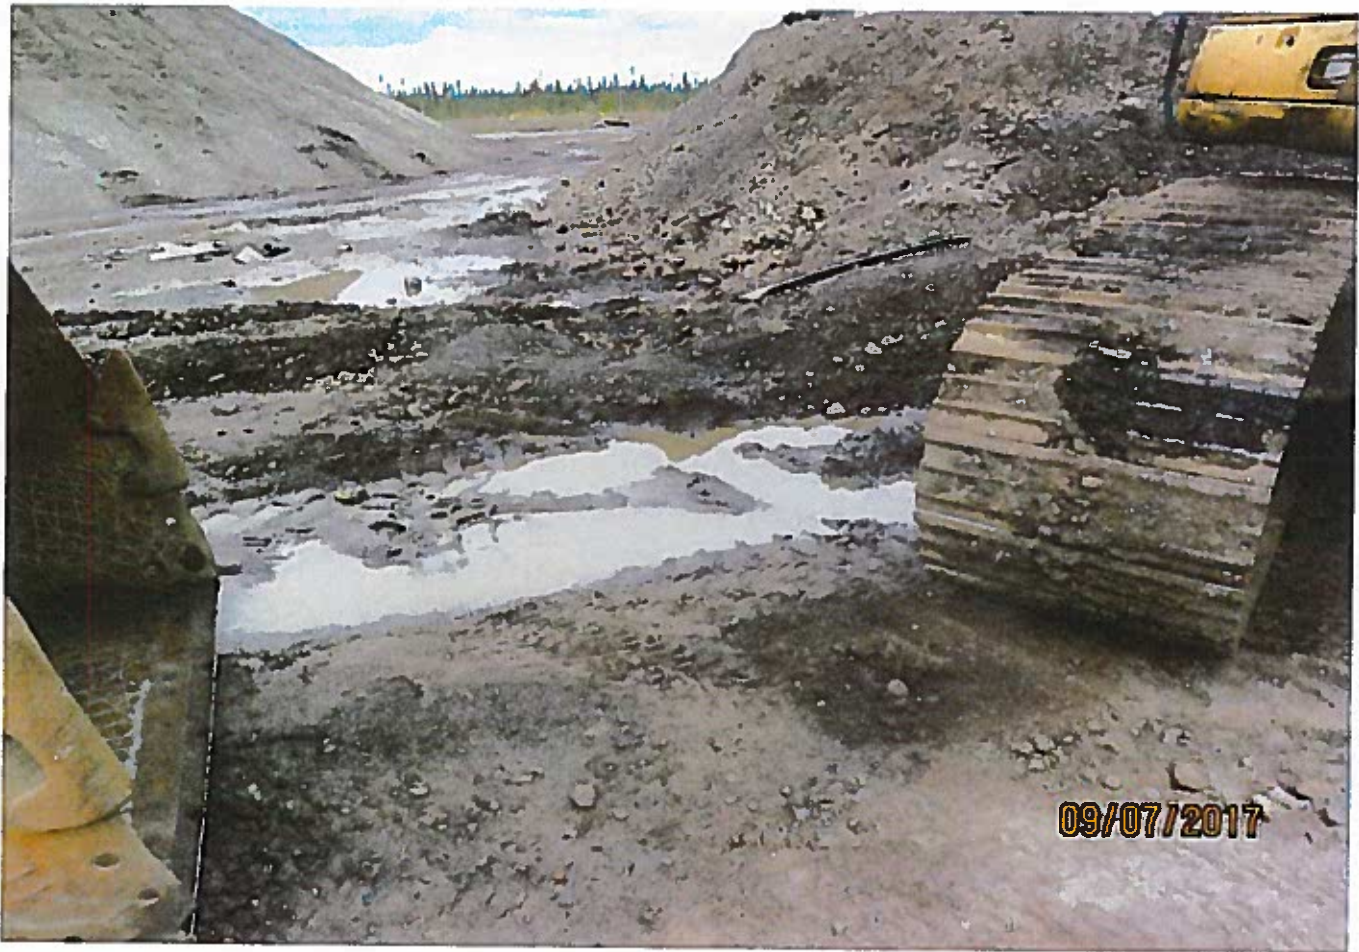
Figure 5

Oil cleaned up from puddle

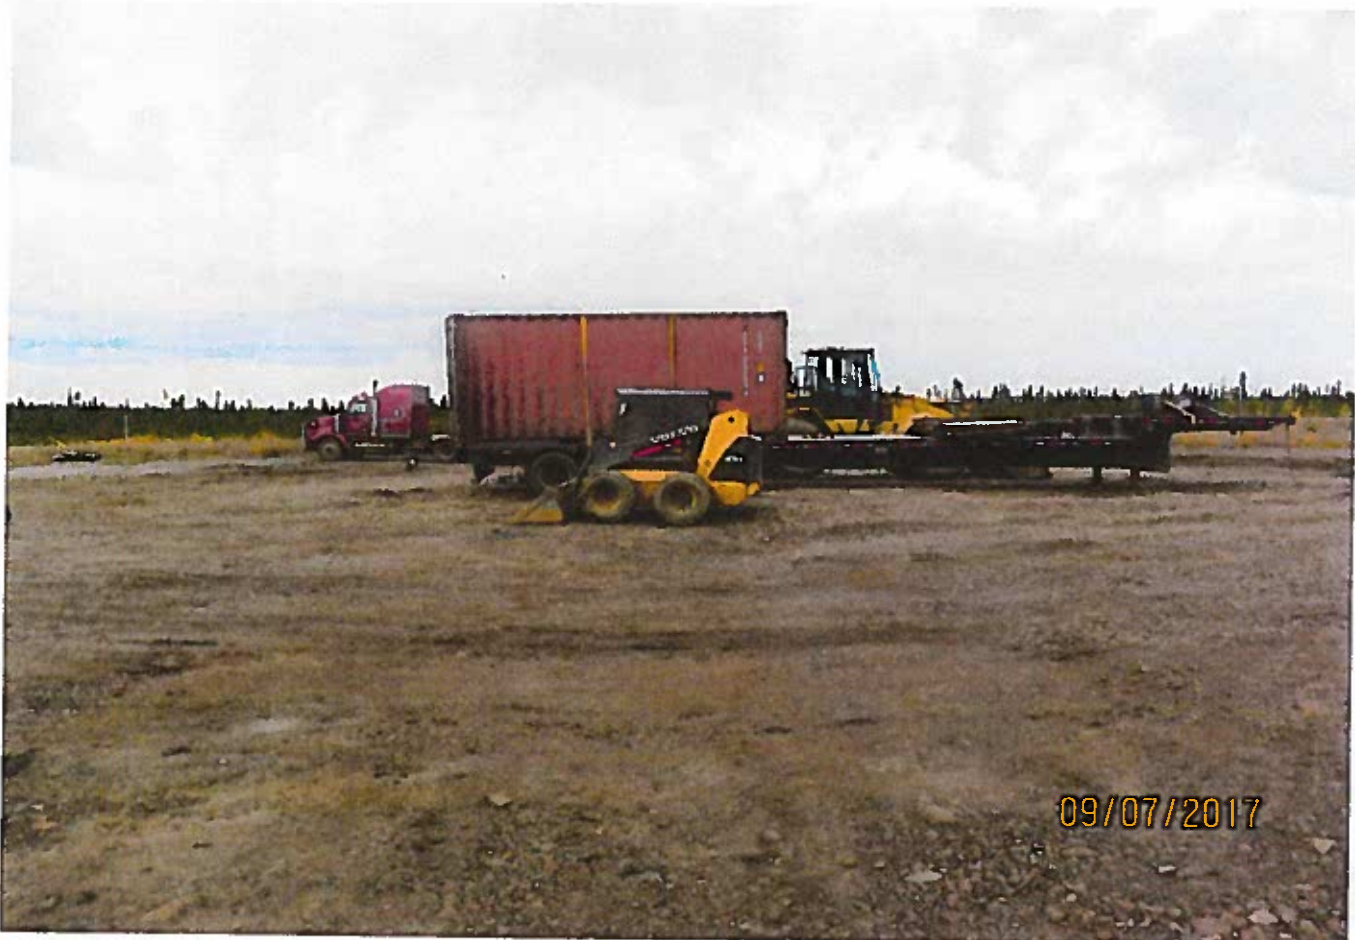
Figure 6

Equipment on site
