December 6, 2018

File Number G18Q003
Type of Operation QUARRY SITE - Existing
Location Frog Creek gravel source

ENVIRONMENTAL INSPECTION REPORT

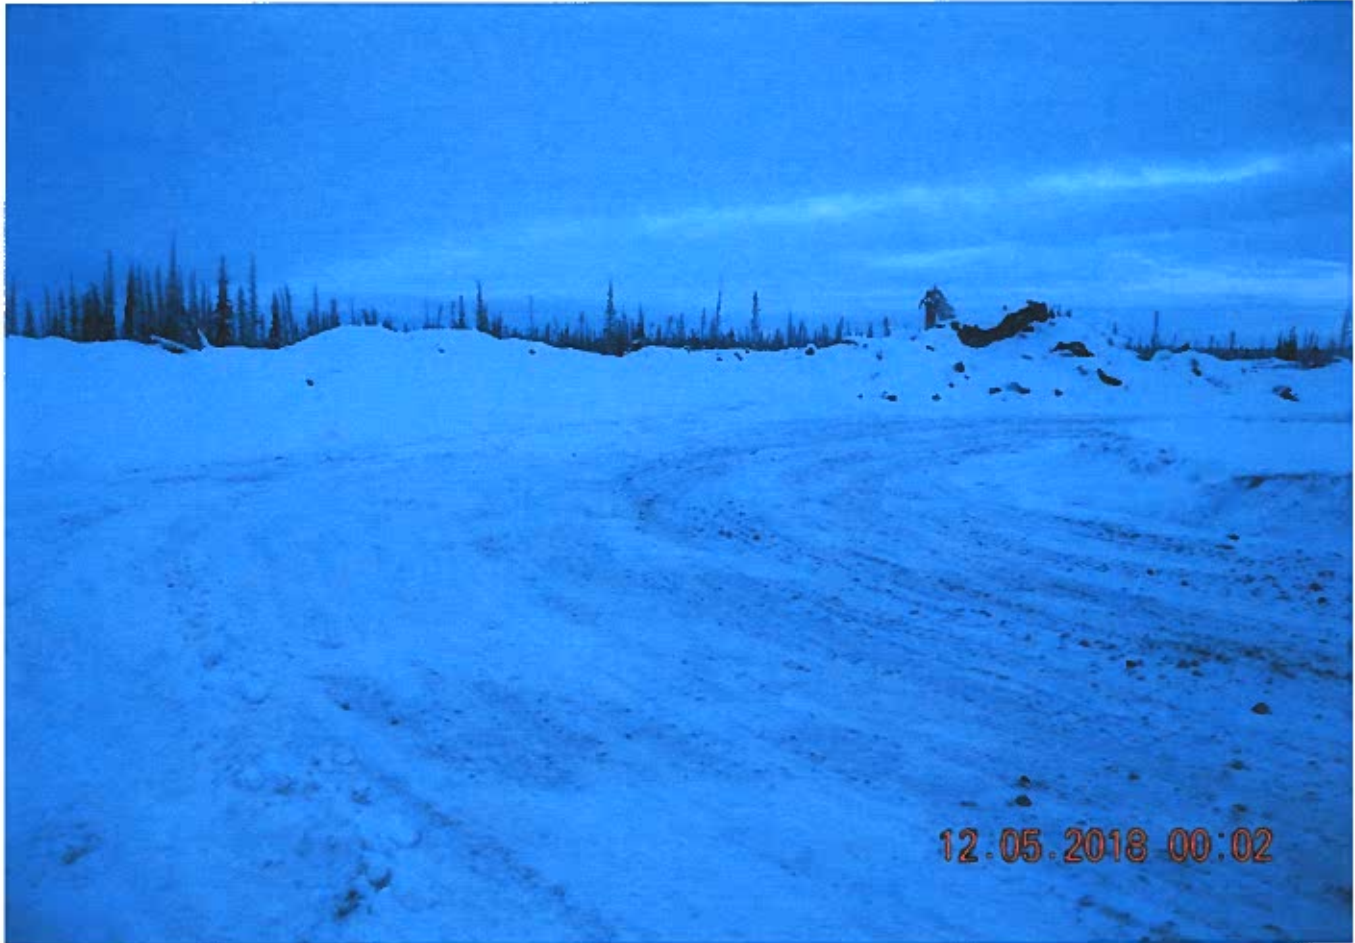
Figure 1

The road to the pit was plowed but there is no activity occurring at the site during the inspection. The gravel pile by the crushers has been removed from the site since the last inspection.

Where the last gravel pile was near the crushers

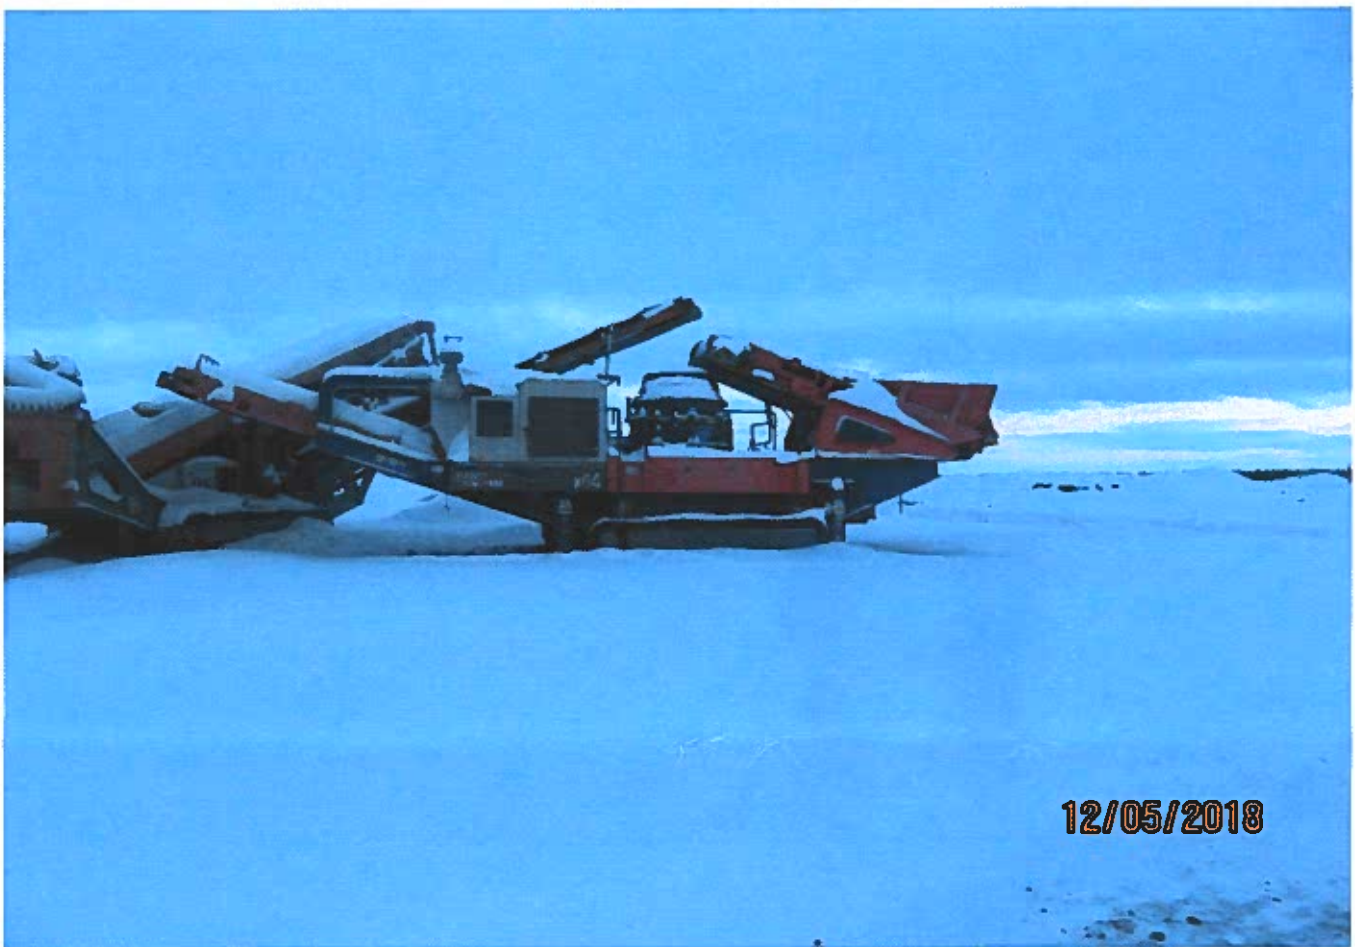
Figure 2

Crushers

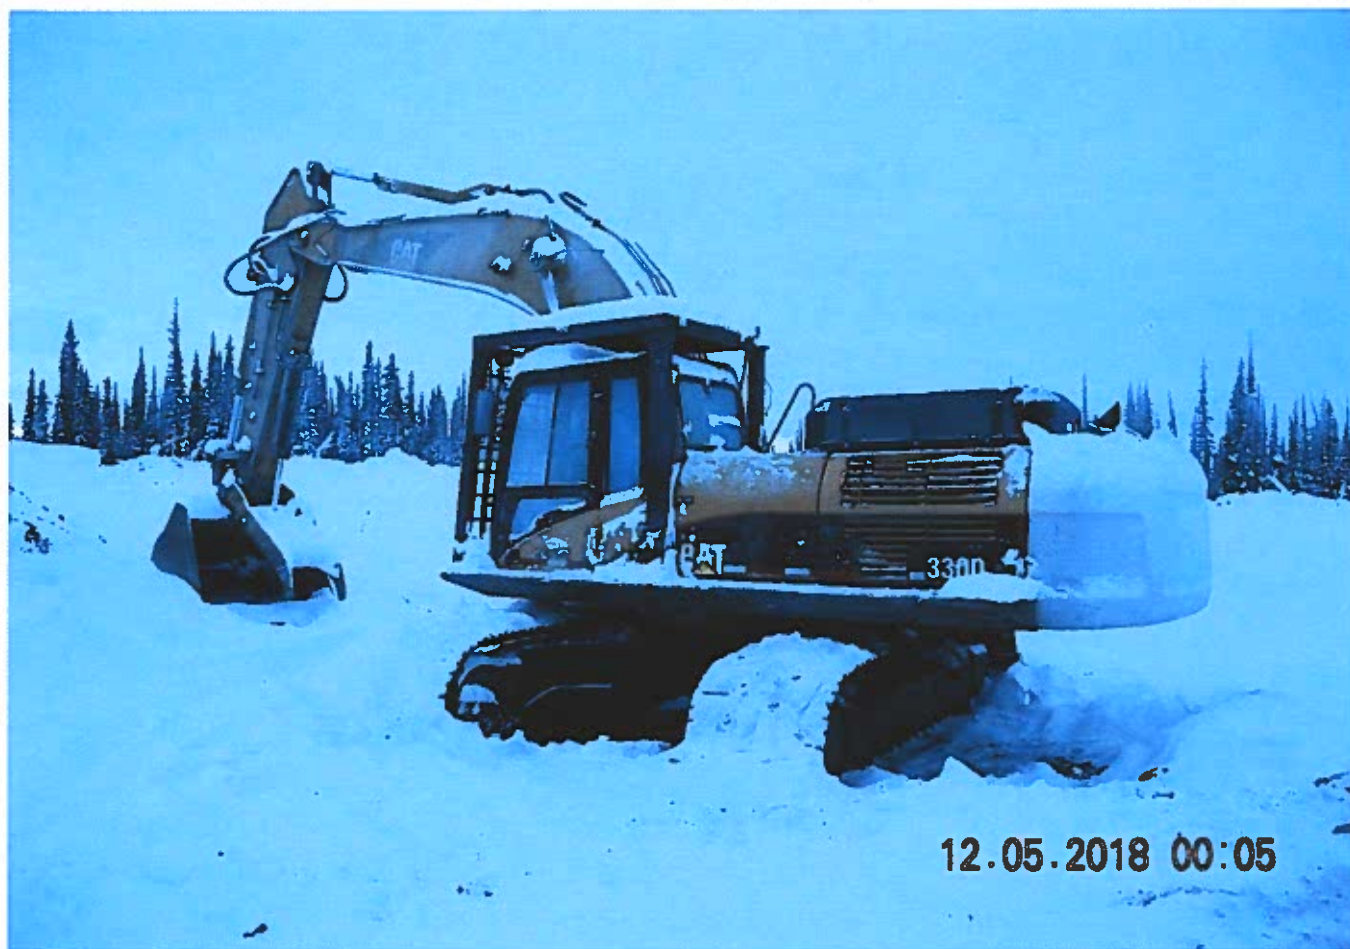
Figure 3
Excavator at the site

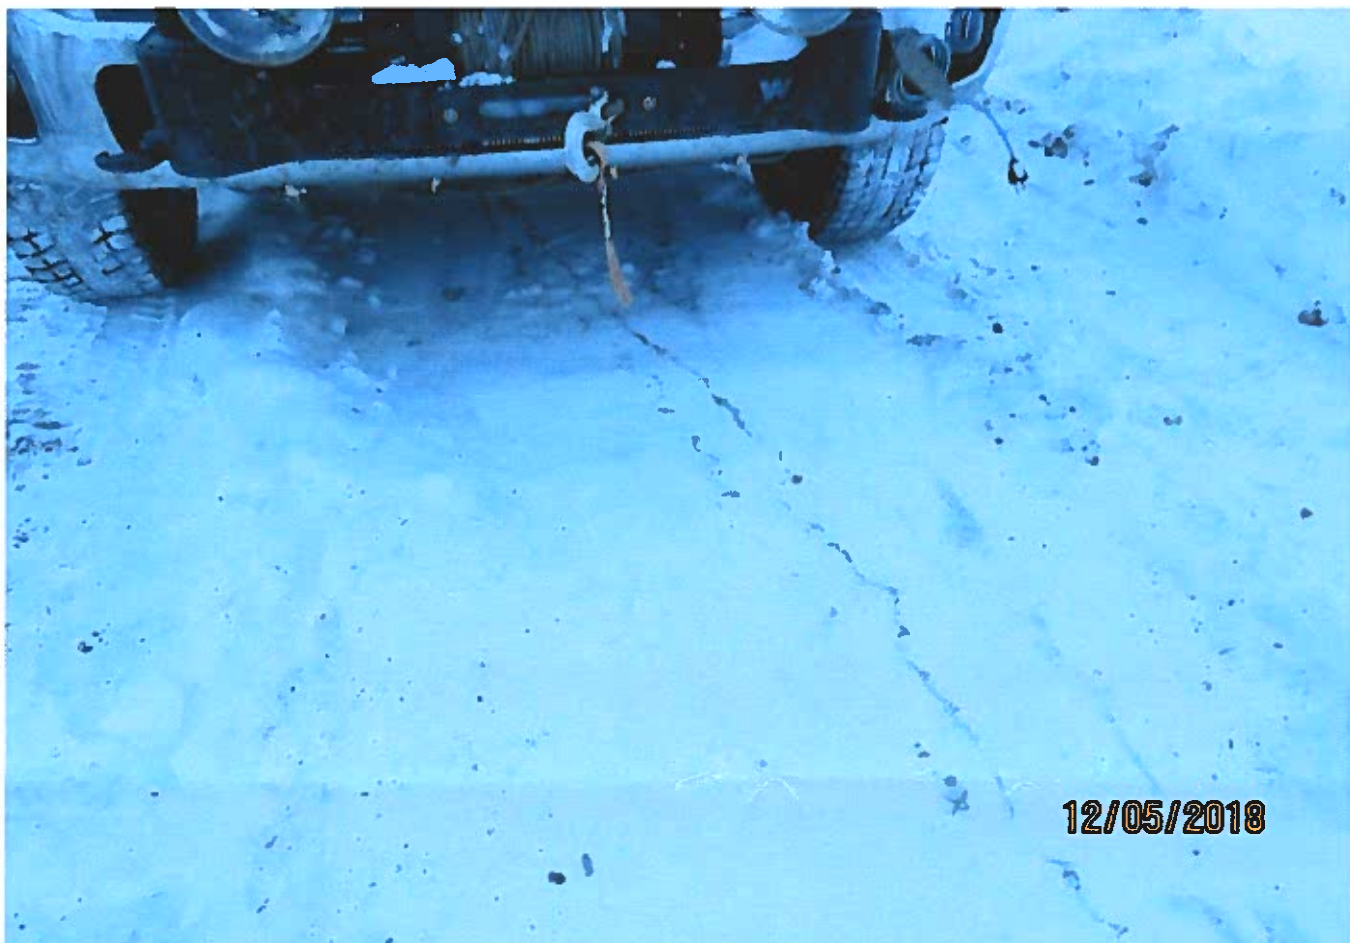
| Operating Condition | Aspect Inspected | | | | |
|---|---|--|--|--|--|
| Chemicals | U | | | | |

There was a small oil leak trail near the excavator which was about 3 meters long.

Figure 4
Small oil trail
