File Number G18Q003
Type of Operation QUARRY SITE - Existing
Location Km 126

ENVIRONMENTAL INSPECTION REPORT

Permittee:	GNWT Department of Infrastructure	Permit Expiry Date:	July 23, 2023
Land Use Permit No.	G18Q003	Previous Inspection:	New
Quarrying Permit No.		Inspection Date:	October 11, 2018
Contractor:		Subcontractor:	
Location(s) Inspected:	Km 126		
Current Stage of Operation:	Existing Quarry		
Program Modifications Approved:	GTC Authorization # GTC18Q001

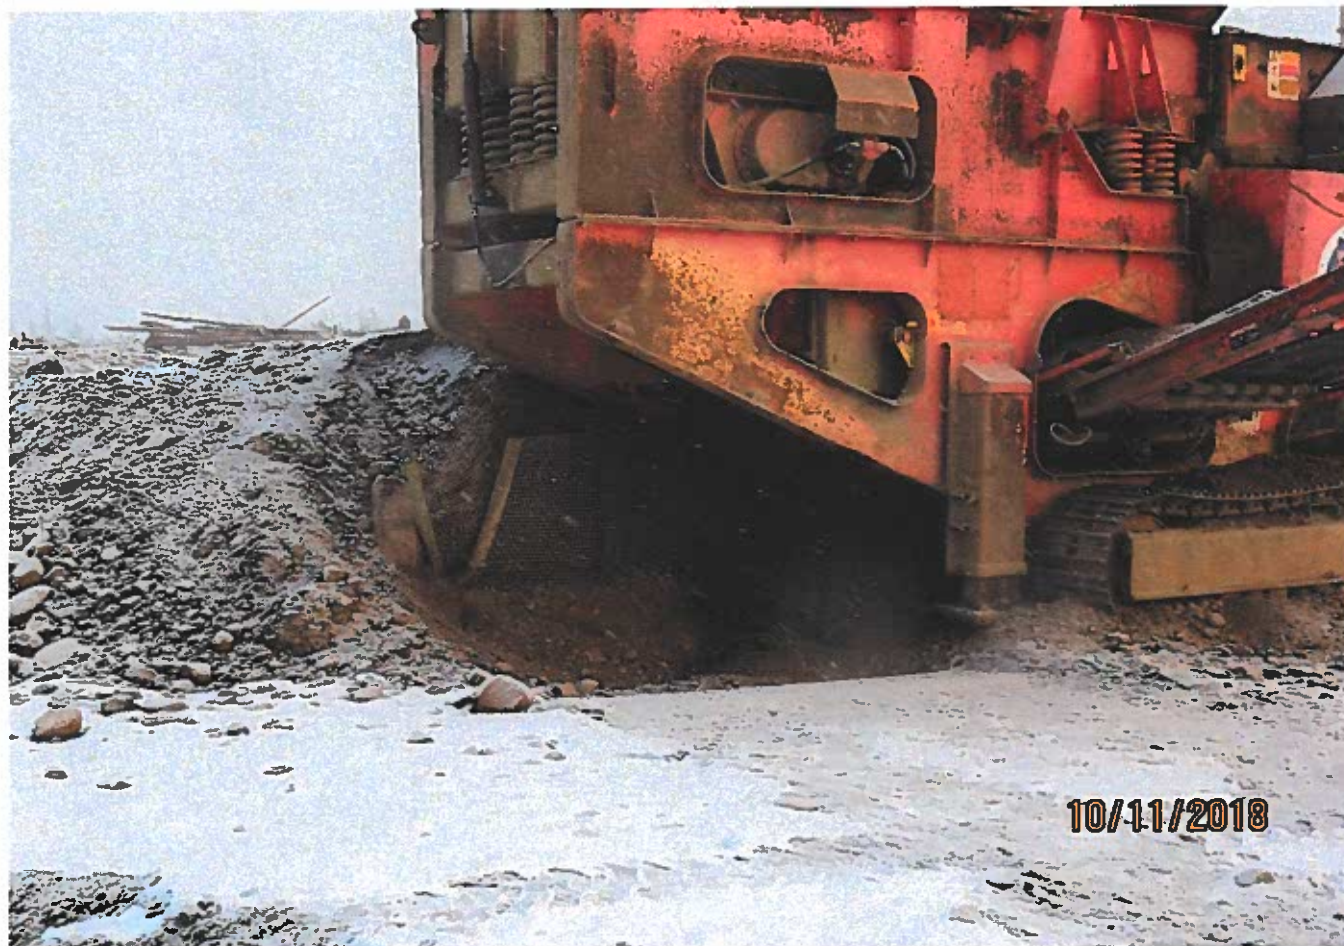
Figure 1

There is an oil leak under one of the rock crushers at the south end of the pit that should be cleaned up before it is covered with snow. The rest of the site looks in order but there is a lot of snow cover over the work site at this time.

Oil under the crusher

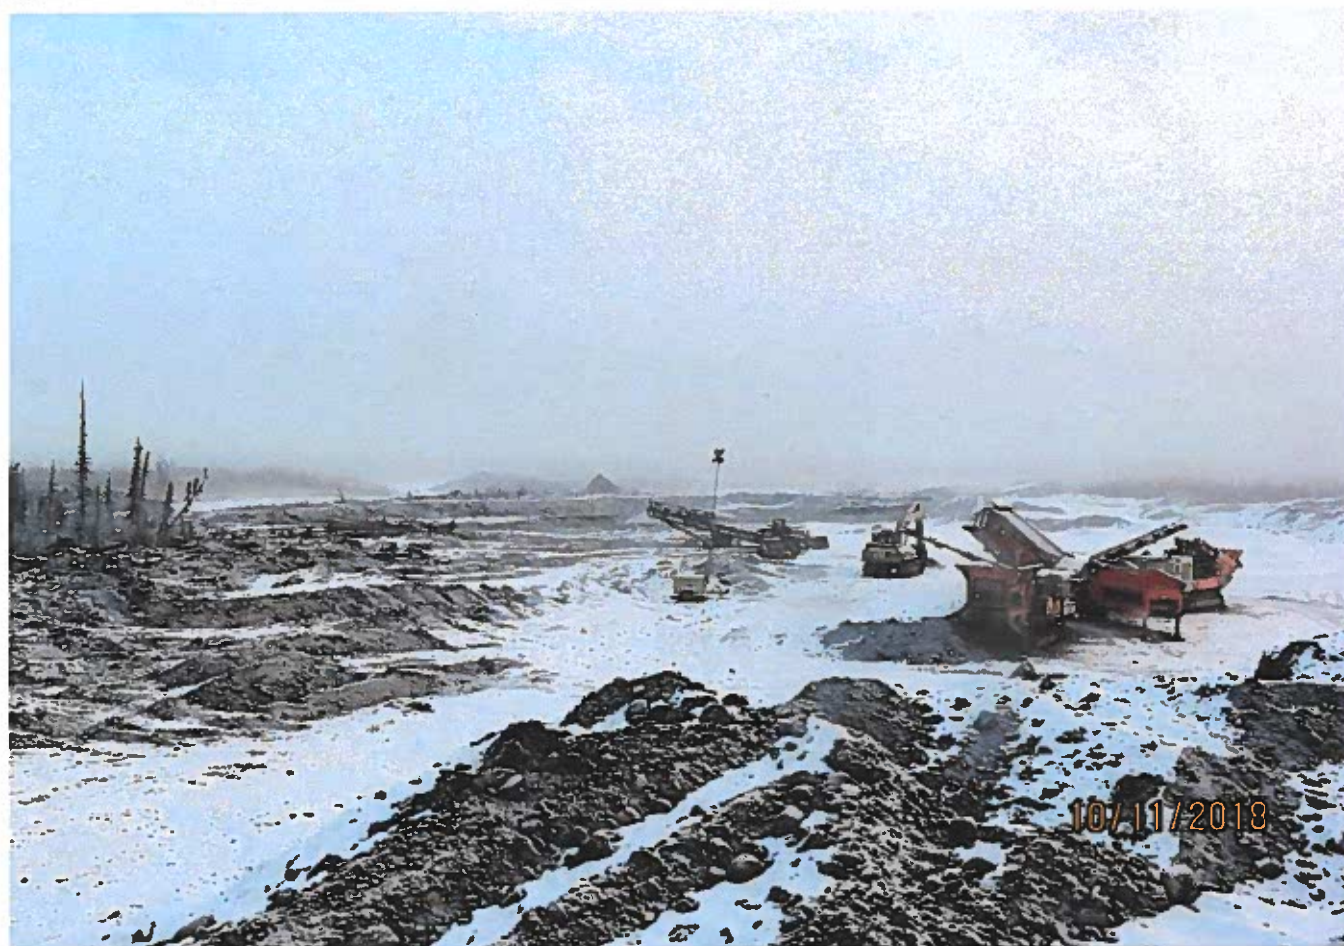
Figure 2

Oil spill is under the closest crusher in this picture
