January 28, 2021

File Number G20X007
Type of Operation MISC.
Location Inuvik Airport, former landfill

ENVIRONMENTAL INSPECTION REPORT

Permittee:	Transport Canada Prairie North	Permit Expiry Date:	
Land Use Permit No.	G20X007	Previous Inspection:	New
Quarrying Permit No.	N/A	Inspection Date:	January 26, 2021
Contractor:		Subcontractor:	
Location(s) Inspected:	Inuvik Airport, former landfill		
Current Stage of Operation:	Just started		
Program Modifications Approved:

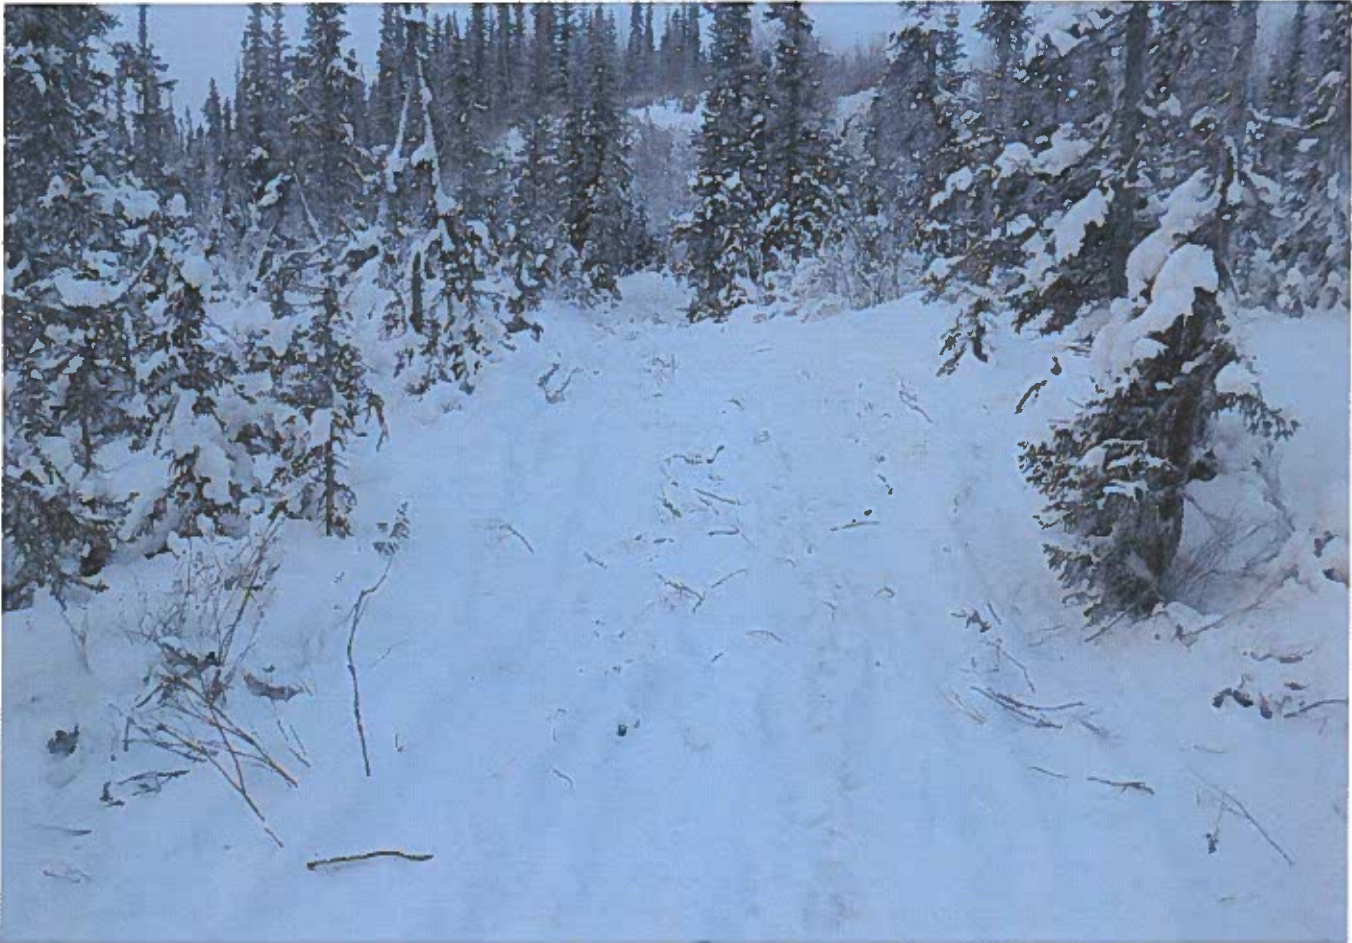
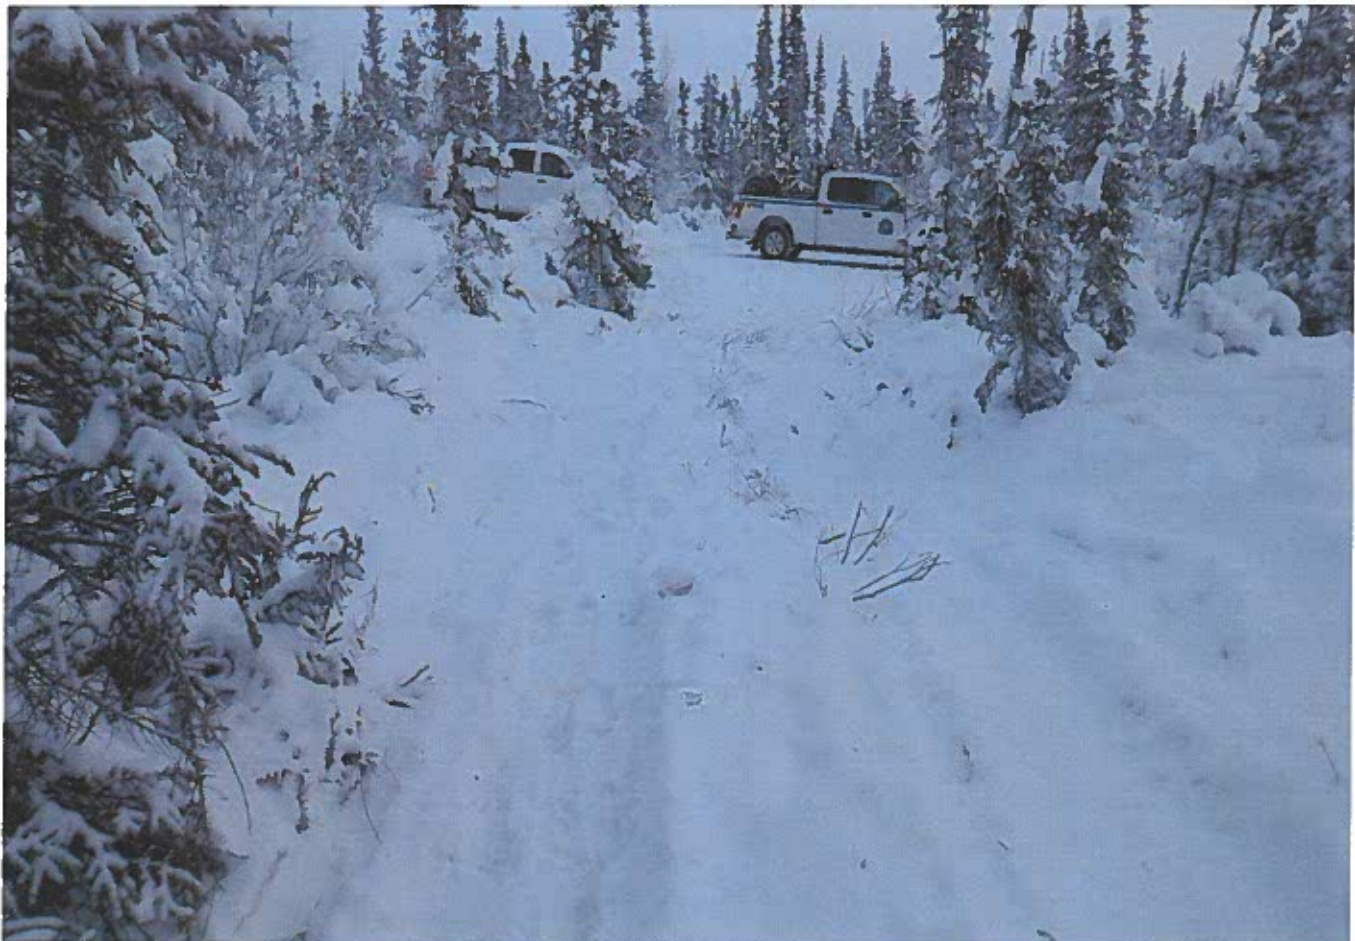
Figure 7
access to MW9

There were six monitoring wells drilled and installed in the area at the west end of the Inuvik Airport runway. Four of the monitoring wells were drilled and installed on gravel roads, one was in a cleared area for runway lighting and one of the monitoring wells was drilled and installed off the road in the bushes about 50 meters, there was minimal disturbance to the vegetation in the area and there was no rutting of the ground.
