RE: **Municipal Water Licence (N3L3-0570)**

WATER LICENCE INSPECTION REPORT

DATE:	August 1, 2007	COMPANY REP:	Archie Arey – DPW, Dean Arey - Hamlet
LICENCEE:	Hamlet of Aklavik	LICENCE #:	G99L3-003 and N3L3-0570

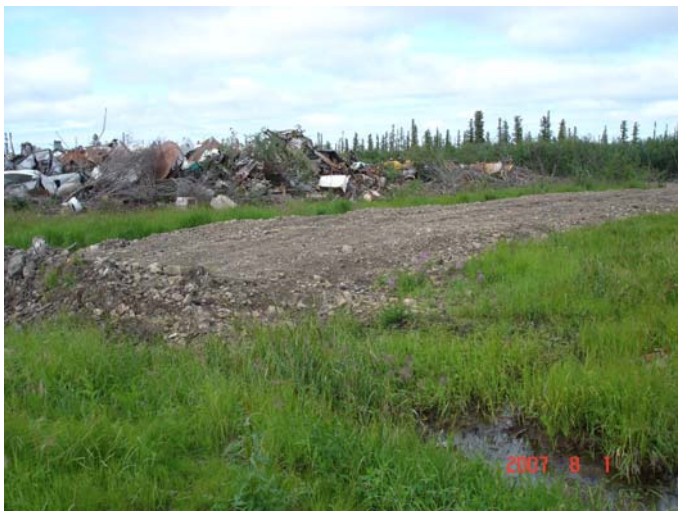
Figure 1
Berm around the Bulky Metal Waste Disposal Area.

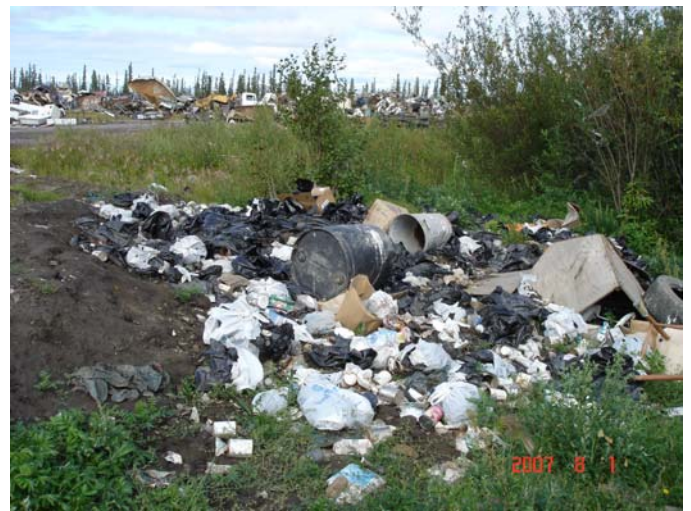
8. Berm for the Honey Bag Pit needs to be lengthened and maintained so it surrounds the whole pit. (figure 2)
9. After the initial inspection with the Hamlet foreman a sheen was noticed on water in the wetland area and ditch along the road outside of the berm on the East Side of the Bulky Metal Waste Area. Water samples need to be taken to identify this sheen. (figure 3)

Figure 2
Honey Bag Pit needs to have the berm lengthened so it surrounds the whole pit.

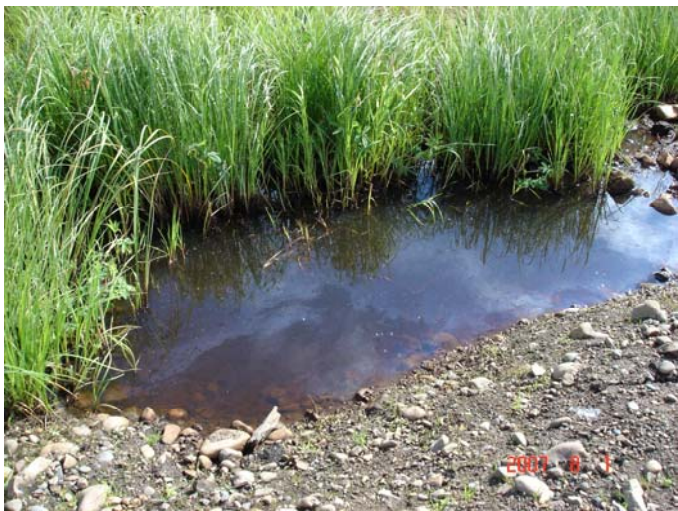
Figure 3
Sheen in the wetland area and ditch by Bulky Metal Waste Disposal Area.
