**RE: Municipal Water Licence (G99L3-003)**

## WATER LICENCE INSPECTION REPORT

<b>DATE:</b>	August 1, 2007	<b>COMPANY REP:</b>	Archie Arey – DPW, Dean Arey - Hamlet
<b>LICENCEE:</b>	Hamlet of Aklavik	<b>LICENCE #:</b>	G99L3-003 and N3L3-0570

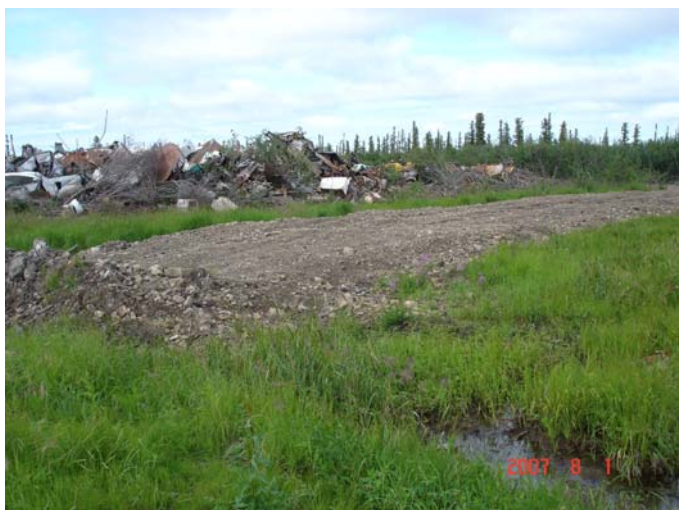
**Figure 1**  
Berm around the Bulky Metal Waste Disposal Area.

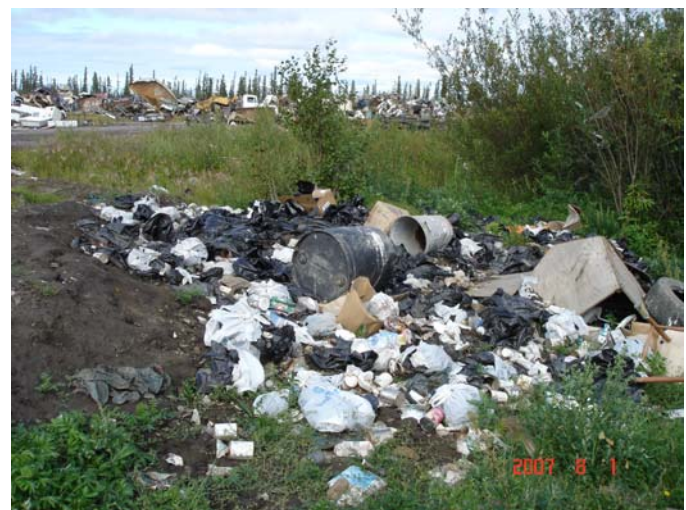
8. Berm for the Honey Bag Pit needs to be lengthened and maintained so it surrounds the whole pit. (figure 2)
9. After the initial inspection with the Hamlet foreman a sheen was noticed on water in the wetland area and ditch along the road outside of the berm on the East Side of the Bulky Metal Waste Area. Water samples need to be taken to identify this sheen. (figure 3)

**Figure 2**  
Honey Bag Pit needs to have the berm lengthened so it surrounds the whole pit.

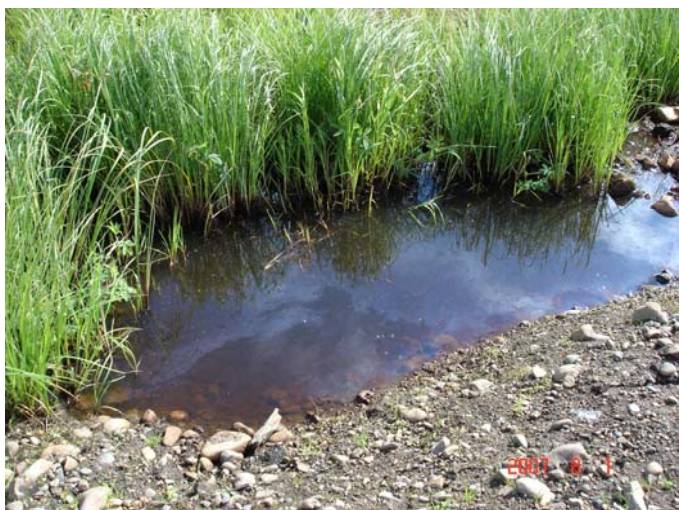
**Figure 3**  
Sheen in the wetland area and ditch by Bulky Metal Waste Disposal Area.
