**RE: Municipal Water Licence G99L3-003  
CLASS B - MUNICIPAL**

**RE: Municipal Water Licence G99L3-003 and N3L3-0570  
CLASS B - MUNICIPAL**

## MUNICIPAL WATER LICENCE INSPECTION FORM

<b>LICENCE #:</b>	G99L3-003 and N3L3-0570	<b>EXPIRY DATE:</b>	November 20, 2014
<b>LICENCEE:</b>	Hamlet of Aklavik	<b>PREVIOUS INSPECTION:</b>	September 2, 2010
<b>COMPANY REP:</b>	Evelyn Storr	<b>INSPECTION DATE:</b>	August 26, 2011

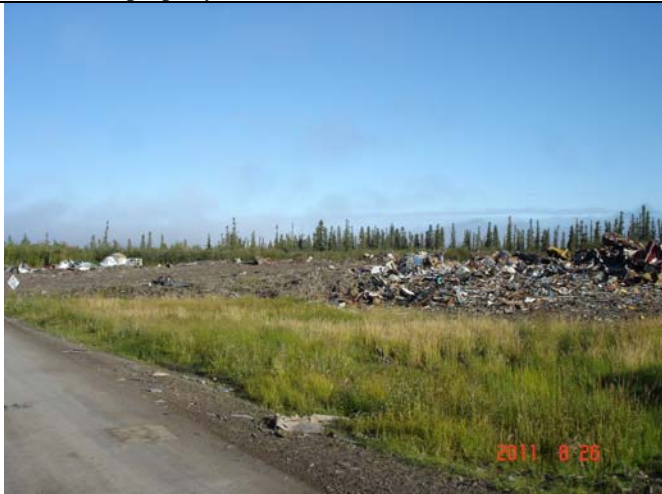
**Figure 3**

- A lot of work was done by the Hamlet to improve the Solid Waste Disposal Facility (SWDF). Fill has been placed over part of the bulk waste area, additionally it is now more spread out and has more crushed metal waste including vehicles (see Figure 3). Previously as of the last Inspection in September 2, 2010 an effort was made by the Hamlet to separate vehicles, crush them and put them in a designated cell. Waste vehicle cell filled with water, clear evidence of hydrocarbon contamination from vehicles and 2 new additions to waste vehicle cell area. Water samples were taken to find concentrations in water in amongst waste vehicle cell. Samples came back with below detection or low levels of oil present.

Fill has been placed over part of the bulk waste area, additionally it is now more spread out and has more crushed metal waste including vehicles.

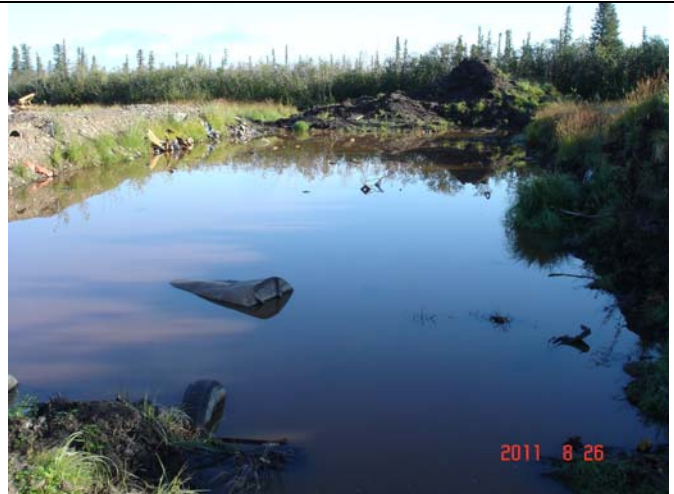
**Figure 4**

Vehicles etc have now been pulled from the flooded cell (see Figure 4). There is no longer a sheen/oil present in cell. There is an excavated ditch now connected to drain it.

Vehicles etc have now been pulled from the flooded cell. There is no longer a sheen/oil present in cell.
