**RE: SEPTEMBER 15, 2005 INSPECTION OF WATER LICENCE N3L3-0570
HAMLET OF AKLAVIK**

MUNICIPAL WATER LICENCE INSPECTION REPORT

DATE:	September 15, 2005	COMPANY REP:	None available
LICENSEE:	Hamlet of Aklavik	LICENCE #:	N3L3-0570

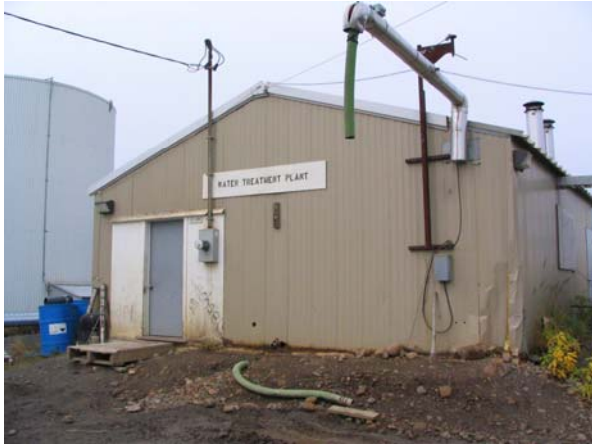
Figure 1. Water Supply. Water Intake and Treatment Facility.

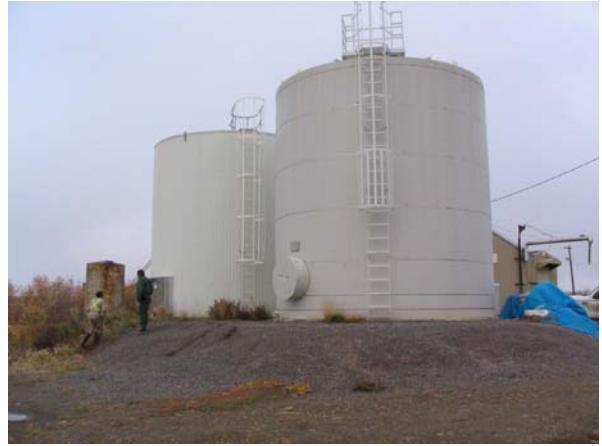
Figure 2. Water Supply. Raw and treated water storage tanks.

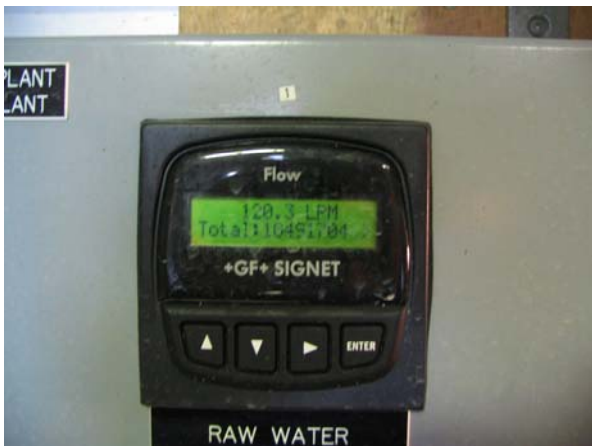
Figure 3. Water Supply. Water intake meter.

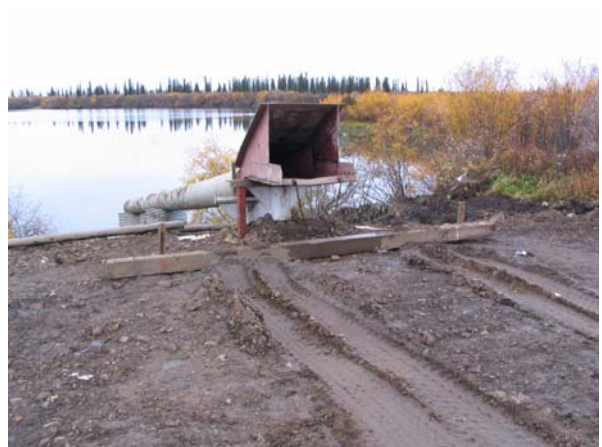
Figure 4. Waste Disposal. Sewage Lagoon raw sewage discharge culvert.

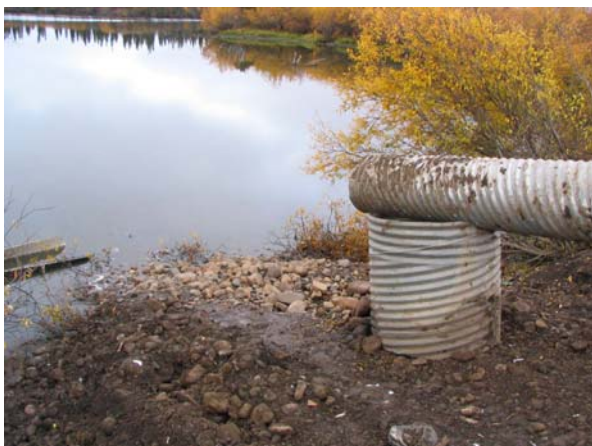
Figure 5. Waste Disposal. Sewage Lagoon raw sewage discharge culvert.

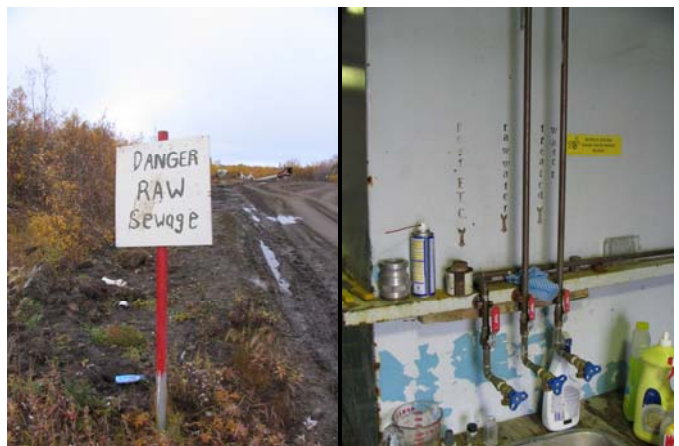
Figure 6. Waste Disposal/Water Supply. Sewage Lagoon signage (warning) and Raw water sampling station (no SNP).

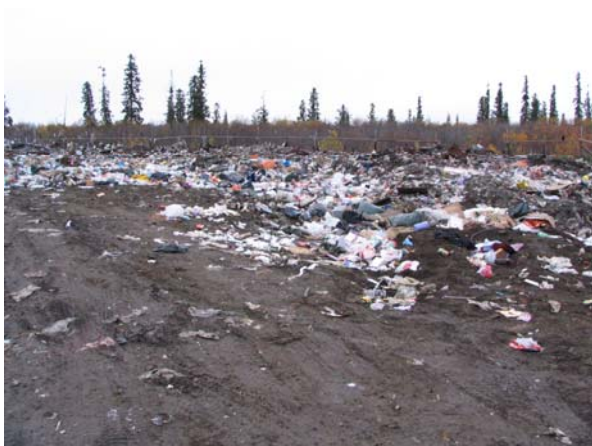
Figure 7. Waste Disposal. Solid Waste disposal Facility (SWDF) domestic garbage disposal area.

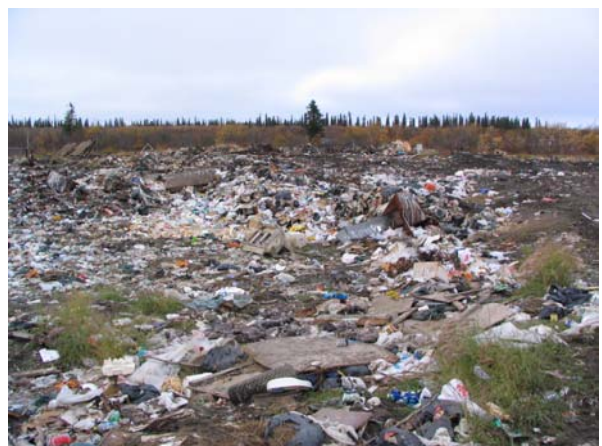
Figure 8. Waste Disposal. SWDF domestic garbage disposal area.

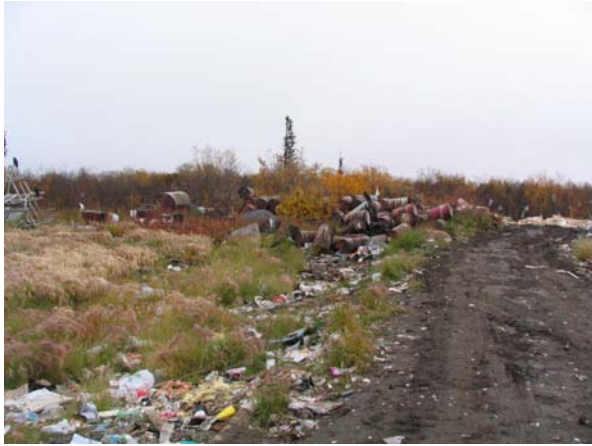
Figure 9. Waste Disposal. SWDF empty barrels.

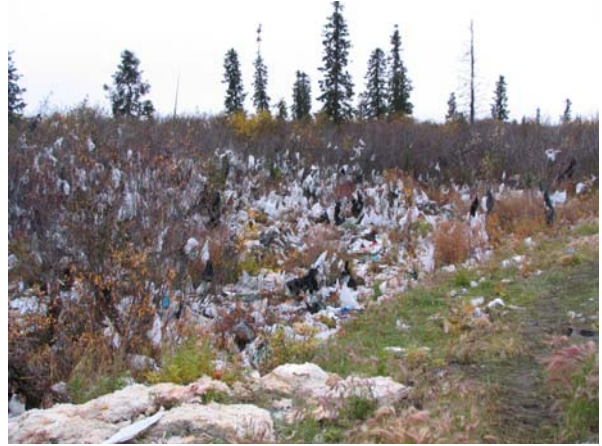
1. Please see concern one (1) below under “SNP”.
2. As indicated in previous Inspection Reports there is considerable wind blown debris (plastic bags) escaping to the northwest of the domestic garbage disposal area (figure 10).
3. To further increase public guidance waste segregation signs should be posted for but not limited to domestic garbage, waste tires, waste appliances (washers/dryers, etc.), wood waste, snowmobiles, empty drums, honey bag pit, and hazardous wastes/waste oil.
4. An appropriate area should be considered / constructed for hazardous wastes/waste oil and lead acid batteries. As with other communities these areas are becoming permanent storage areas. Effort should be taken to dispose of this material appropriately. Long term storage of this material is not recommended.
5. Updated O&M plan not received. Please see records and reporting under “SNP” below.

Figure 10. Waste Disposal. SWDF. To the south of the domestic waste disposal area.

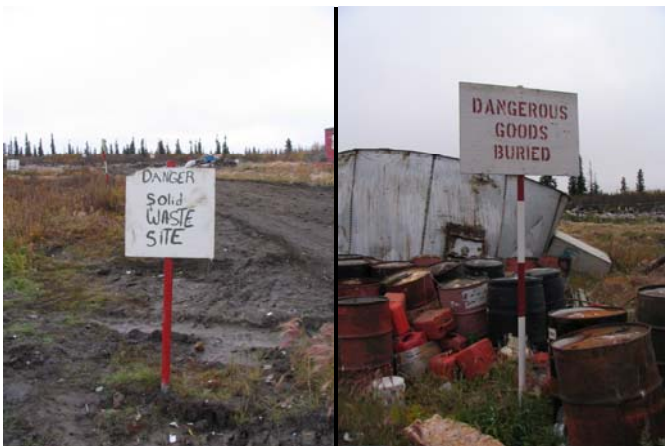
- As per concern 5 in the 2004 Inspection Report asbestos was buried to the north of the hazardous wastes/waste oil storage area and is the rationale for the “Dangerous Goods Buried” sign (figure 11).
- Facilities are posted and identified (figure 6, 11).
- In 2004 the SAO indicated that a screen was installed at the outflow of the Sewage Lagoon (Part B3).
- Part B6 bulky metal waste location identified (figure 13, 14). Currently this area is quite full.

Figure 11. Waste Disposal. SWDF signage (warning), and hazardous wastes/waste oil disposal area.

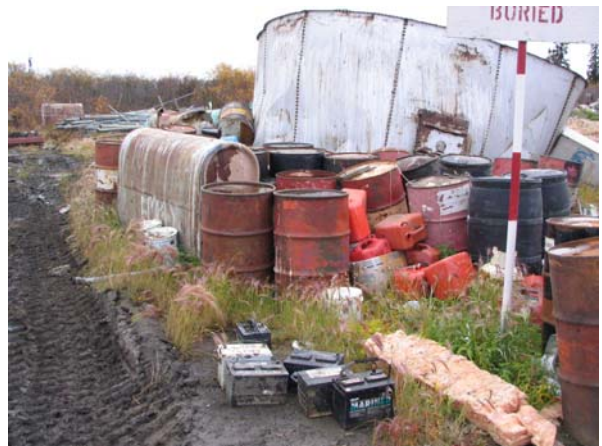
Figure 12. Waste Disposal. SWDF hazardous wastes/waste oil disposal area.

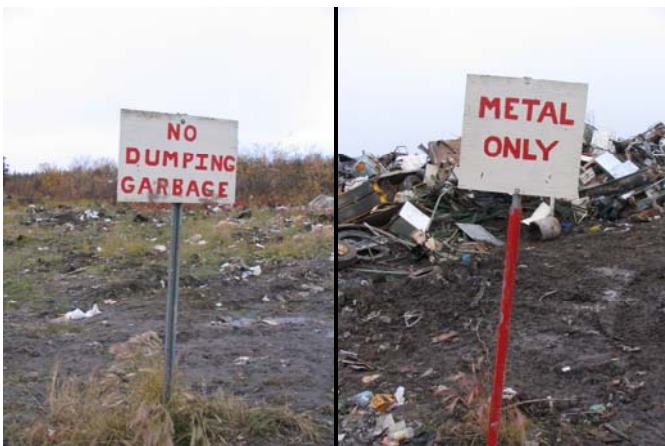
Figure 13. Waste Disposal. SWDF signage.

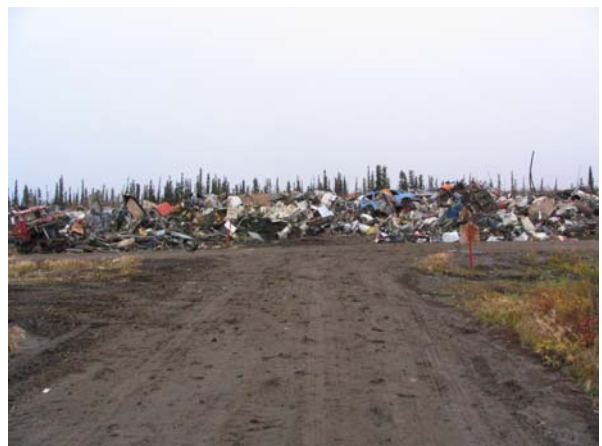
Figure 14. Waste Disposal. SWDF bulky wastes (metal) disposal area.

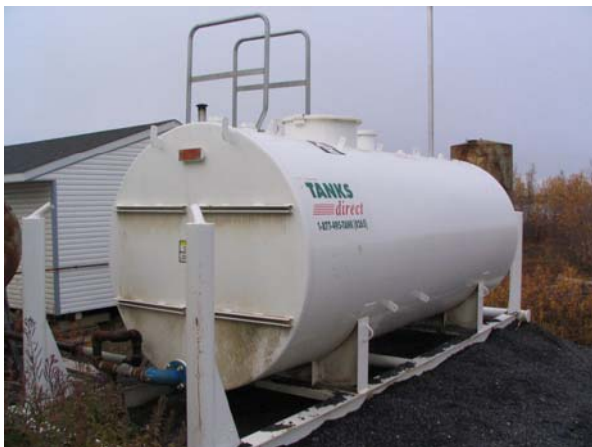
Figure 15. Fuel Storage. Water intake and Treatment Facility fuel storage.

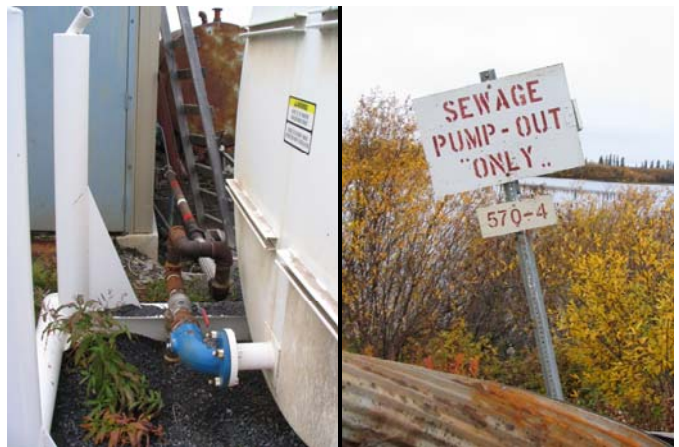
- Tank in excellent condition including transfer lines (figure 16).

Figure 16. Fuel Storage/SNP. Fuel storage transfer lines and SNP station 570-4 respectively.
