**RE: Municipal Water Licence (G99L3-003)**

## WATER LICENCE INSPECTION FORM

<b>DATE:</b>	September 24, 2008	<b>COMPANY REP:</b>	Evelyn Storr
<b>LICENCEE:</b>	Hamlet of Aklavik	<b>LICENCE #:</b>	G99L3-003 and N3L3-0570

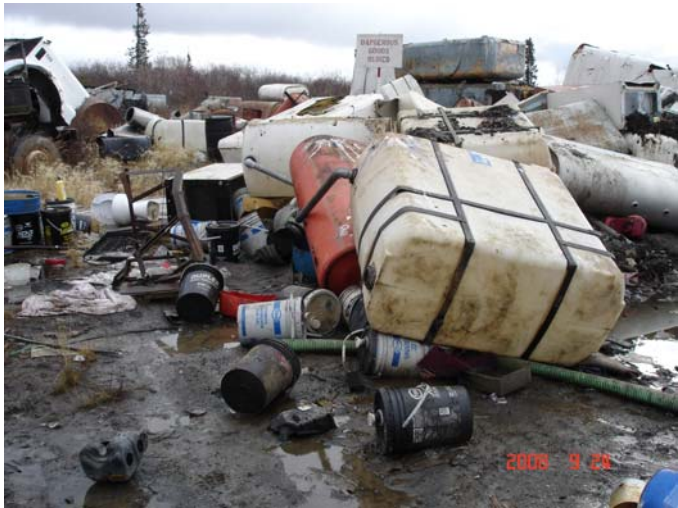
**Figure 1**

7. Spillage of used oil was noticed in the waste oil storage area. Ensure that the waste oil storage area is organized and materials stored properly. When there has been spillage, make sure the soil is cleaned up, contained and properly disposed of. (Figure 1)

8. Hazardous waste(waste oil, batteries etc.) areas are becoming permanent storage areas. Effort should be taken to

dispose of this material appropriately. Long term storage of this material should not occur in this Solid Waste Disposal Site. (Figure 1)

Ensure hazardous waste is properly stored and storage area is maintained.

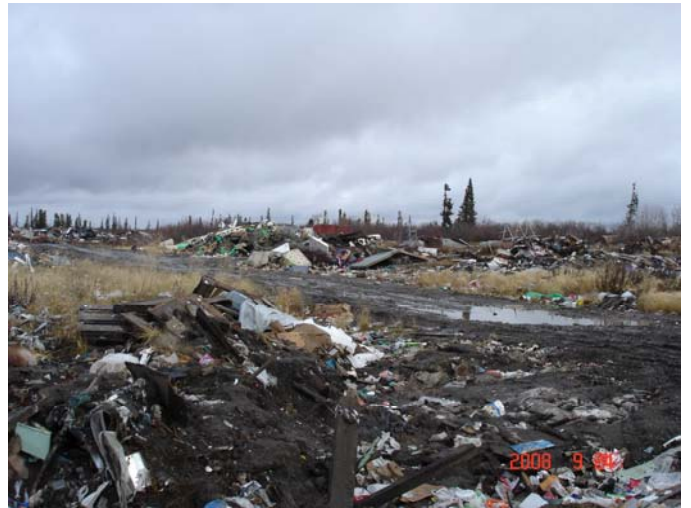
**Figure 2**

10. Solid waste in cells within the Solid Waste Disposal Site need to be properly maintained and capped. (Figure 2)

Proper maintenance and capping needed for solid waste cells.
