RE: Municipal Water Licence (G99L3-003 and N3L3-0570)

WATER LICENCE INSPECTION FORM

DATE:	September 2, 2010	COMPANY REP:	Evelyn Storr
LICENCEE:	Hamlet of Aklavik	LICENCE #:	G99L3-003 and N3L3-0570

WATER LICENCE INSPECTION REPORT Pg. 4 (Continued)

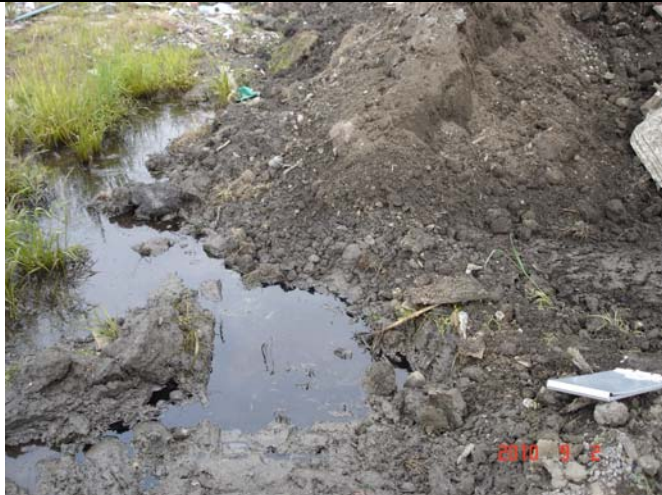
Figure 1

1. Spill of used oil next to waste metal area. Mentioned to Senior Administrative Officer (SAO) and Hamlet Foreman. This needs to be cleaned up, absorbents suggested to be used (see Figure 1).

Spill of used oil next to waste metal area and needed to be cleaned up.

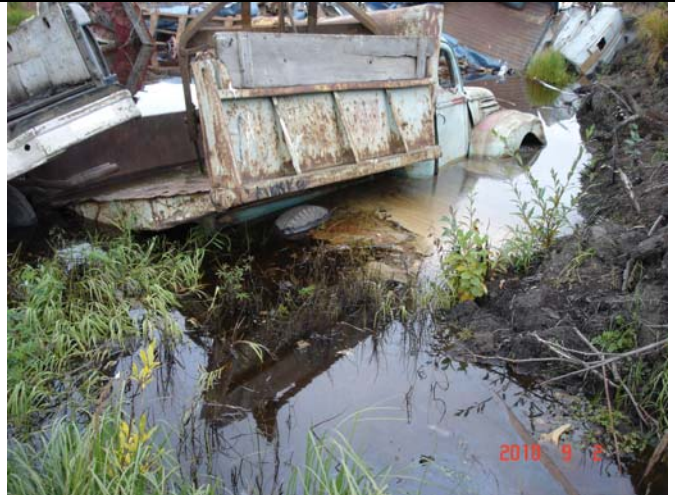
Figure 2

2. A lot of work was done by the Hamlet to improve the Solid Waste Disposal Facility (SWDF). Of the bulky metal waste area an effort was made to separate vehicles, crush them and put them in a designated cell. Waste vehicle cell filled with water, clear evidence of hydrocarbon contamination from vehicles and 2 new additions to waste vehicle cell area (see Figure 2). Water samples were taken to find concentrations in water in amongst waste vehicle cell. Waste vehicles need to be removed from water as this is furthering contamination of the area. This was mentioned to the SAO during our site visit to SWDF during the inspection. Vehicles need to be above the water and it was discussed about them being on a gravel pad.

Waste vehicle cell filled with water, evidence of hydrocarbon contamination from vehicles.

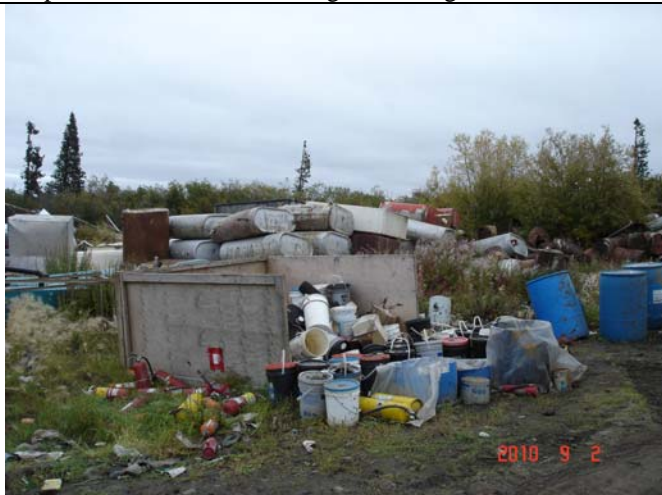
Figure 3

6. Hamlet needs to collect oil/glycol to send out for proper disposal.
7. Should be a berm around the waste oil storage to provide containment as the pails etc. are in various stages of being secure (see Figure 3). Berm for around sewage bags needed to contain this material.

Berm needed around the waste oil storage for containment, the pails etc. are in various stages of being secure.

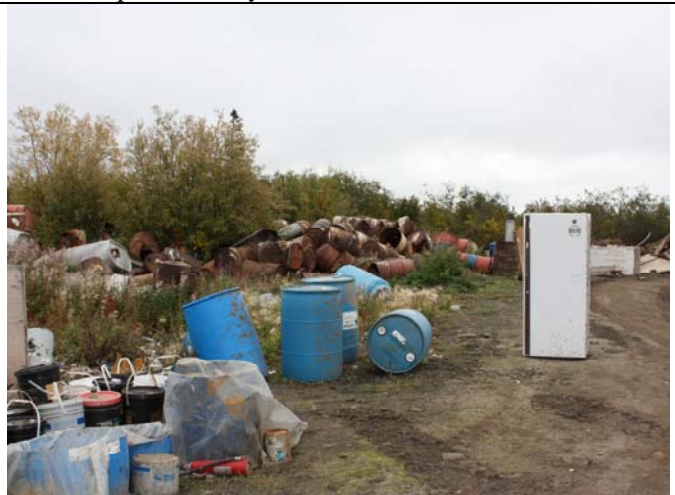
Figure 4

10. Ensure hazardous waste is stored in an area at the SWDF with a berm constructed around it to provide better containment as per Part D: Conditions Applying to Waste Disposal, Item 9, in Water Licence N3L3-0570 (see Figure 4). Hazardous waste(waste oil, batteries, barrels, etc.) should be temporarily stored and then disposed at approved and designated facilities. Spilled oil was noticed around the SWDF. When there has been spillage, make sure the soil and used oil is cleaned up, contained and properly disposed of. Ensure that the hazardous waste storage area is organized and materials stored properly. This will ultimately keep the area clean and encourage the public to segregate waste properly.

Ensure hazardous waste is stored in an area at the Solid Waste Disposal Facility with a berm constructed around it.

5. Part D: Conditions Applying to Waste Disposal, Item 9,
"The Licensee shall segregate and store hazardous Waste in a temporary storage area, to the satisfaction of an Inspector."

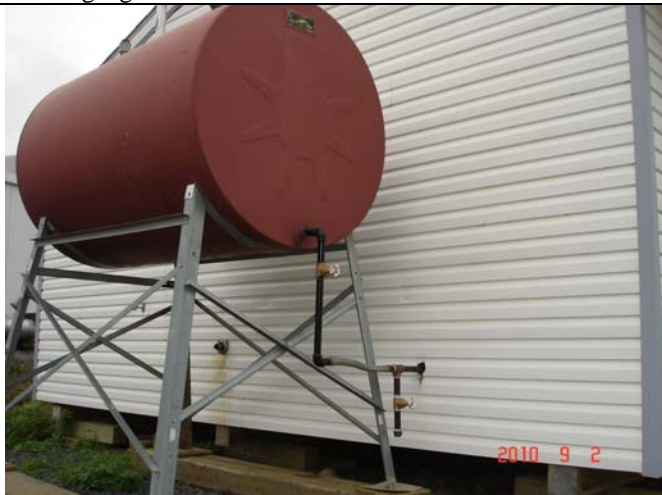
Figure 5

1. Flex pipe for the chemical storage building fuel tank is showing signs of movement. Continue to monitor for spill prevention (see Figure 5).
2. The new Water Treatment Plant's fuel tank has a set up for the pipeline that is a concern. The flex pipe appears to be supported with pipe hangers attached to the main building but on the fuel tank's side of the flex pipe. It is questionable if this is appropriate because it does not appear that either the main building or the fuel tank are now fully independent of one another (see Figure 6).

Flex pipe for the chemical storage building fuel tank is showing signs of movement. Continue to monitor.

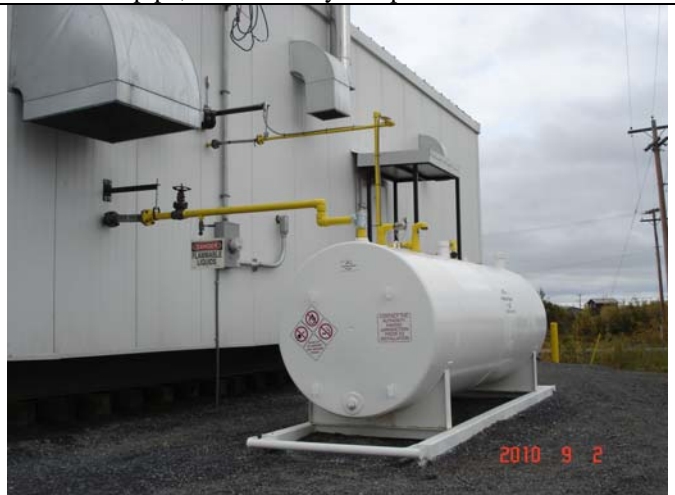
Figure 6

WTP Pipe hangers from main building attached to fuel tank's side of flex pipe, both not fully independent of one another.
