January 29<sup>th</sup>, 2015

**Re: Follow-up Spill Report – Excavator Through Ice – De Beers Gahcho Kue Mine – 30 December 2014**

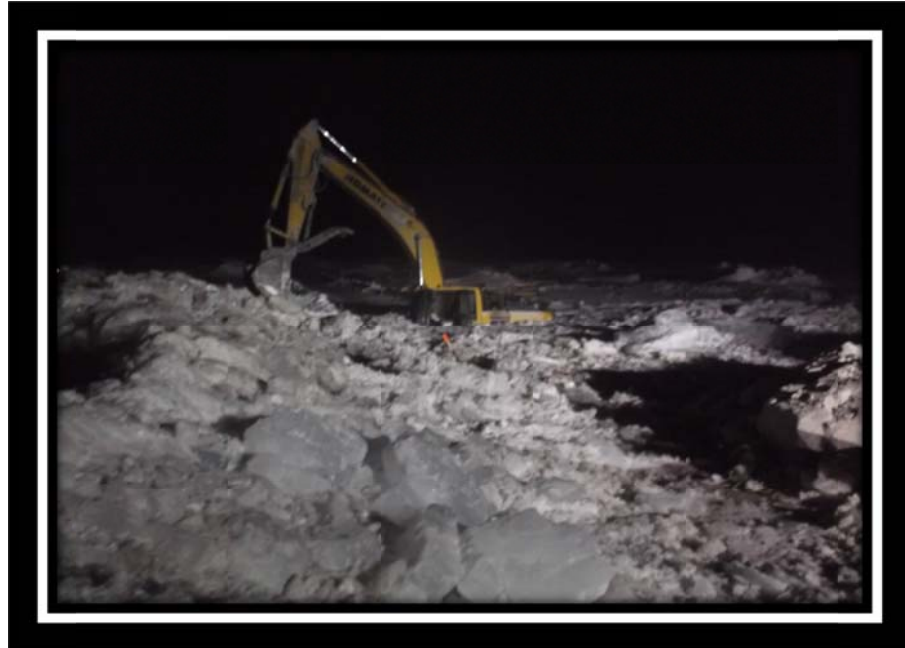
While clearing the lake bed grounded ice, the excavator was mistakenly positioned over a portion of the lake ice that was not in-fact grounded. The ice gave way causing the excavator to fall through and come to rest upright in approximately 4 feet of water which allowed the operator to safely exit the excavator. Site personnel were immediately notified and retrieval of the excavator from the water was initiated. The excavator was towed out of the water and onto the partially constructed jetty by a bull dozer.

The results of the internal De Beers investigation revealed that the incident's primary cause was related to improper positioning of equipment when compared to planned work activities as well as miscommunication of information between supervisors and work crew as the excavator operator was not adequately briefed regarding the fact that areas nearby the jetty were not lake bed grounded and posed a potential hazard.

Photo 1 – PC-390 Excavator Positioning After Breach Through Ice

- Prior to the commencement of operations involving close proximity to water, the work area is to be profiled and clearly demarcated for hazards present;
- Reinforcement of the importance of Job Hazard Assessment (JHA) and Reporting to all staff operating equipment on site;
- Review and alterations to existing Operating Instructions with emphasis of integrating lessons learned from this incident;
- Improvement of communications of work tasks and associated hazards by using media such as drawings and maps that serve to enhance and re-enforce verbal instructions.

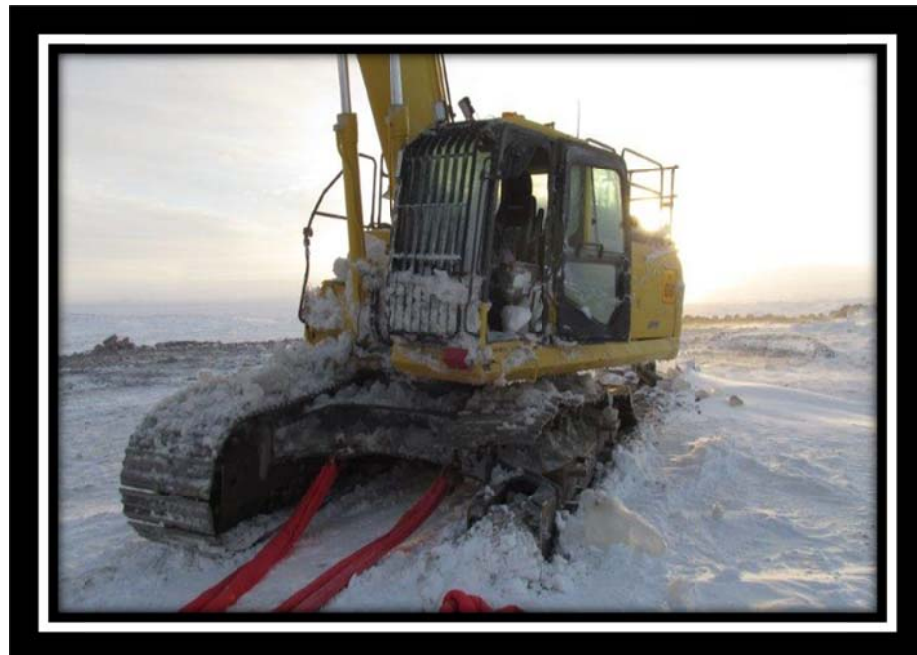
After the area was secured and the excavator removed, the fuel tank of the excavator was assessed and found to be competent alleviating the concern of a full tank rupture and loss of entire contents into Area 3 of Kennady Lake. The assessment revealed that the cause of the release of the estimated 105 L to land was confirmed to be the loosening of the fuel filter during retrieval operations.

Photo 2 – PC-390 After Retrieval From Kennady Lake

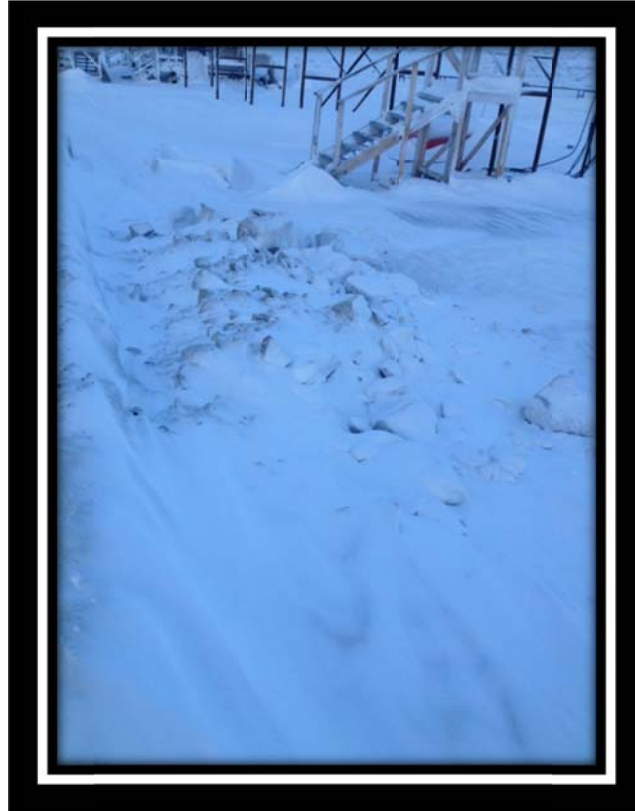
Inspection of the area revealed a faint sheen of hydrocarbons on the surface of the water caused by the washing of limited greases from the undercarriage of the excavator. Further inspection of the area revealed surface staining of the granular material on the jetty.

Photo 3 – Contaminated Granular Material Placed Within Appropriate Containment (Existing Lined Area at the AEP Camp)

In response to the spilled material on the jetty, the hydrocarbon impacted material was immediately excavated and placed in the existing lined containment at the Advanced Exploration Camp. Absorbent pads could not be deployed to remove the sheening of the waters at the location of the break through due to safety concerns as well as the fact that ice crush had back-filled the hole. It should be noted that this portion of the lake is isolated from the Dyke A cofferdam.
