DE BEERS GROUP

Subject: Follow-Up Spill Report – 390 Excavator Fire – Gahcho Kué Mine – March 18, 2019 (GNWT Spill # 2019126)

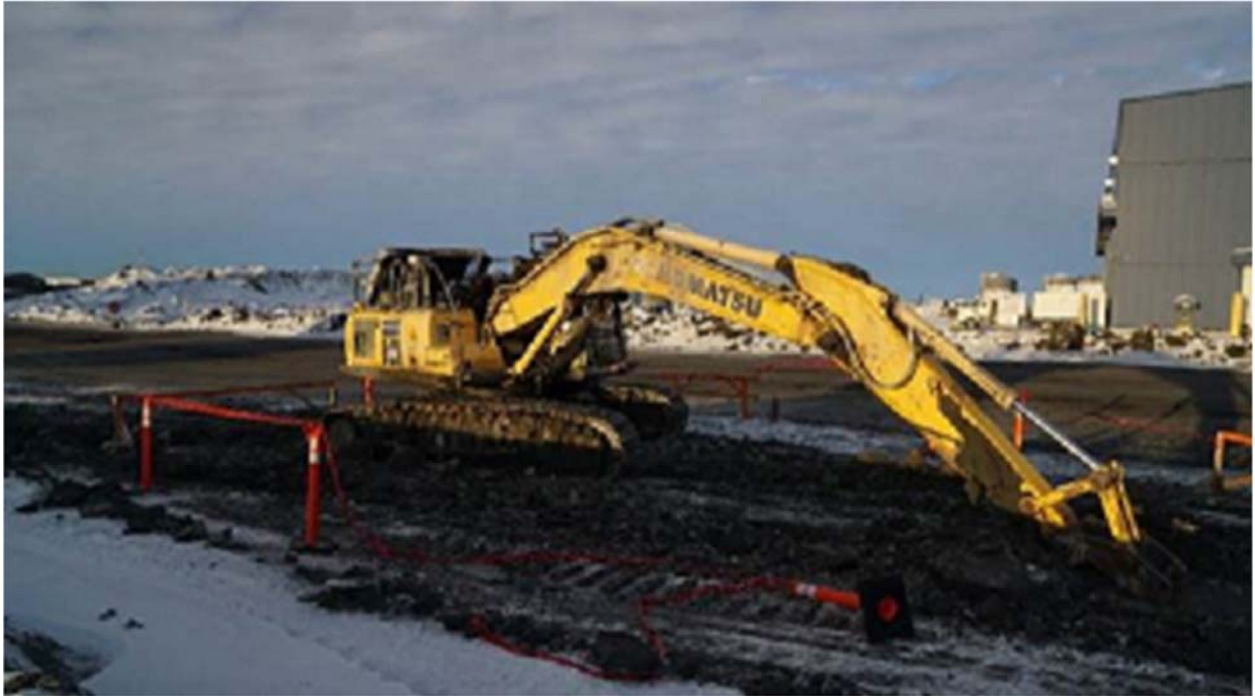
PHOTOS

On March 18, 2019, at 16:40, while removing loading coarse processed kimberlite from the rejects conveyor at the process plant, a fire in the engine compartment of a 390 excavator was reported. There was no injury to the operator. The fire was immediately extinguished by the onsite Emergency Response Team and scene secured for the investigation into cause. It is not expected that a spill in excess of reportable volume occurred due to the nature and location of the fire (engine compartment).

The source of the ignition is a suspected hydraulic pilot circuit hose that failed spraying atomized hydraulic fluid onto an exposed wire (ignition source). The wire was powering a 24v heated mirror mounted on the left front corner of the operator's cab. It is believed the outer insulation on the wire became compromised. The installation for the heated mirrors was a non-factory install and completed off-Site through the Komatsu dealer prior to arrival on Site in 2013.

As a precaution, the surface material which the excavator was working around has been scraped and removed for placement into the Type 3 zone within the South Mine Rock Pile.
