October 5, 2015

MV2005L2-0015
MV2005C0032

Subject: Follow-Up Spill Report –Sewage Treatment Plant (STP) Emergency Overflow Lift Station - Gahcho Kué Project – September 5, 2015

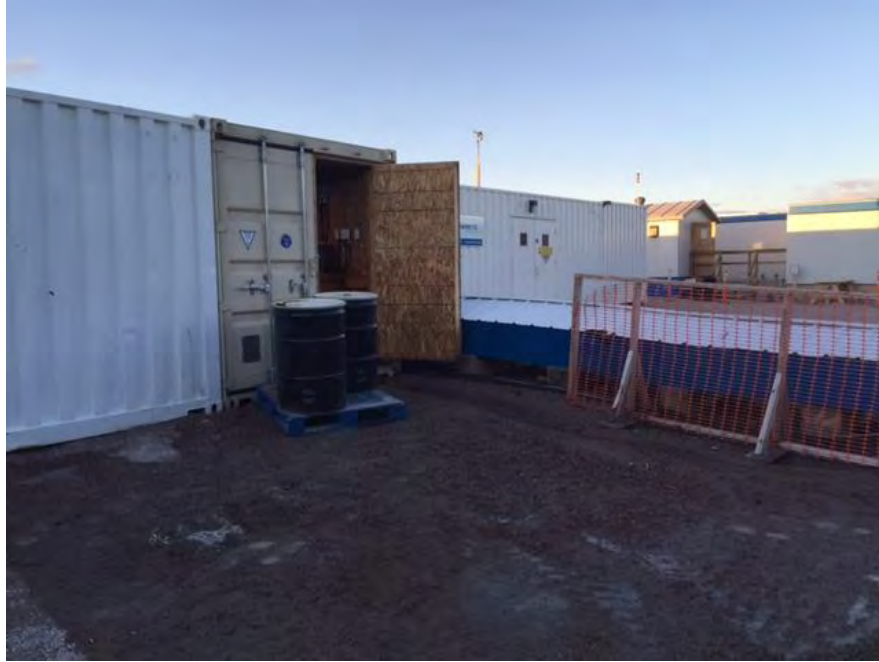
At approximately 19:15 on 05 September, 2015, a worker within the Gahcho Kué camp complex reported a spill of liquid flowing to the ground from the STP Emergency Overflow Lift Station. The ground outside this building consists of an engineered pad with a surface of crushed aggregate (20 mm minus). Upon notification of the spill the STP plant operator attended the scene and shut down the treatment system to prevent additional untreated sewage from being released to the ground. Approximately 500 L of untreated sewage was spilled. The spill was confined to the immediate area outside of the building containing the overflow lift station and covered an area of approximately 50 m².

The results of the internal De Beers investigation revealed that the incident's primary cause originated from a missing interlock (electronic switch) that triggers a shut off of sewage from the main lift station to the emergency overflow lift station when the screener in the STP hits

a high level. Prior to the spill, the need for an interlock was identified and had been scheduled for installation on 06 September.

A secondary cause was an audible alarm that sounded within the overflow lift station building but could not be heard outside of the building, delaying the response time by the STP operator.

a. Location of spill outside of Emergency Overflow Lift Station (building with open door)

- The interlock switch has been installed by ADCO the on-site electrical/mechanical contractor. . The STP plant is also now tied into the fire alarm system that includes a paging/notification system. This will alert the STP operator immediately to any alarms within the STP at any given time.
- Additional capacity has been added to the overflow lift station to allow for a greater volume of overflow storage, should it be required.

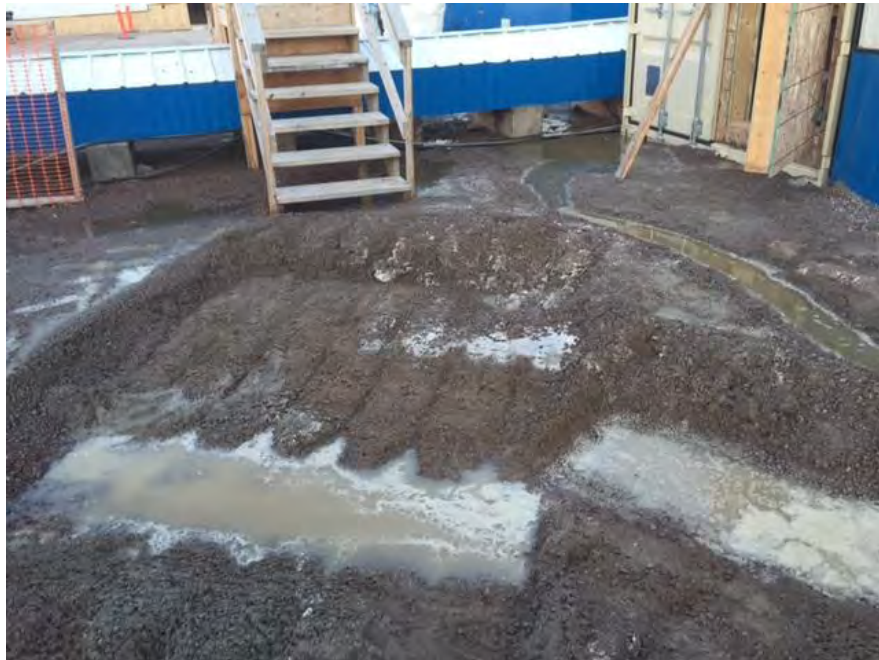
b. Sump to collect/contain spread of overflow excavated outside of Emergency Overflow Lift Station.

- A sump was excavated into the pad outside of the overflow tank building to collect any overflow and contain the spread of untreated sewage;
- Additional personnel and equipment were employed to excavate the contaminated aggregate and transport it to landfill for disposal where a covering of lime was applied over the material; and
- Lime was also applied to the excavated area at the pad and a fresh covering of aggregate was placed to restore the pad surface to its' original condition.
