Re: Follow-up Spill Report – Sewage Spill at Sewage Treatment Plant (Oct.16, 2014)

Below, please find a summary and description of the corrective actions related to a reportable spill that occurred at the "Newterra" Sewage Treatment Plant (STP) at the De Beers Canada Inc. Gahcho Kué site on October 16th, 2014.

Incident Summary

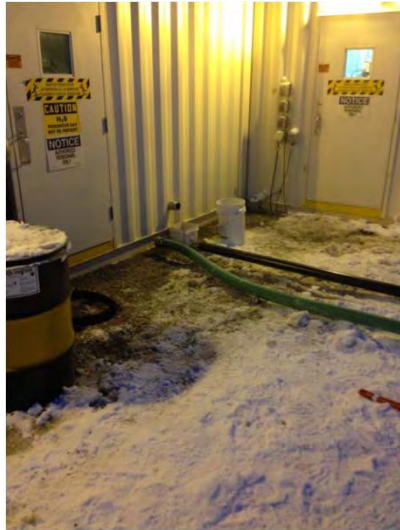
The cause of the spill was determined to be a frozen transfer pipe that is intended to convey sewage to an exterior tank.

Oct. 16, 2014 – Photo of spill outside STP showing frozen pipe

Upon discovery of the spill, the STP was immediately shut down to stop the source of the spill and determine the cause. Once it was determined that the cause of the spill was a frozen pipe, the pipe was replaced and the STP was restarted.

In order to prevent a reoccurrence, the affected pipe was insulated and heat traced to prevent freezing. This preventative action was completed on October 26th. Additionally, an audit was conducted to determine whether any other pipes associated with the STP were at risk of freezing, and several additional pipes, as well as the exterior overflow tank, were insulated and heat-traced.

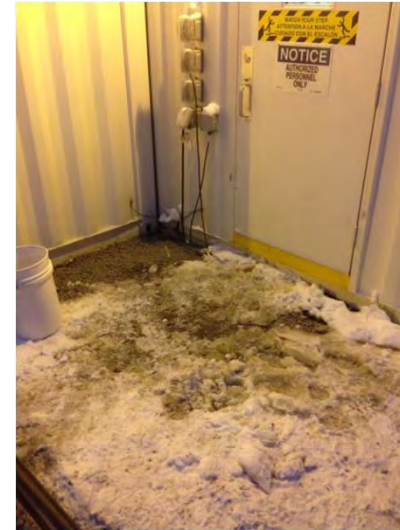
The spill occurred at the Gahcho Kué "Newterra" sewage treatment plant (STP) at approximately 19:00 on October 16, 2014. An estimated 200 litres of untreated sewage overflowed from a holding tank located inside the STP. The sewage exited the STP via an access door, and spilled onto an engineered pad constructed out of crushed mine rock (gravel) which was snow covered at the time of the spill.

Oct. 16, 2014 – Photo of spill outside STP

Concurrent with the pipe replacement, contaminated snow and gravel were cleaned up, and the spilled sewage inside the STP was vacuumed up and reintroduced into the system.

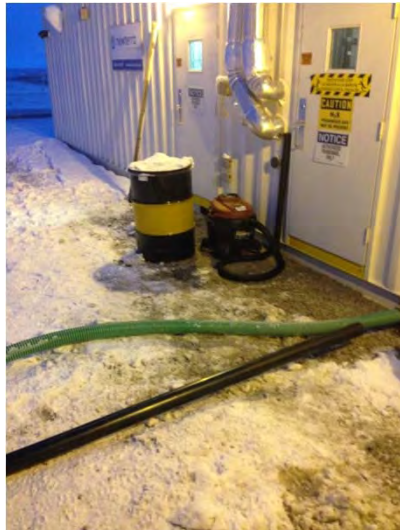
Oct. 16, 2014 – Photo of spill outside STP showing frozen pipe

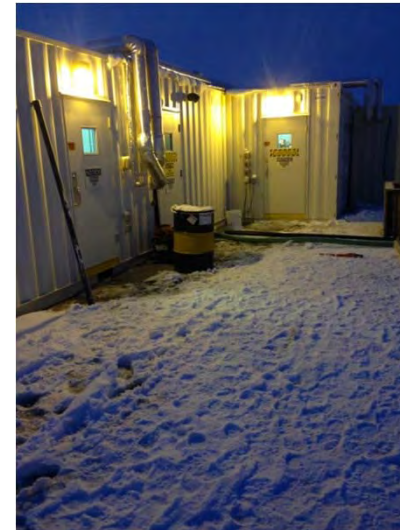
Oct. 16, 2014 - STP

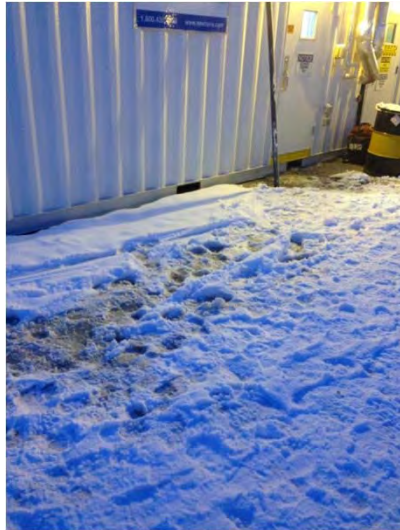
Oct. 16, 2014 – Photo of spill outside STP

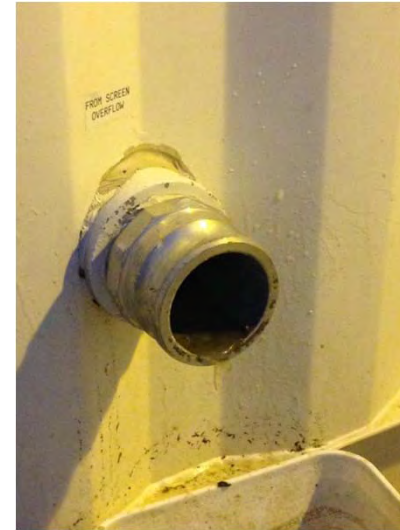
Oct. 16, 2014 – Exterior hose connection

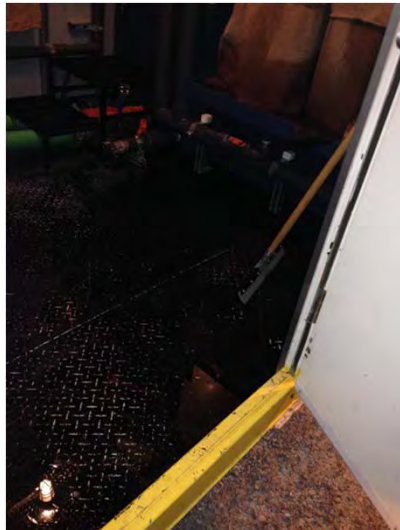
Oct. 16, 2014 – Inside STP

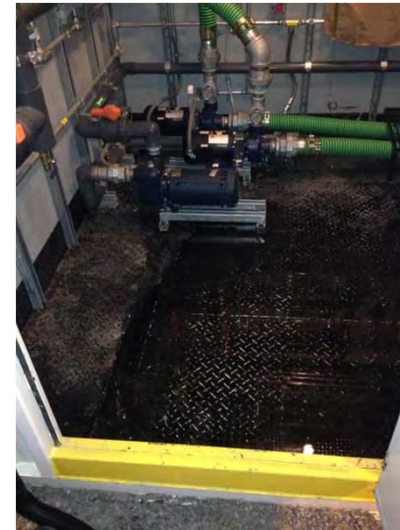
Oct. 16, 2014 – Inside STP

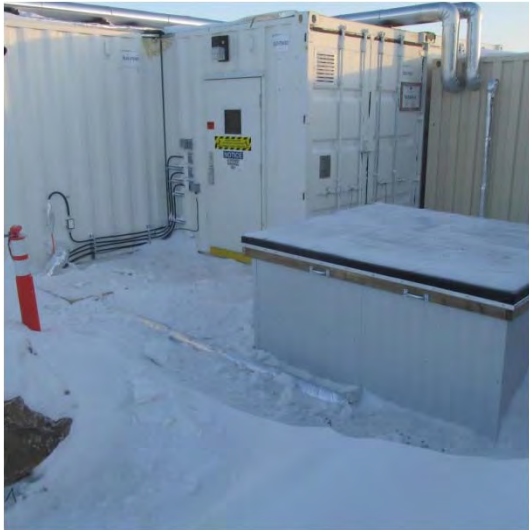
Nov. 16, 2014 – STP showing winterized pipe

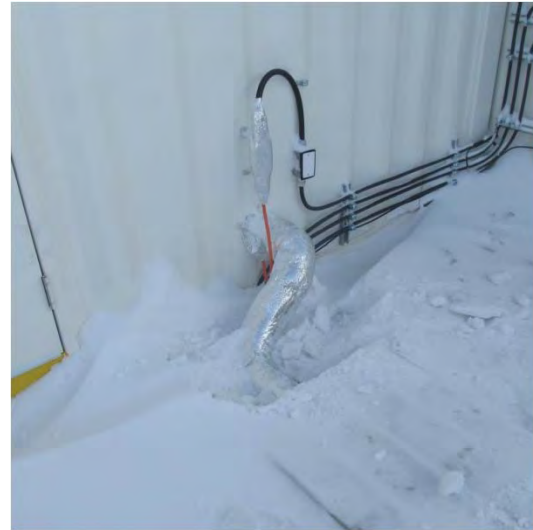
Nov. 16, 2014 – Winterized pipe and heat trace

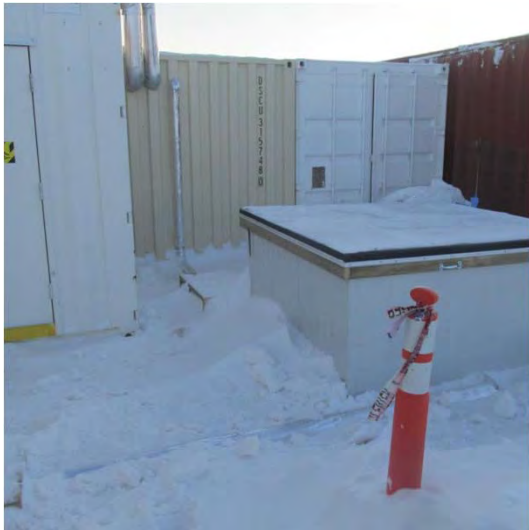
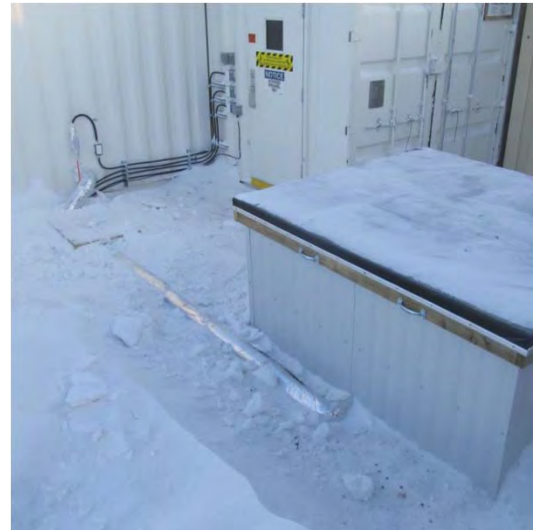
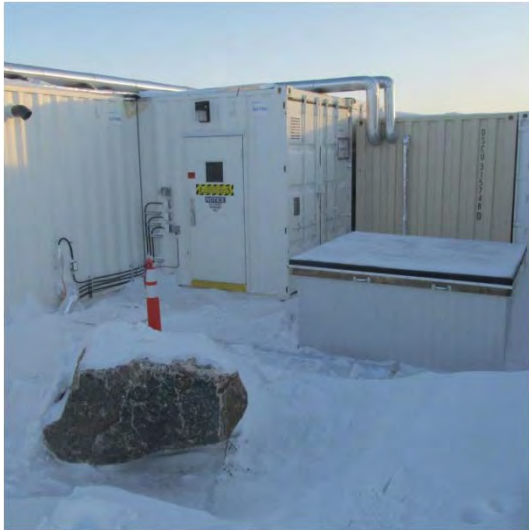
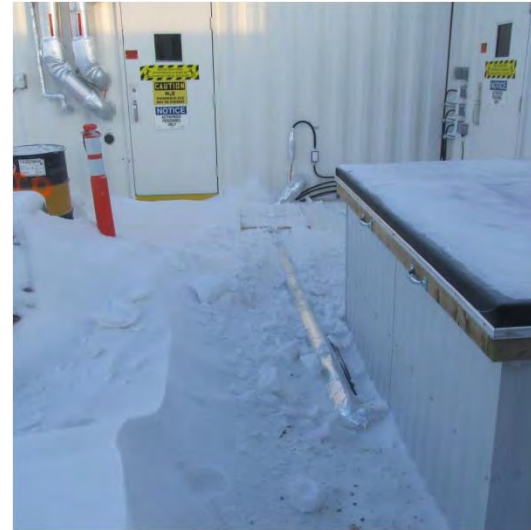
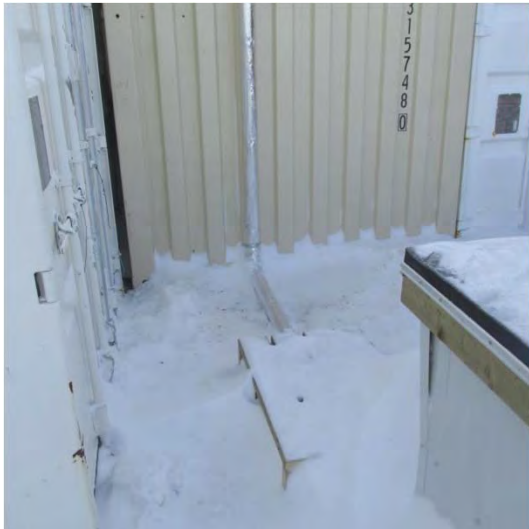
Nov. 16, 2014 – Winterized pipe and exterior tank

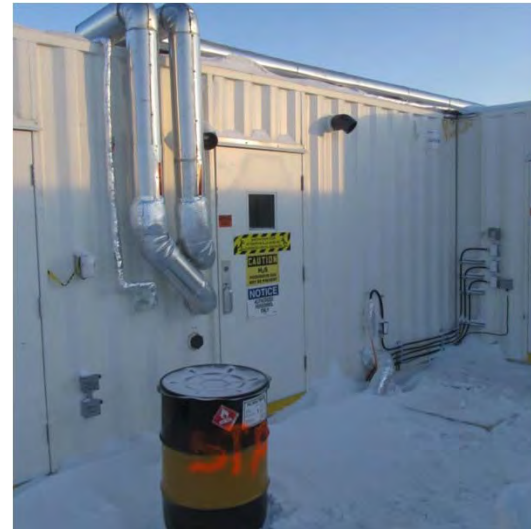
Nov. 16, 2014 – Winterized pipes
