FIGURE 1 – FALL 2011 SCENARIO

FIGURE 2 – CURRENT SCENARIO

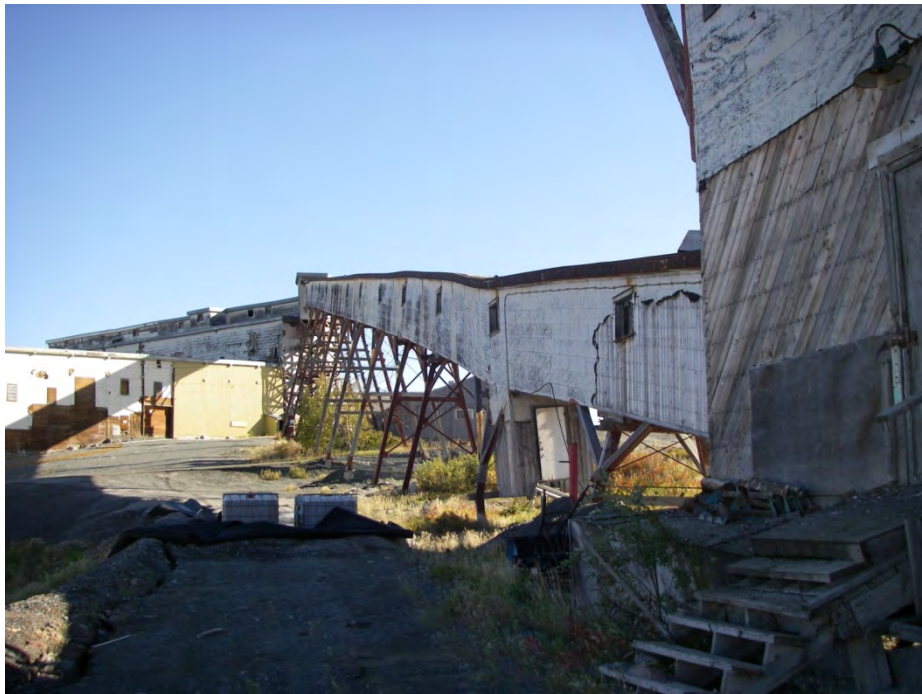
Conveyor gallery

September 2011 – Uneven roof line indicates structure is moving

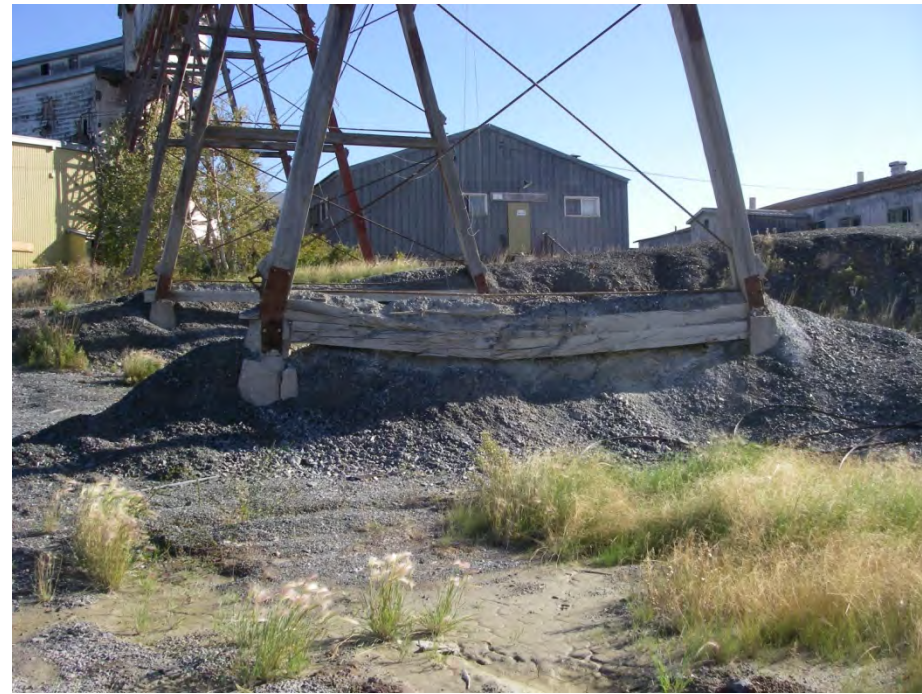
September 2011 – Damaged support frame and concrete support pier

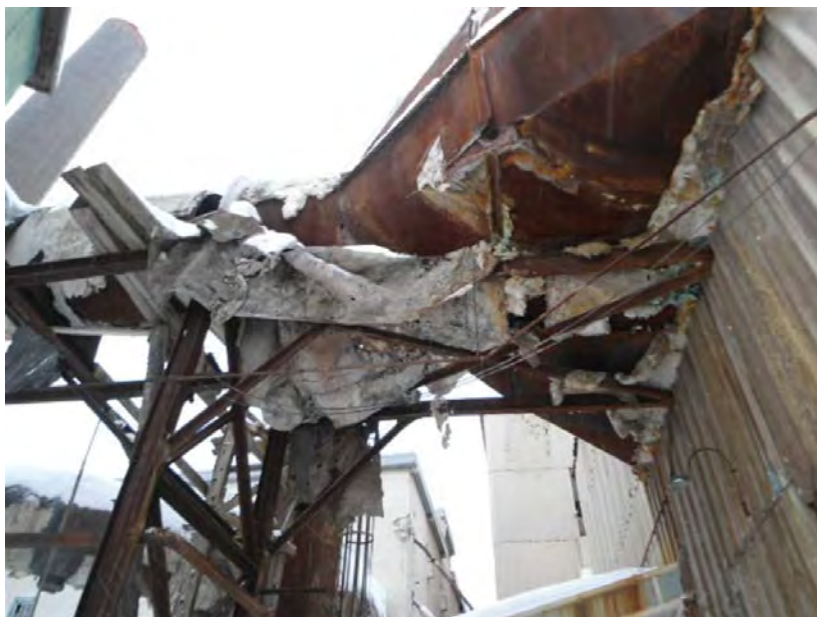
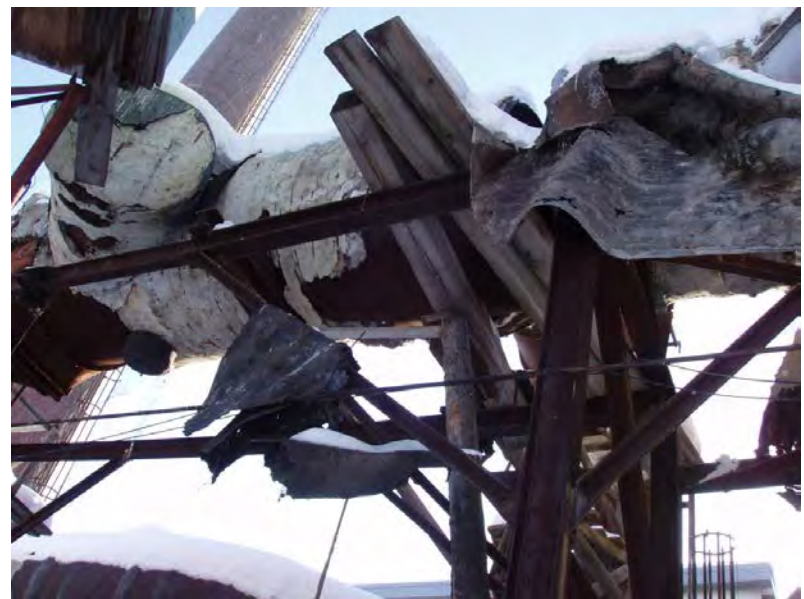
Exterior “Flues” (series of ductwork)

- Contain arsenic trioxide and insulated with asbestos
- Evidence of corrosion and weather damaged and risk of collapse

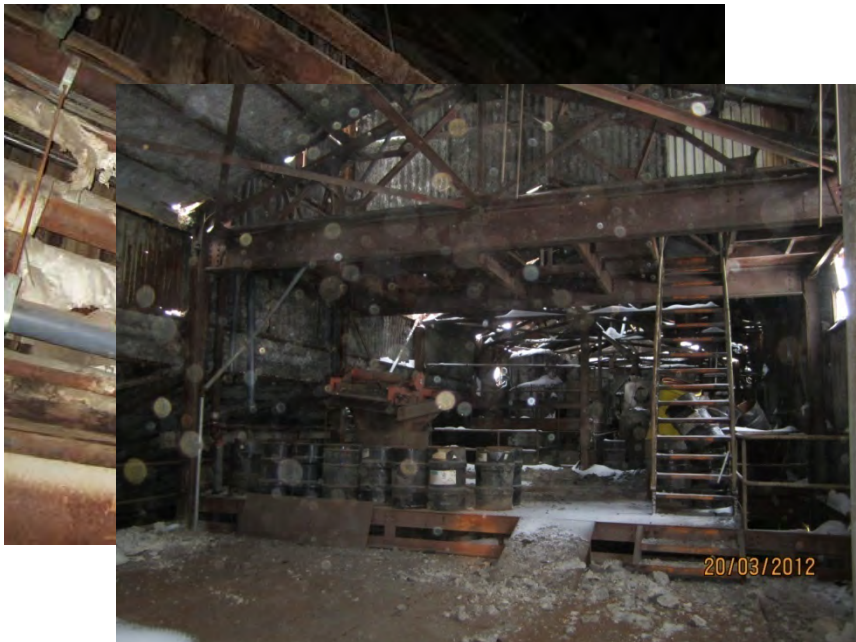
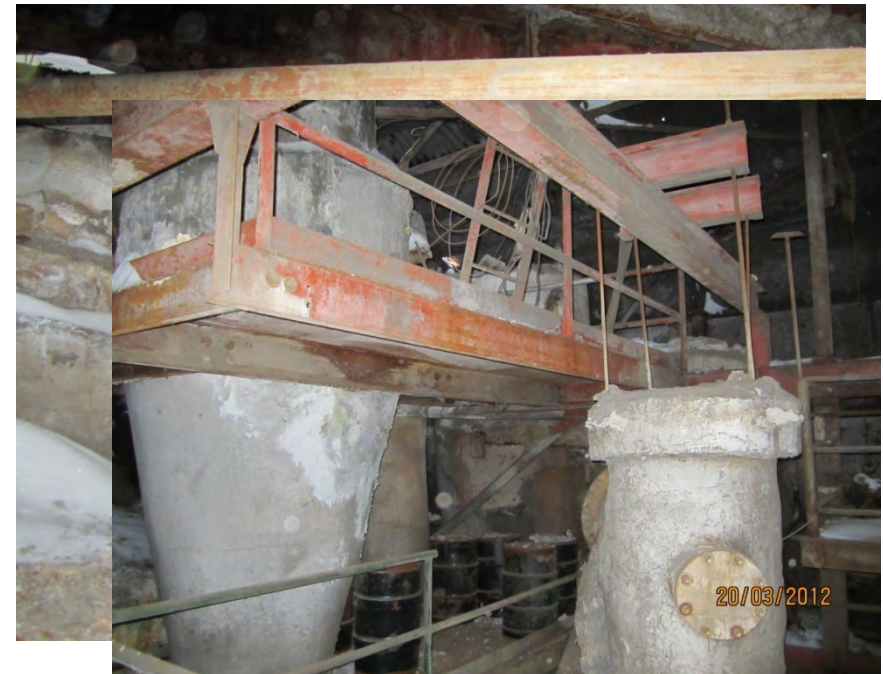
Roaster Complex - Interior Highly Contaminated with Arsenic, Asbestos and other hazardous materials.

- Asbestos insulation in poor condition, fallen off on pipes, ceilings, etc.

- Abandoned duct network containing arsenic trioxide.
- Surfaces Contaminated with arsenic dust

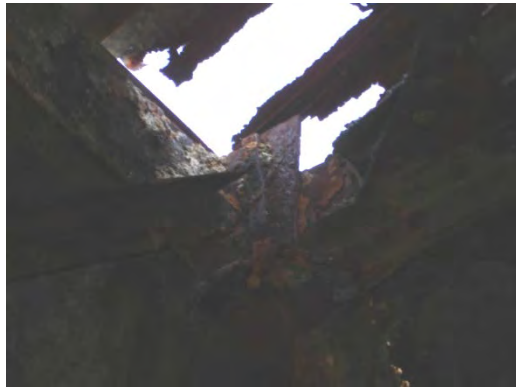
- Deterioration of interior ceilings and walls

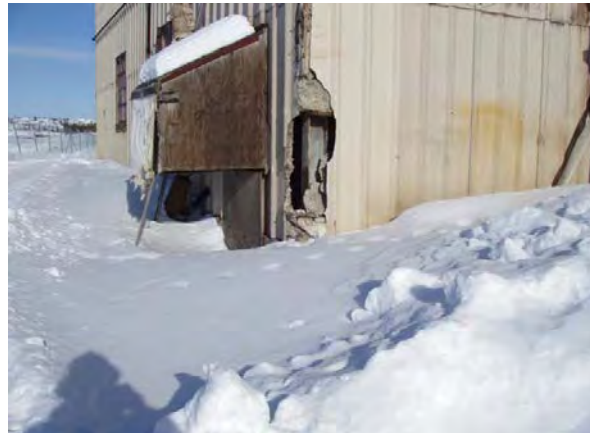
- Deterioration of exterior

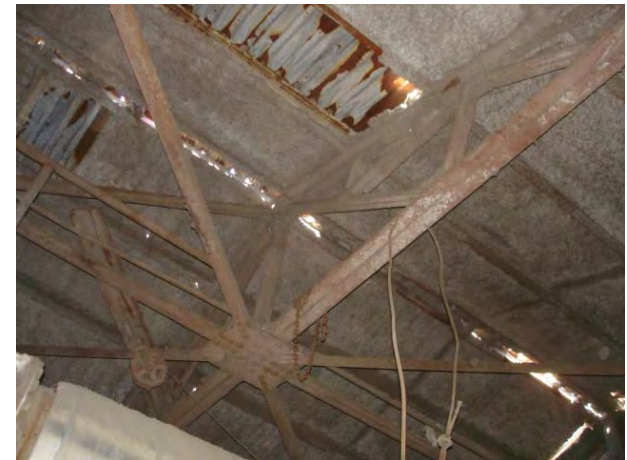
- Gaps identified in roof structures

Openings in Structures/deterioration = Increased exposure risks to hazardous materials.

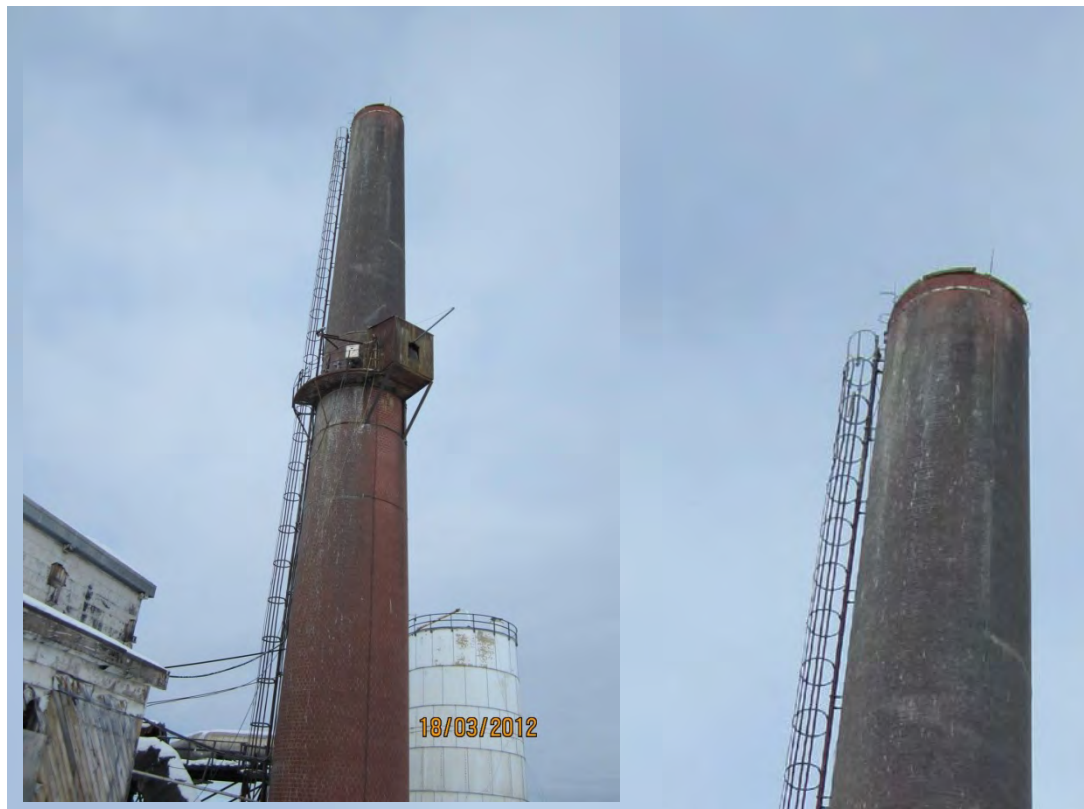
Roaster Stack

- **Stack reported to contain ~14 tons of Arsenic Trioxide**
- **Deterioration and shifted steel plates at top of stack**

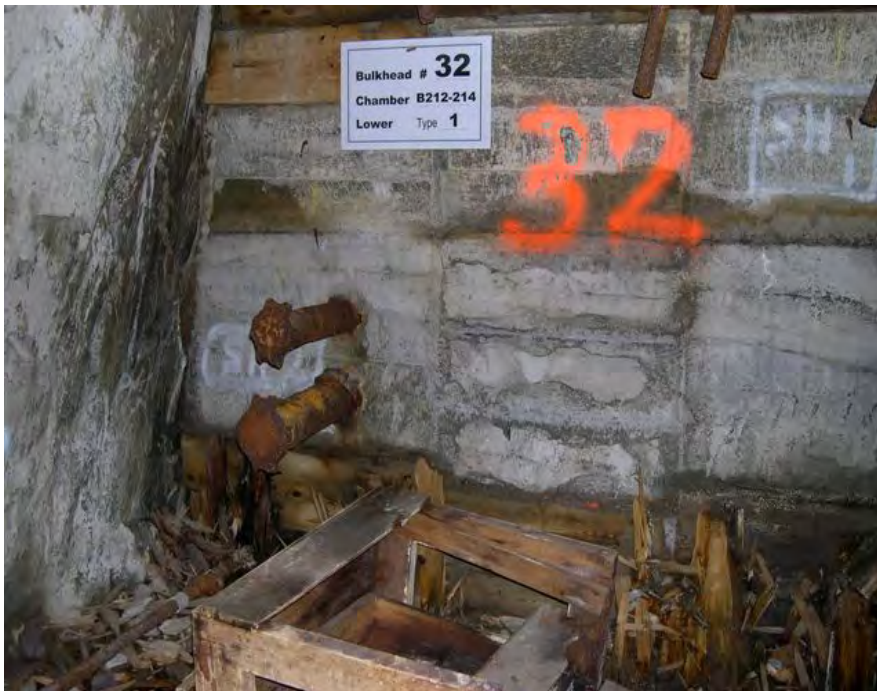
Underground Stabilization

- 2011 risk analysis identified that underground improvements were necessary to address potential bulkhead or crown pillar failures
- Improvement activities include
 - Drilling crown pillars to determine actual thickness
 - Backfill drifts and construct new drift plugs
