**RE: Water Licence MV2012L8-0010 – NT/NU Spill 16-299 – Giant Mine – Inspection**

## WATER LICENCE ENVIRONMENTAL INSPECTION REPORT

Current Stage of Operation:	Bridge Stabilization Project / NT/NU Spill Report 16-299
-----------------------------	--

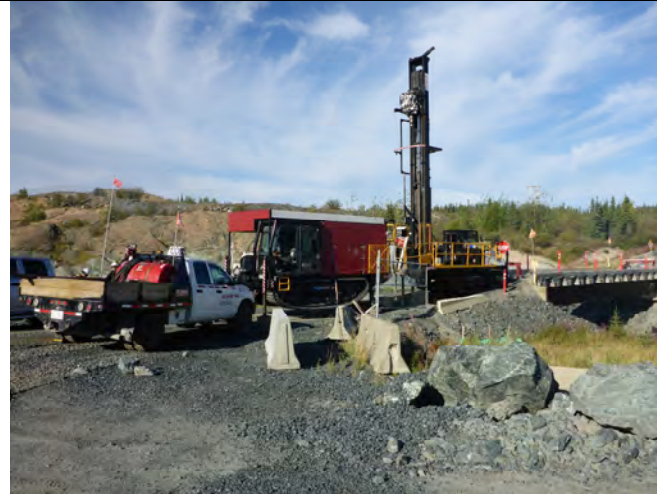
**Photo 1: Overview of the final drilling location for the bridge stabilization project. (Looking west from the east side of the bridge)**

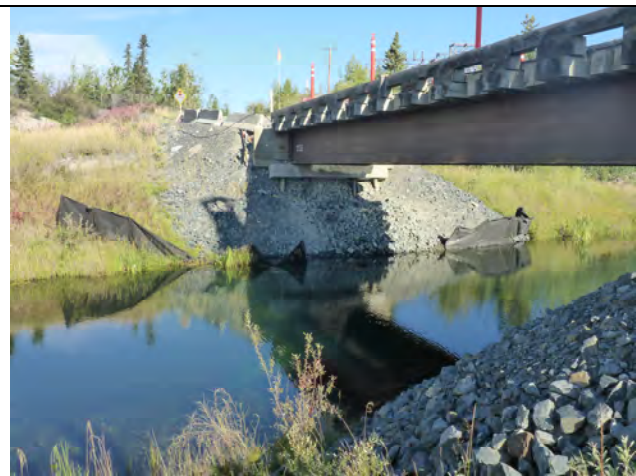
The Major Drilling crew was performing maintenance to the drill rig at the time of the inspection, therefore no drilling was taking place during the inspection. The Inspector noted that there was no noticeable plume in Baker Creek during the inspection (Photo's 2 & 3). The Inspector discussed the incident with the drilling crew who stated that they were drilling the second of three holes near the bridge. About 25 feet down (out of a planned 30 feet) one member of the crew observed a release from under the bank of Baker Creek. Drilling was immediately ceased and the plume was monitored. Baker Creek flow rate is very low and has reduced to almost standing water. The reduced flow rate of Baker Creek caused the plume to not spread downstream and remain in the immediate area of the bridge.

**Photo 2: Northwest view from under the bridge towards the location of the spill.**

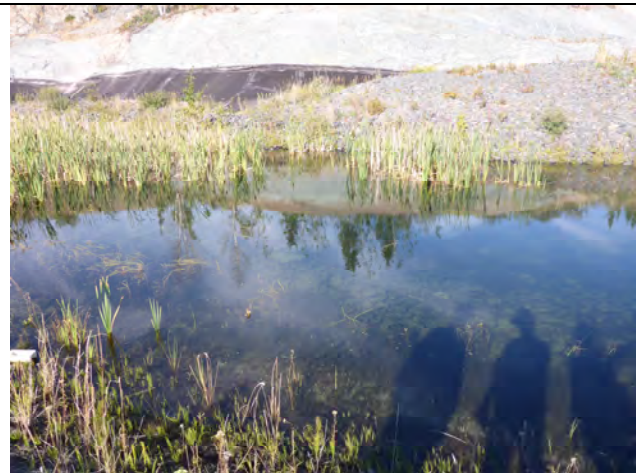
Due to the flow rate of Baker Creek, estimated quantities of released drill water, and the fact that this borehole was not associated with the arsenic stopes it appears that the impact to Baker Creek and surrounding environment is very minor.

**Photo 3: Overview of the southern portion of Baker Creek immediately downstream of the spill location.**

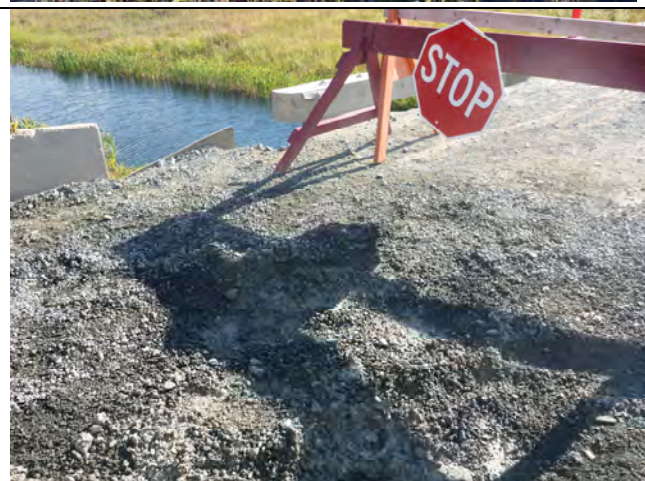
An estimated 275 gallons of water from the Polishing Pond as per condition Part C #1 of the licence was used to drill the hole. No other chemicals or additives were used in the drilling process. The crew estimated that an estimated 25 gallons was lost in the hole prior to the rig being shut down.

**Photo 4: Close up of the drill location.**

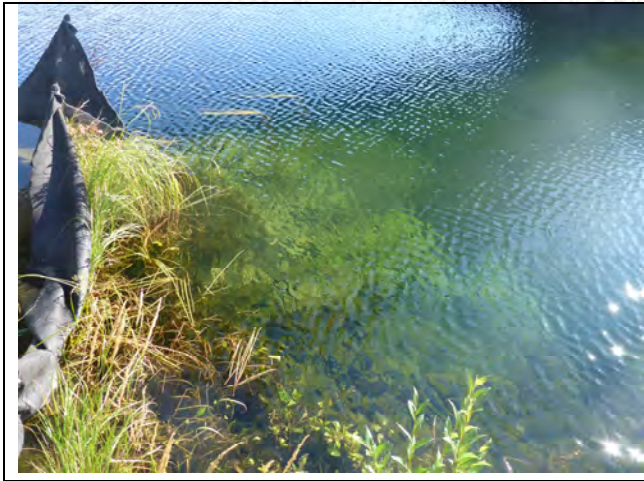
According to site staff the sediment plume had settled out to the bottom of the creek within the hour (Photo #5). There was no ability for the Inspector to see the plume first hand or take samples since the Inspector was notified by the spill 24 hours after the incident. The Inspector expects that all future incidents are reported to the NT/NU Spill line and to the Inspector immediately without delay.

**Photo 5: View directly underneath the west side of the bridge. Note the greenish/brown area under water where the sediment settled.**
