RE: Water Licence MV2012L8-0010 – Roaster Complex – Giant Mine – Inspection

WATER LICENCE ENVIRONMENTAL INSPECTION REPORT

Location(s) Inspected:	Roaster Complex Deconstruction / Waste Management Area
------------------------	--

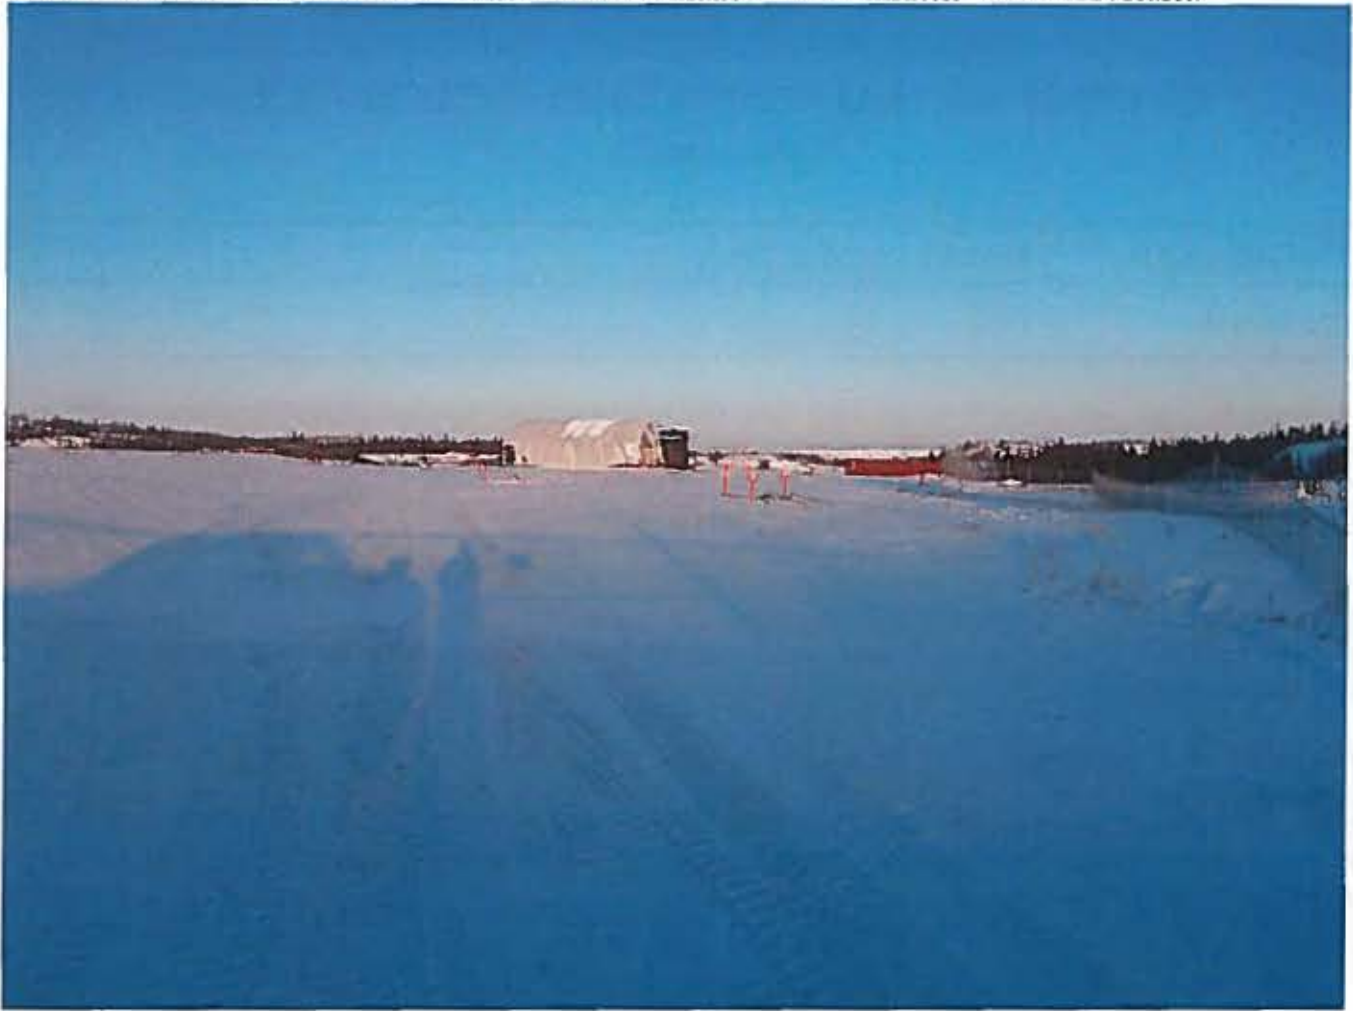
At the time of the inspection the roaster deconstruction project had been completed for the 2014 season. There were no concerns noted during the course of the inspection by either officer. The majority of the work has been completed with only the final crushing of foundations, infill sumps, and a final scraping of the site (Photo 1). All of the associated waste has been removed from the roaster site and placed in an approved location (Photos 2 & 3).

Photo 1 – Overview of the Roaster site after the demobilization of the contractor for the 2014 season

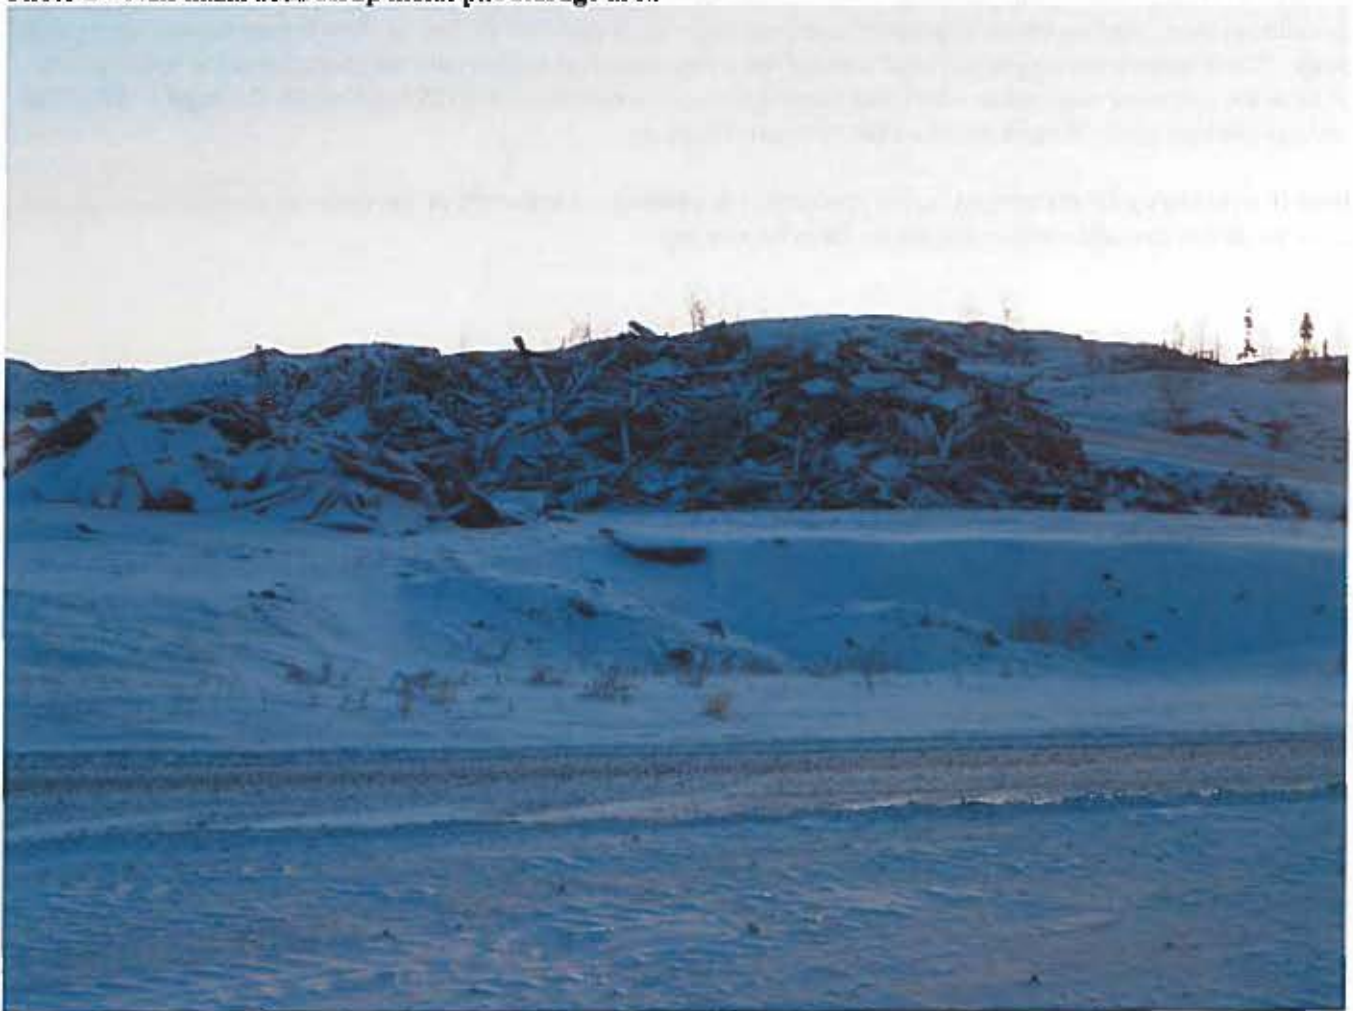
Photo 2 – Non-hazardous scrap metal pile storage area

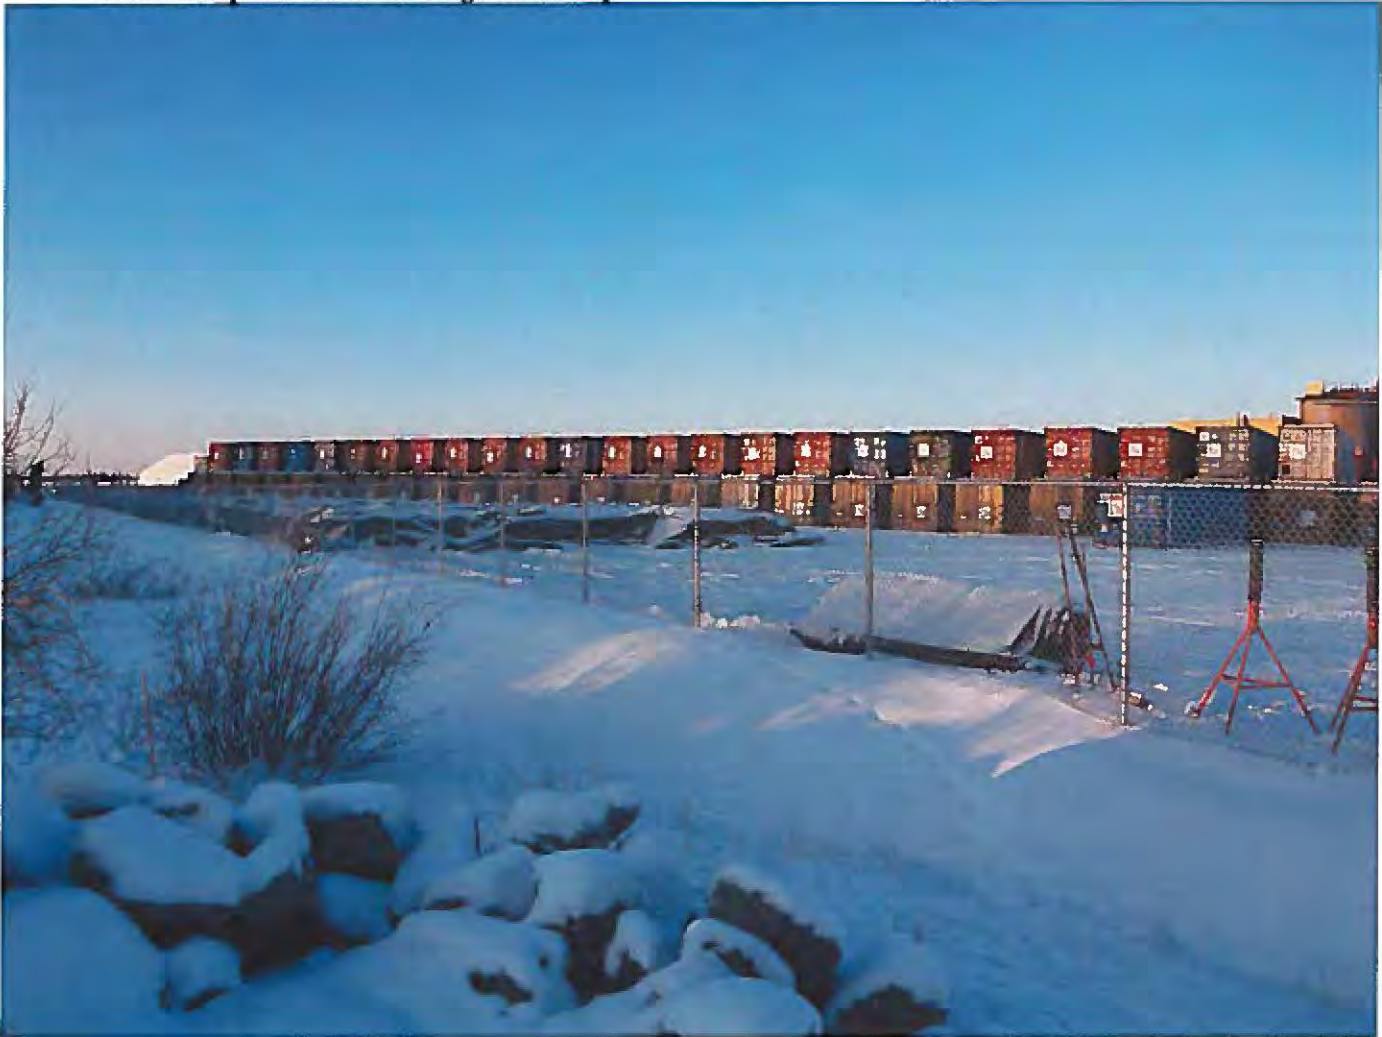
During the inspection it was noted that there were approximately 600 mega bags of hazardous waste located in the waste storage area. These mega bags have been placed under a tarp and secured within the waste storage area. There has been a delay in receiving the final sea cans needed to store all of the remaining mega bags that are currently placed under the tarp in the waste storage area. The sea cans are expected to arrive in January 2015 with the remaining mega bags being placed in the sea cans in the summer of 2015.

Photo 3 – Overview of the waste storage area. The remaining mega bags that are not in sea cans are located to the left side of the photo under the large black tarp.

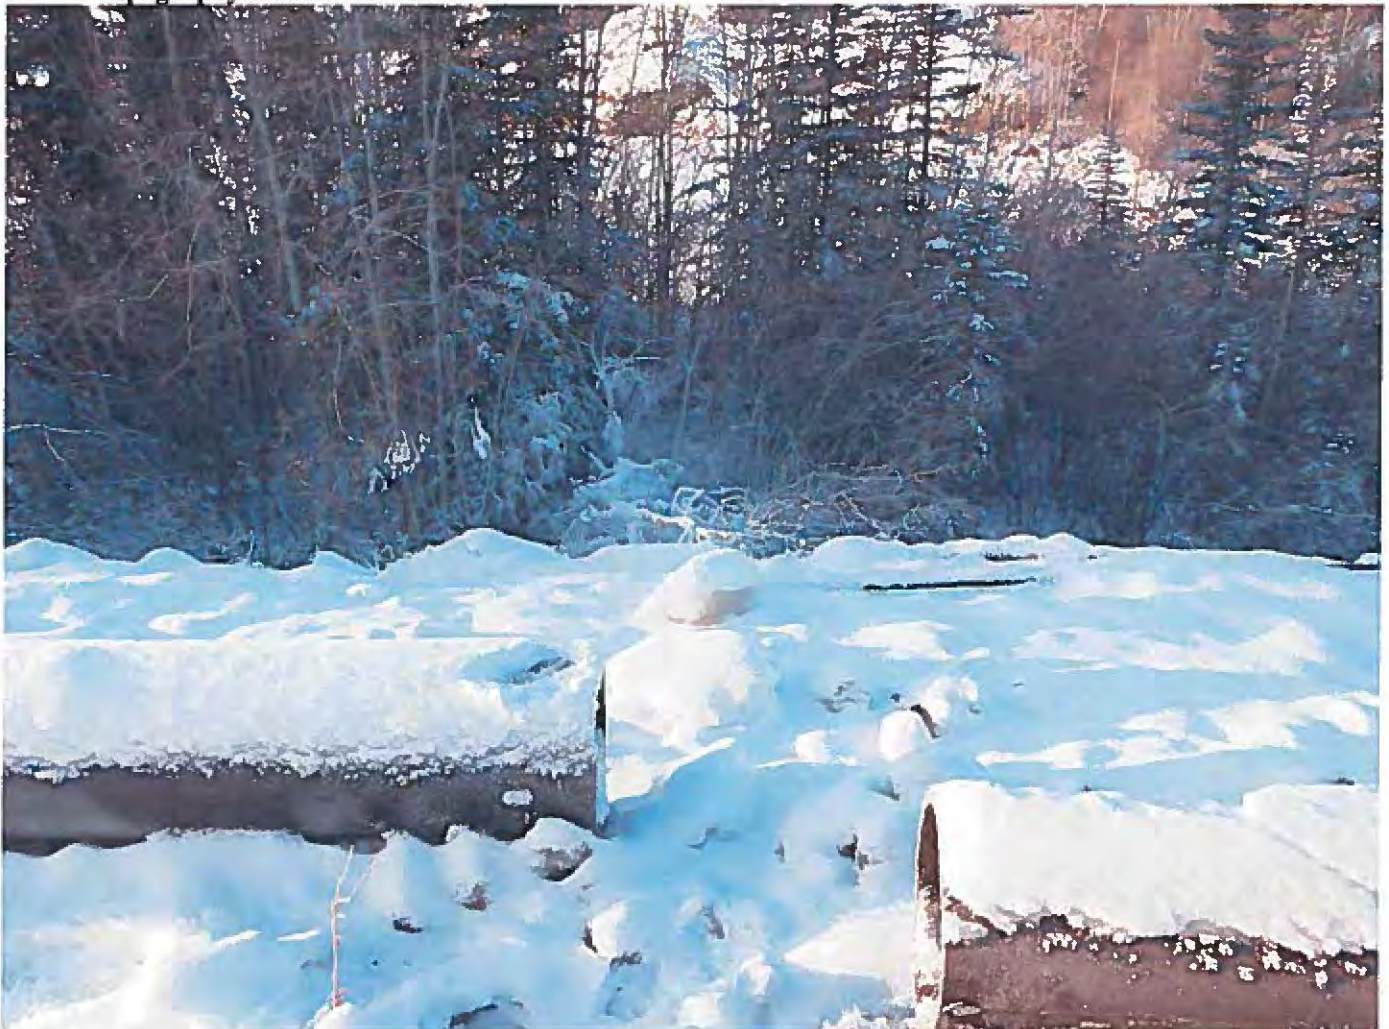
While onsite the officers followed up with the spill that occurred on Nov 12th 2014 of waste water from the pipeline that runs from the Northwest Pond. The pipeline was being used to pump water down from the Northwest Pond to access tailings for the paste backfill project. During the pumping, it was identified that there was a major blockage of ice in the line. A steam truck was called to steam the line which required that several holes be drilled into the line to allow for a complete removal of the blockage. These holes were not plugged and some of the waste water had spilled onto the ground near the Settling Pond. Samples from the discharge were taken which indicated Arsenic concentration of 0.825 mg/L and 0.701 mg/L. All of the water that was released either flowed into the settling pond (Photo 4).

Photo 4 – Location of Spill NT/NU 2014 – 408. Note that the pipeline had been cut to drain the water and remove the blockage. Also, note the proximity of the Settling Pond in the back of the photo to the location of the spill and the topography between the two.

Part F, Item 1(c) requires a detailed report on the occurrence that includes a summary of any clean up that has occurred and preventative measures to avoid similar discharges from happening.
