File Number	MV2015Q0022
Type of Operation	QUARRY SITE - Existing
Location	Km 191.6, NWT Highway No. 1

ENVIRONMENTAL INSPECTION REPORT

Permittee:	Rowe's Construction	Permit Expiry Date:	February 17, 2021
Land Use Permit No.	MV2015Q0022	Previous Inspection:	October 07, 2016
Quarrying Permit No.	17/0002	Inspection Date:	June 06, 2017
Contractor:		Subcontractor:	
Location(s) Inspected:	Km 191.6, NWT Highway No. 1		
Current Stage of Operation:	No activity at the time of inspection.		
Program Modifications Approved:

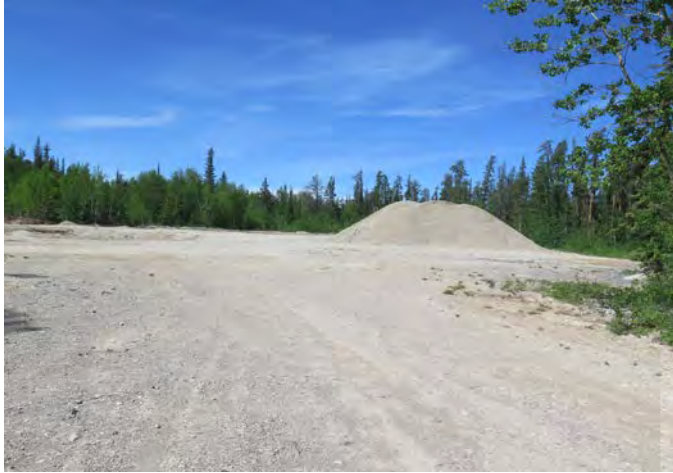
Figure 1

There was no equipment on site during the inspection. Granular material has been removed from the large stockpile (Quarry Permit #2014QP0027).

Stockpile of processed material.

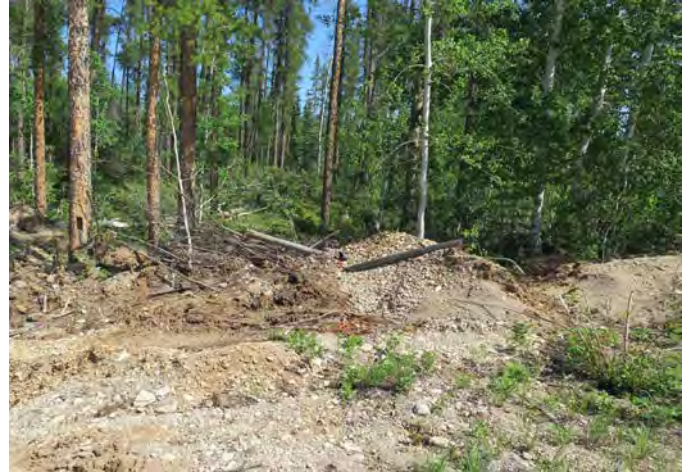
Figure 2

There is a small excavation near the northwest corner of the clearing. The brush and gravel that has been pushed into the trees must be pulled back out of the standing timber. Brush should be properly disposed of by burning when conditions are safe. **Condition 10:** Sewar pipes are mixed in with the dirt piles. These must be removed from Territorial Lands and properly disposed of. There is some garbage consisting of coffee cups, plastic, tin cans, hoses, grease tubes, etc around the site that must also be cleaned up.

Digging in the northeast corner of the clearing. Sewar pipes have been left in the pile of gravel and debris and must be properly disposed of.

1. All salvageable timber windrowed to the west side of the project area must be separated from the overburden and stacked neatly for firewood salvage (Condition 29).
2. All woody debris located within the project area be piled and totally disposed of through burning when conditions are safe.
3. Sewer pipes from the camp trailers must be removed from site and taken to an authorized disposal facility.

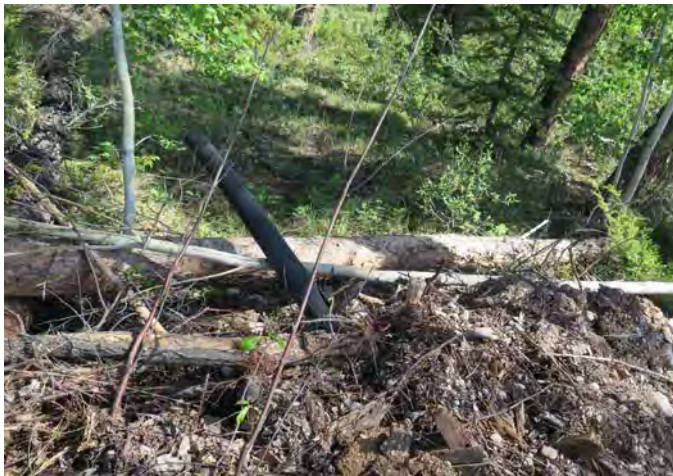
Figure 3

Sewar pipes from the camp pushed into a pile of gravel and debris.

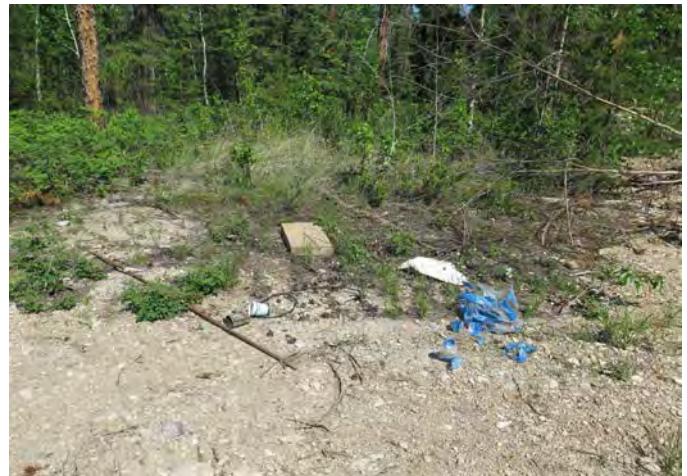
Figure 4

Garbage that must be cleaned up.

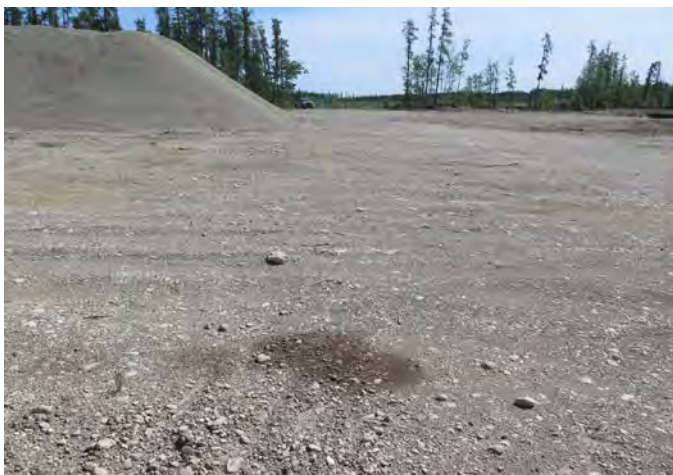
Figure 5

Condition 26: There is a small spill, approx. 0.75m², located near the stockpile and a second spill where the dump truck was parked on the west side of the clearing. These spill must be cleaned up and the contaminated soil taken to an authorized disposal site.

Spill near where the camp was located.

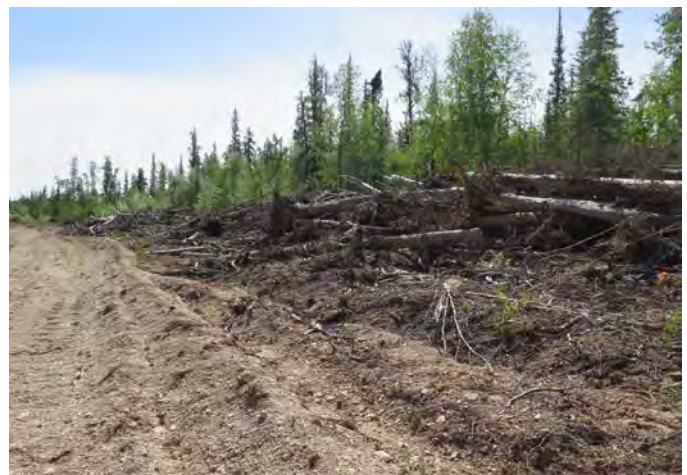
Figure 6

Condition 29: Cleanup of the windrowed timber and brush remains outstanding.

Large timber mixed with brush and overburden must be removed from the windrow and decked for salvage.

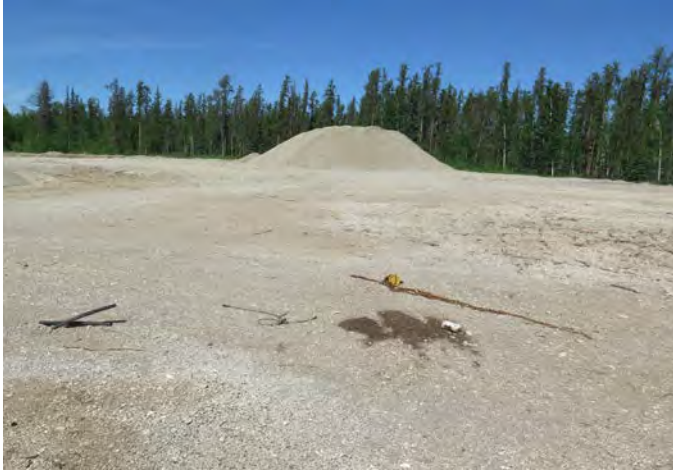
Figure 7

Spill requires cleanup. Bits of garbage around the site that must be cleaned up.
