File Number	MV2015Q0022
Type of Operation	QUARRY SITE - Existing
Location	Km 191.6, NWT Highway No. 1

An inspection of the above noted operation was conducted on October 07, 2016 by Resource Management Officers Jayda Robillard and Norm McCowan.

ENVIRONMENTAL INSPECTION REPORT

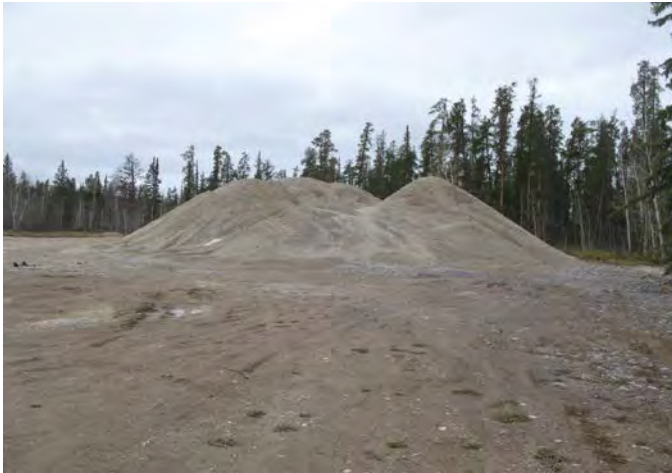
Figure 1

No material has been removed from the stockpile of processed granular material since the previous inspection. The royalties for the overquarry (1473m³) identified in the previous inspection has been paid to the GNWT. Should Rowe's Construction wish to process any further granular material from this quarry, it must be stored separately from the existing stockpile of granular material which has been both surveyed and paid for.

Stockpile of processed granular material.

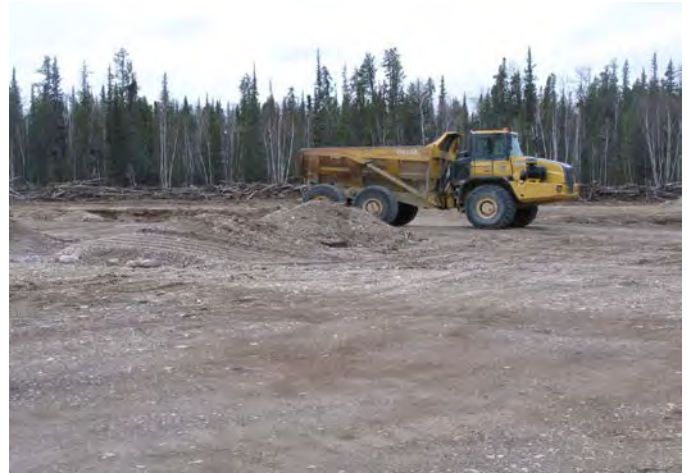
Figure 2

There was a John Deer 3500 truck parked on site at the time of inspection. **Condition 25** of your land use permit requires that *"All equipment that may be parked for two hours or more, shall have a hazmat/drip tray under it or be sufficiently diapers."* The truck has been parked with no hazmat/drip tray beneath. Please ensure compliance with this condition in the future.

John Deere truck parked on site.

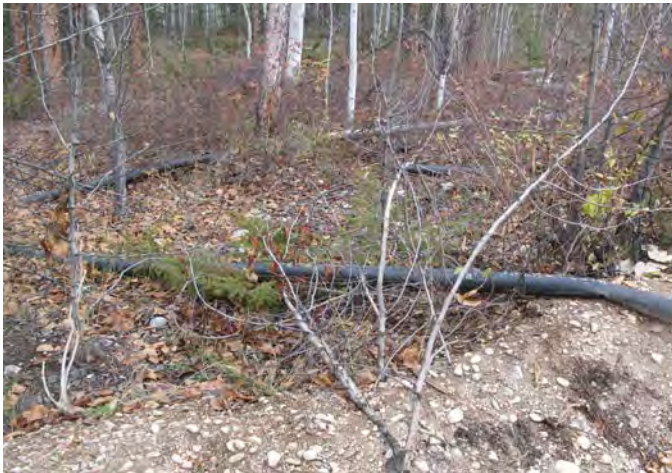
Figure 3

The camp has been removed and the camp sewage sump has been backfilled. The plastic piping from the camp trailers to the sump have been left behind and must be removed from site. There are also small bits of garbage consisting of tin cans, coffee cups, plastic, rubber hose, etc that have been left around the worksite which must be cleaned up (**Condition 10 -**

Pipes used for sewage sump left behind after camp removal.

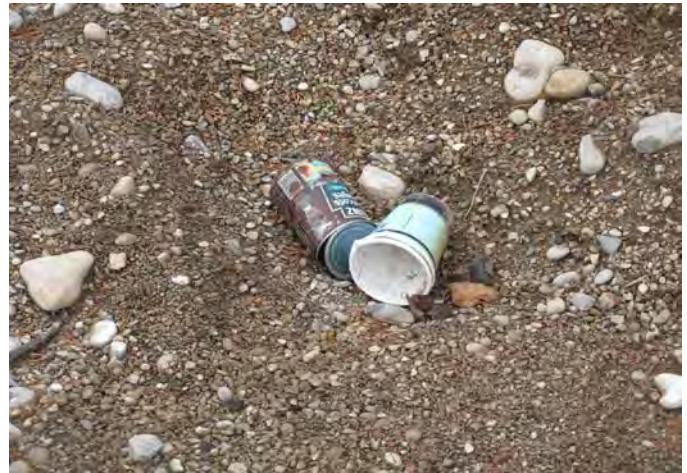
Figure 4

clean work area)

Garbage left behind from crushing operation and camp.

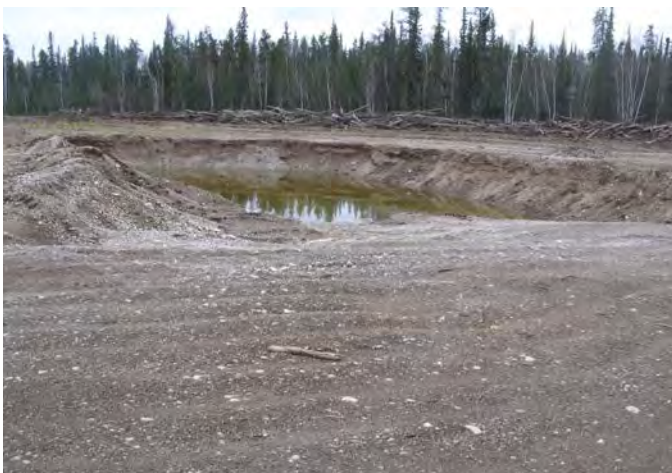
Figure 5

Salvageable timber windrowed along the west side of the project area must be separated from overburden and stacked neatly for salvage.

1. All salvageable timber windrowed to the west side of the project area must be separated from the overburden and stacked neatly for firewood salvage (**Condition 29**).
2. All woody debris located within the project area be piled and totally disposed of through burning when conditions are safe.

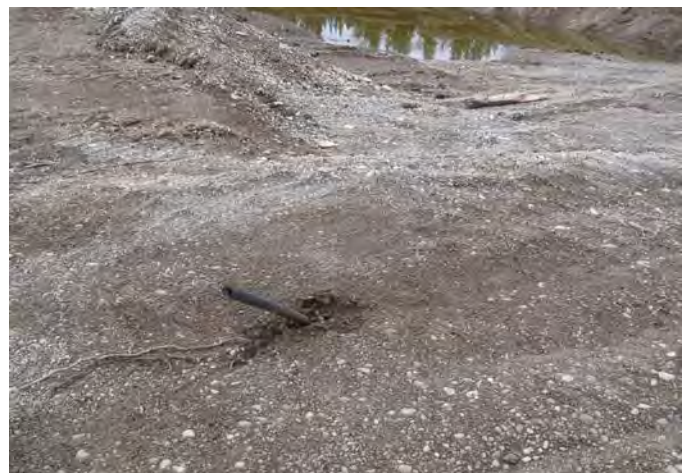
Figure 6

Rubber hose partially buried must be removed.

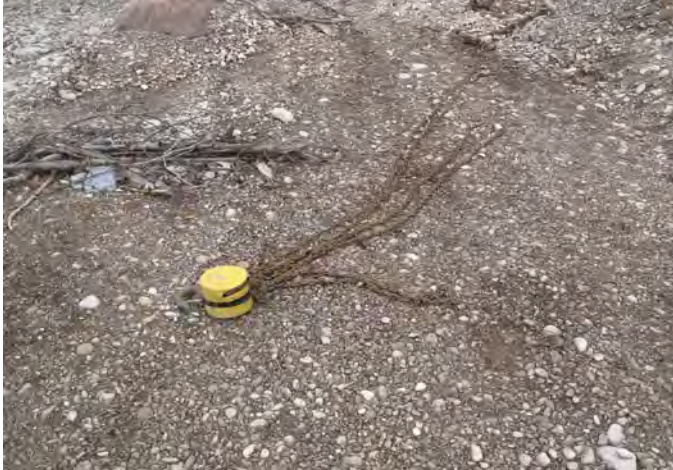
Figure 7

Block and tackle left behind in the pit must be removed.
