File Number	MV2016E0006
Type of Operation	HWY MAINTENANCE & OPERATIONS
Location	2016QP0029 - KM 682 Quarry

ENVIRONMENTAL INSPECTION REPORT

Permittee:	GNWT - Department of Transportation	Permit Expiry Date:	June 08, 2021
Land Use Permit No.	MV2016E0006	Previous Inspection:	February 10, 2017
Quarrying Permit No.	14/47, 15/14, 15/28, 16/12, 16/29	Inspection Date:	February 17, 2017
Contractor:		Subcontractor:	Rowe's Construction
Location(s) Inspected:	2016QP0029 - KM 682 Quarry		
Current Stage of Operation:	Crushing		
Program Modifications Approved:

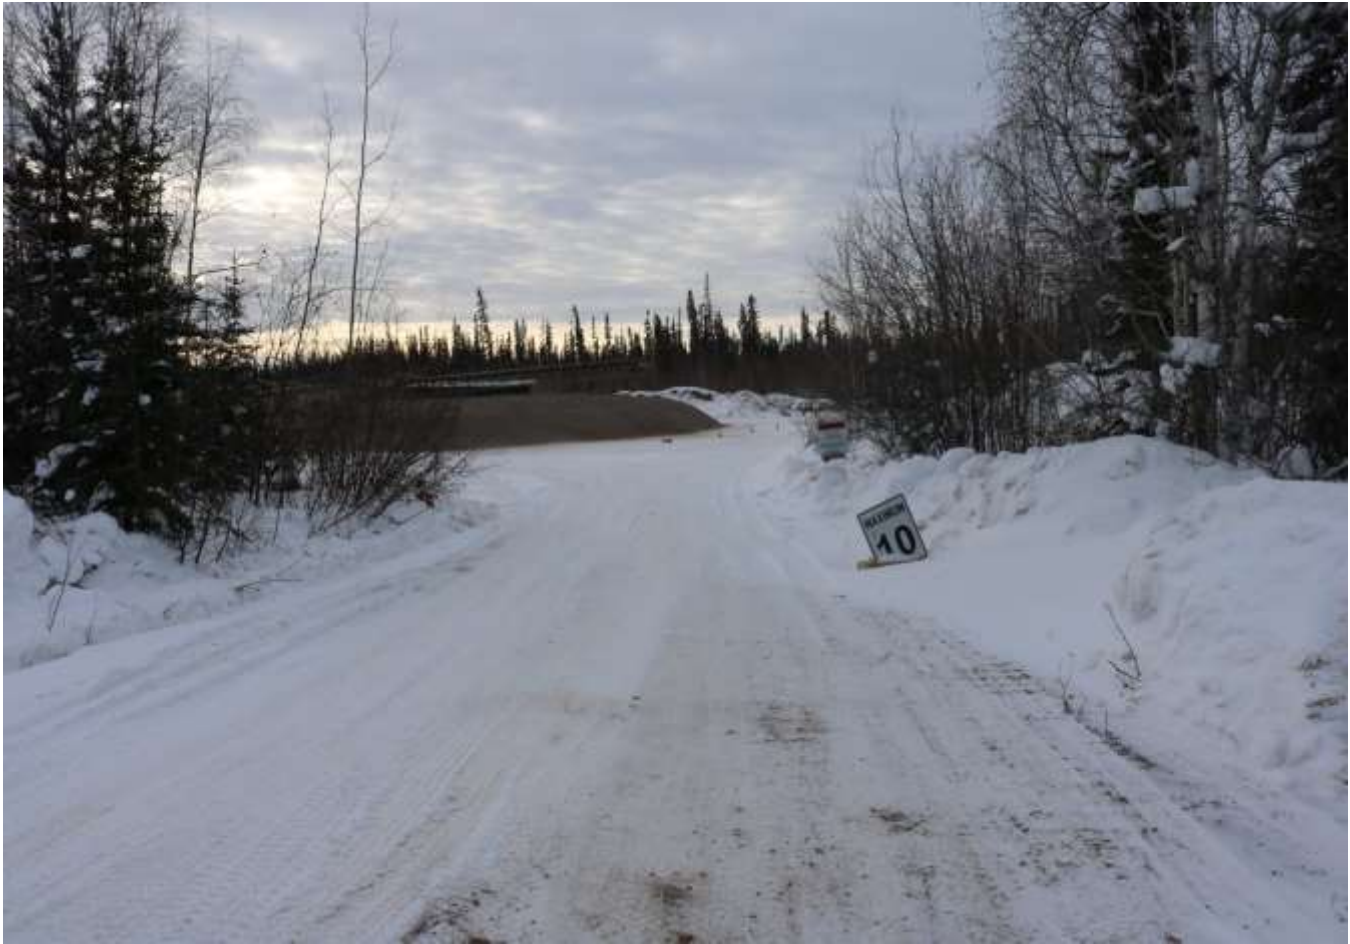
Figure 1

Access to quarry from Highway 7.

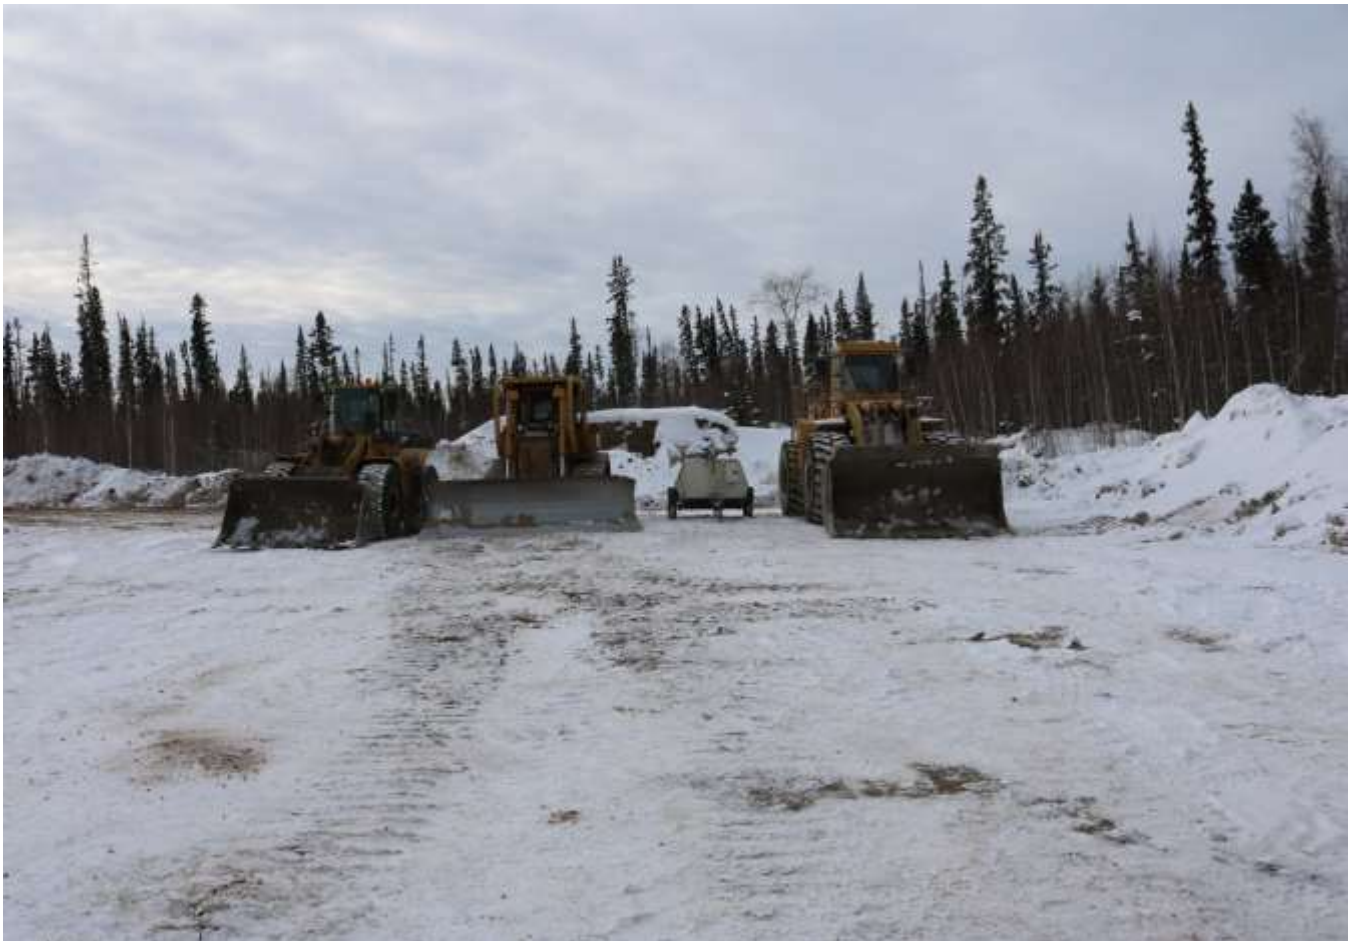
Figure 2

Machinery on site during inspection.

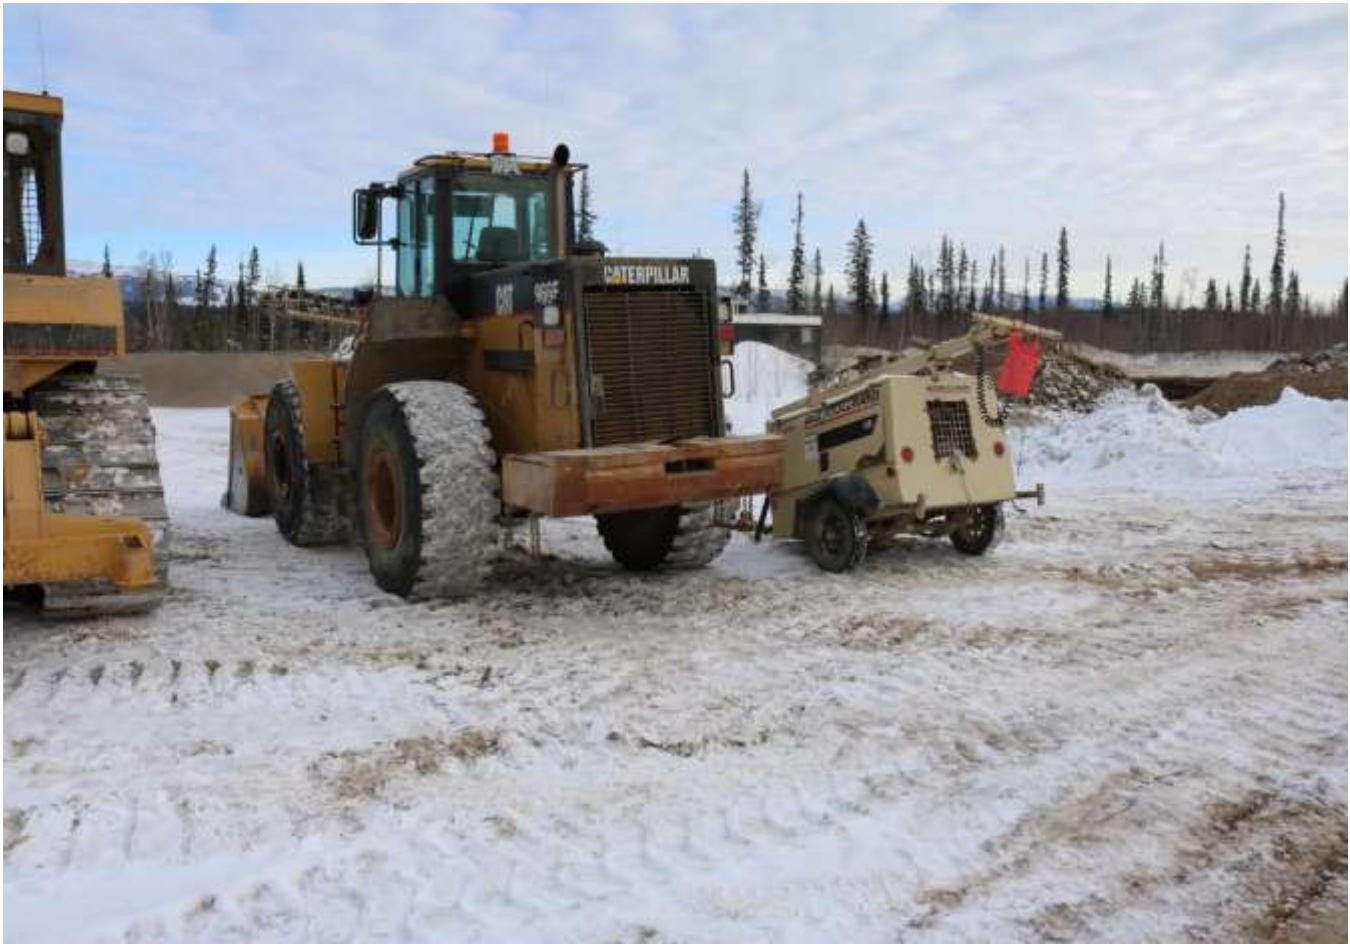
Figure 3

At the time of inspection crushing activities were halted due to the crusher requiring mechanical work. There was two vehicles on site when inspectors first arrived. One was a Heavy Duty Mechanic truck, while the other was a low-bed that was being used to haul the broken crusher off site. There were two loaders and a bulldozer on site during the inspection. All three pieces of machinery were lacking a drip tray. Inspectors request that drip trays be utilized underneath any piece of motorized equipment that is stationary for more than two hours. Two light plants were also situated in the same area as the three pieces of machinery and both also require drip trays.

Loader and light plant that were lacking drip trays.

Inspectors request that any motorized equipment utilized a drip tray when stationary for more than 2 hours.

72. Drip Trays: All equipment that may be parked for two hours or more, shall have a haz-mat/drip tray under it or be sufficiently diapered. Leaky equipment shall be repaired immediately.

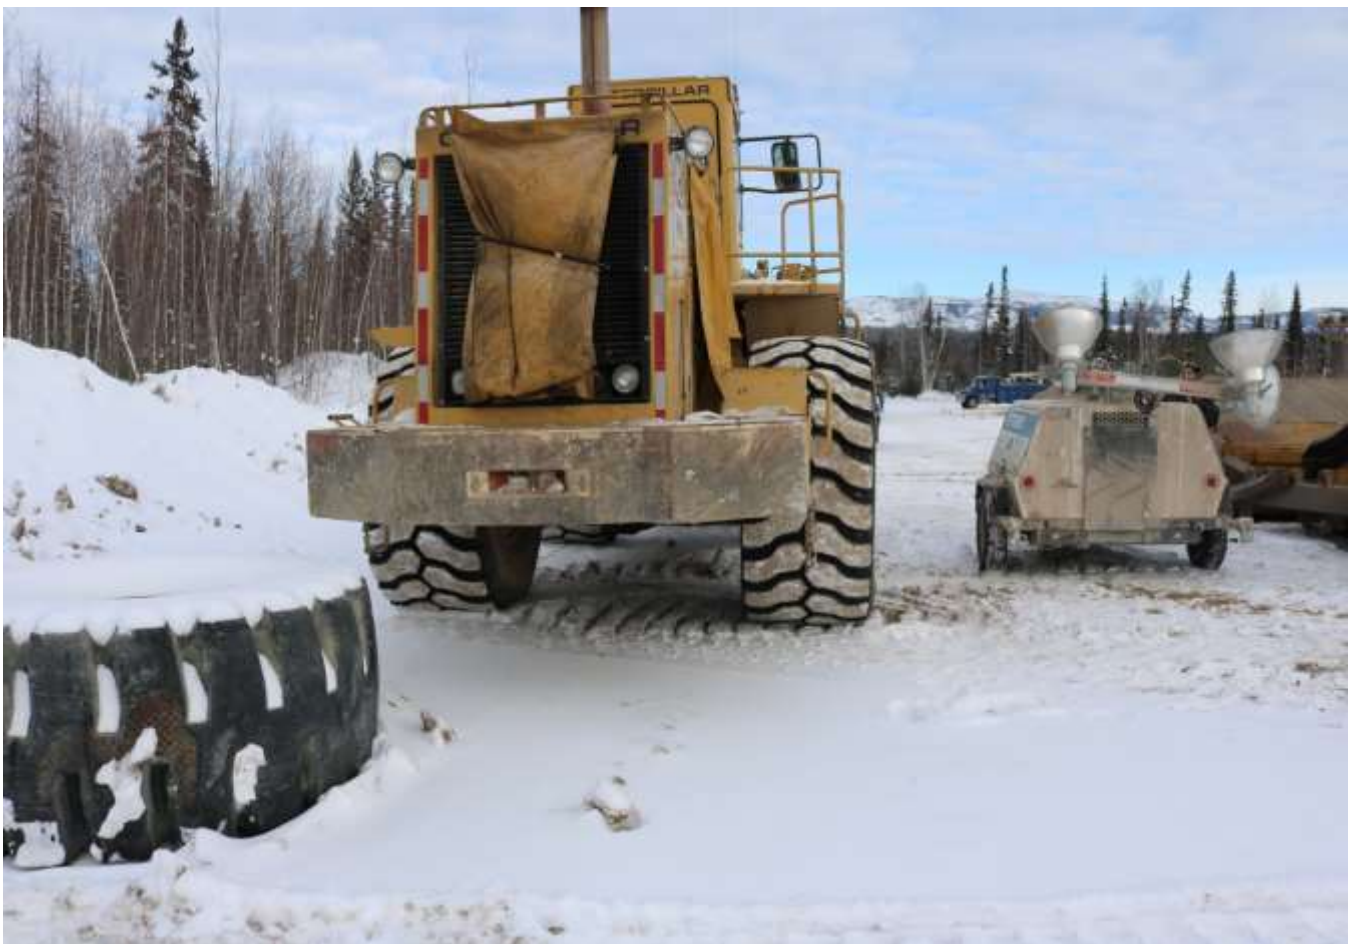
Figure 4

Another loader and light plant missing drip trays.

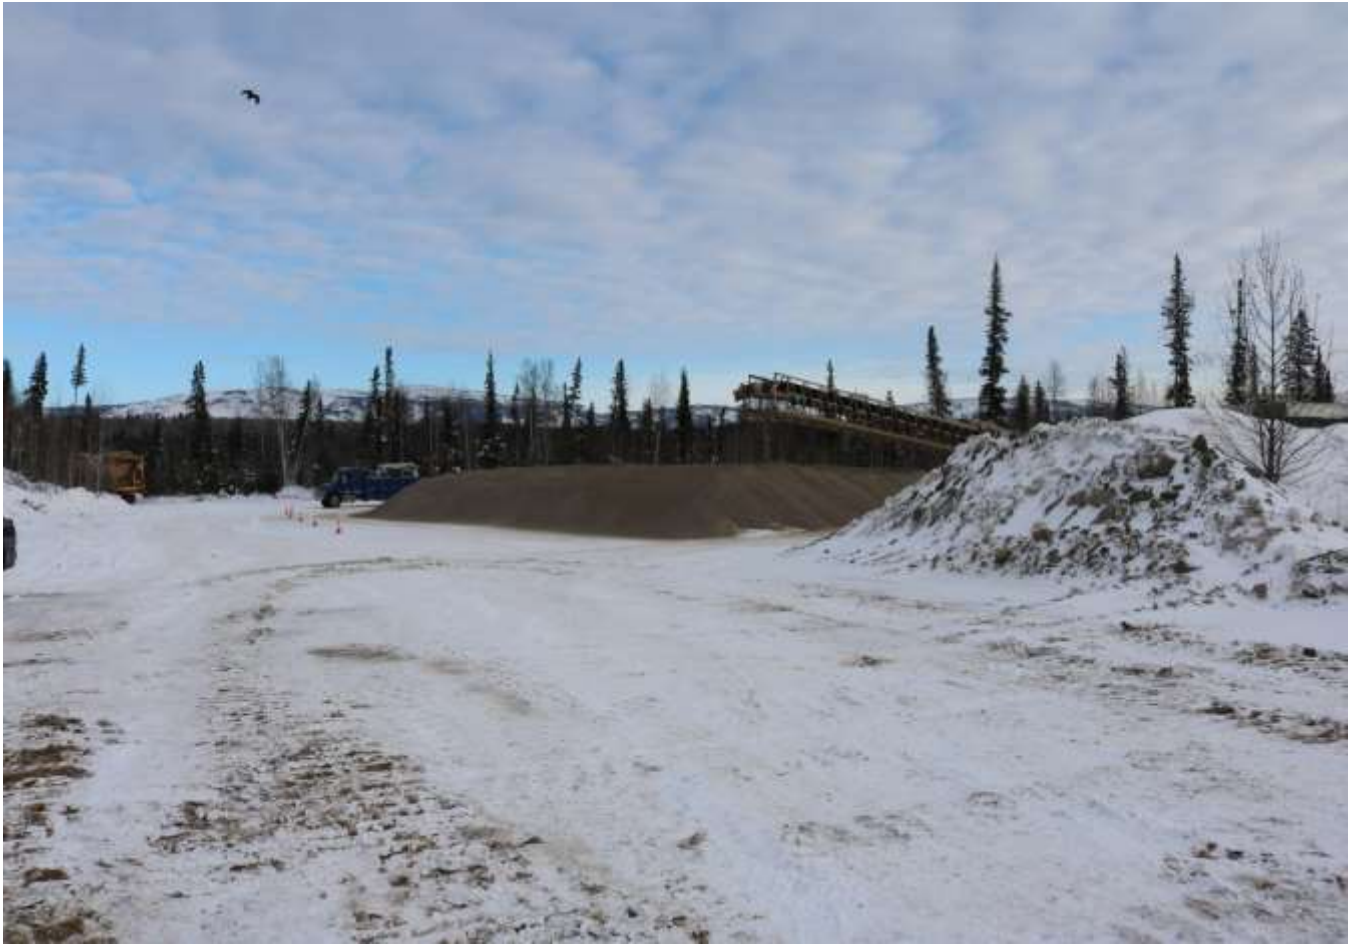
Figure 5

Produced material stockpile with low-bed trailer hauling the crusher away and heavy duty mechanic following in background.

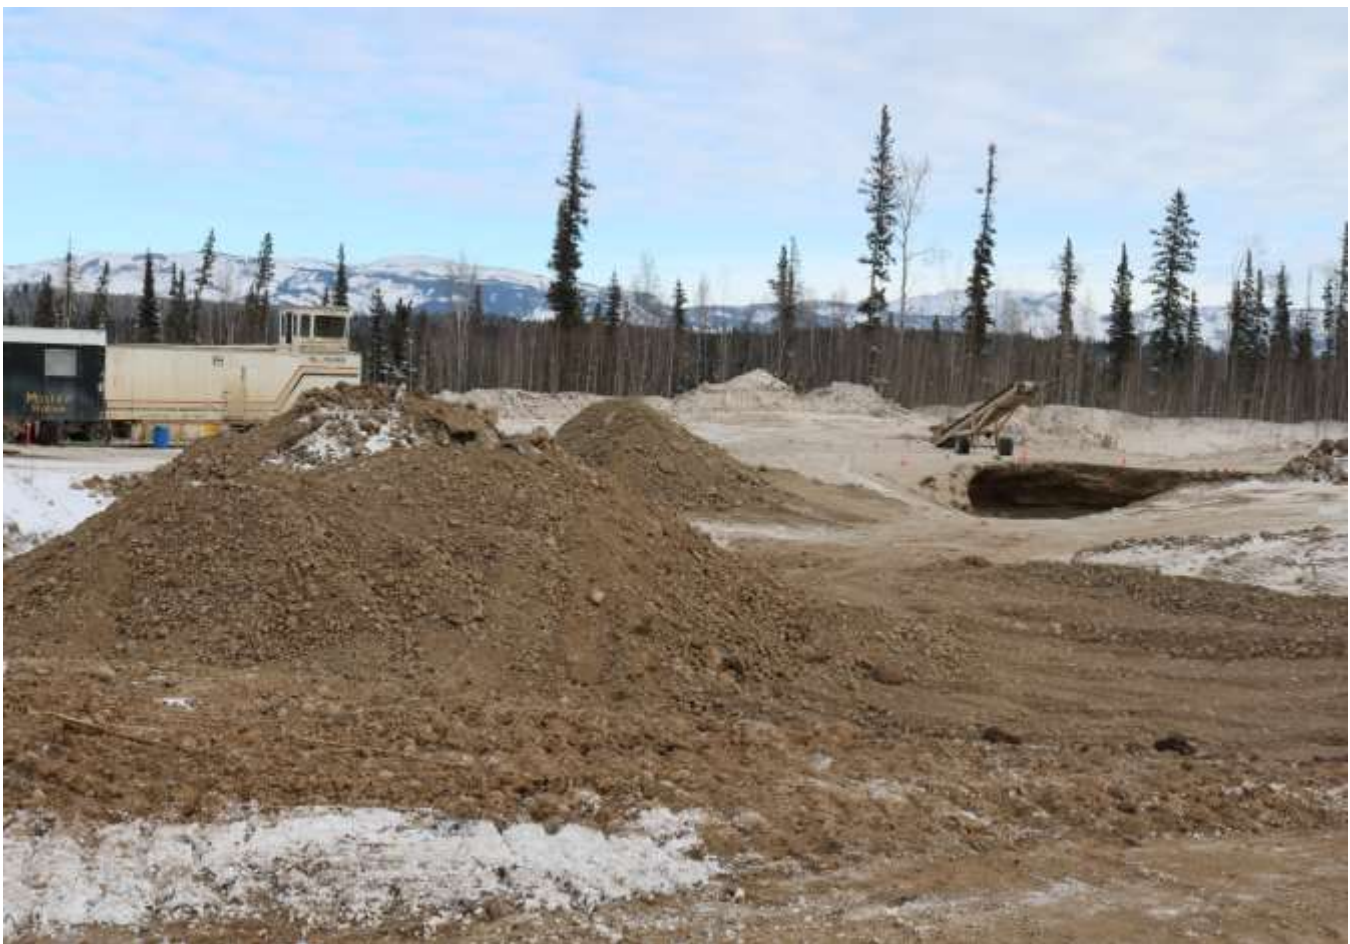
Figure 6

There was three smaller stockpiles situated in front of the entrance to the excavation area with some material piled next to the excavation. The excavation was marked using pylons and was left as is for the shutdown until a different crusher was brought to site.

Smaller non-produced stockpiles near excavation area.

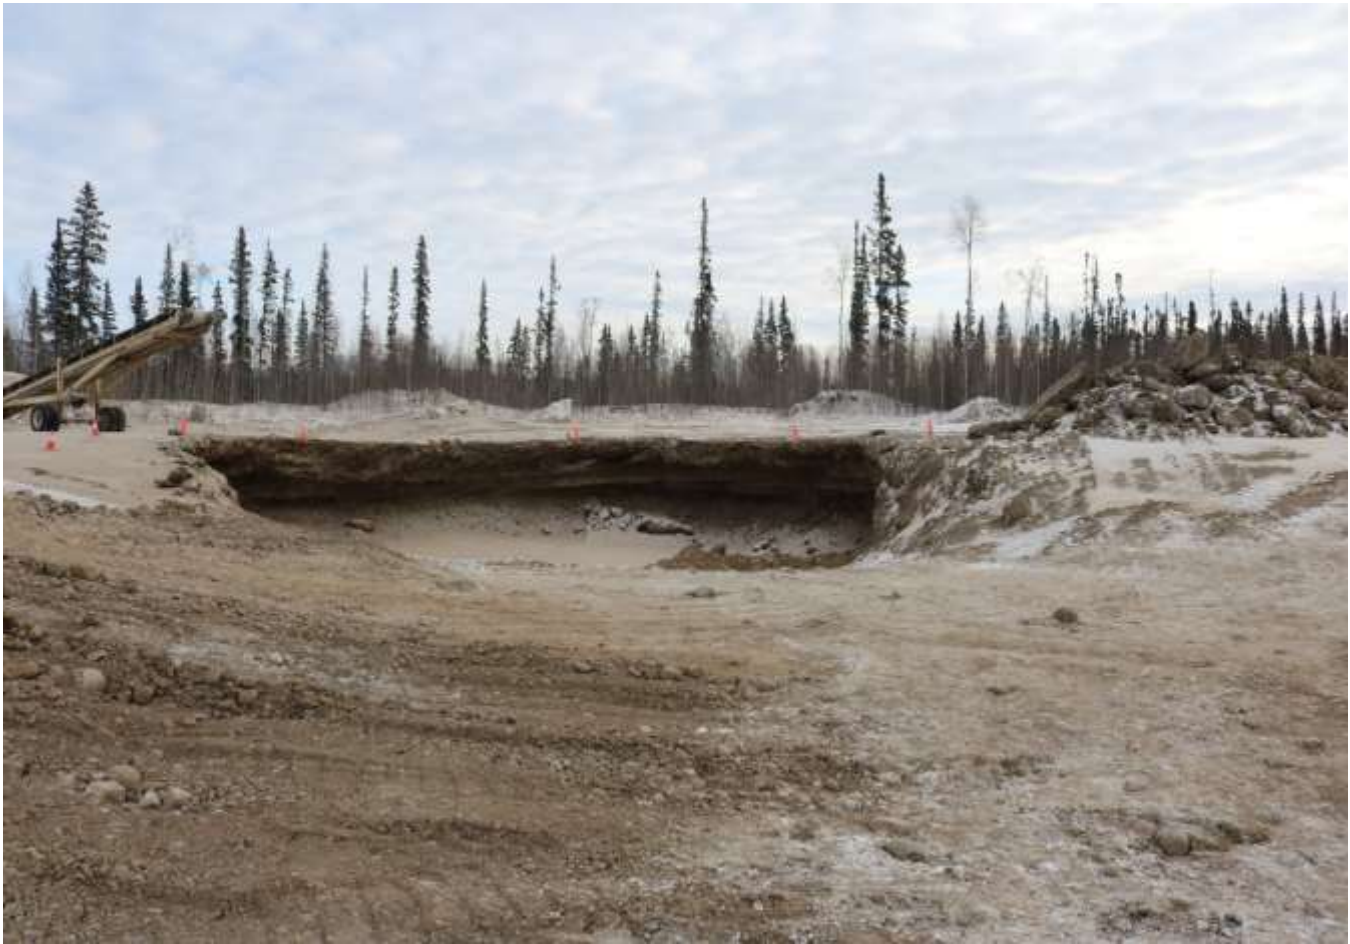
Figure 7

Excavation that was present during the inspection.

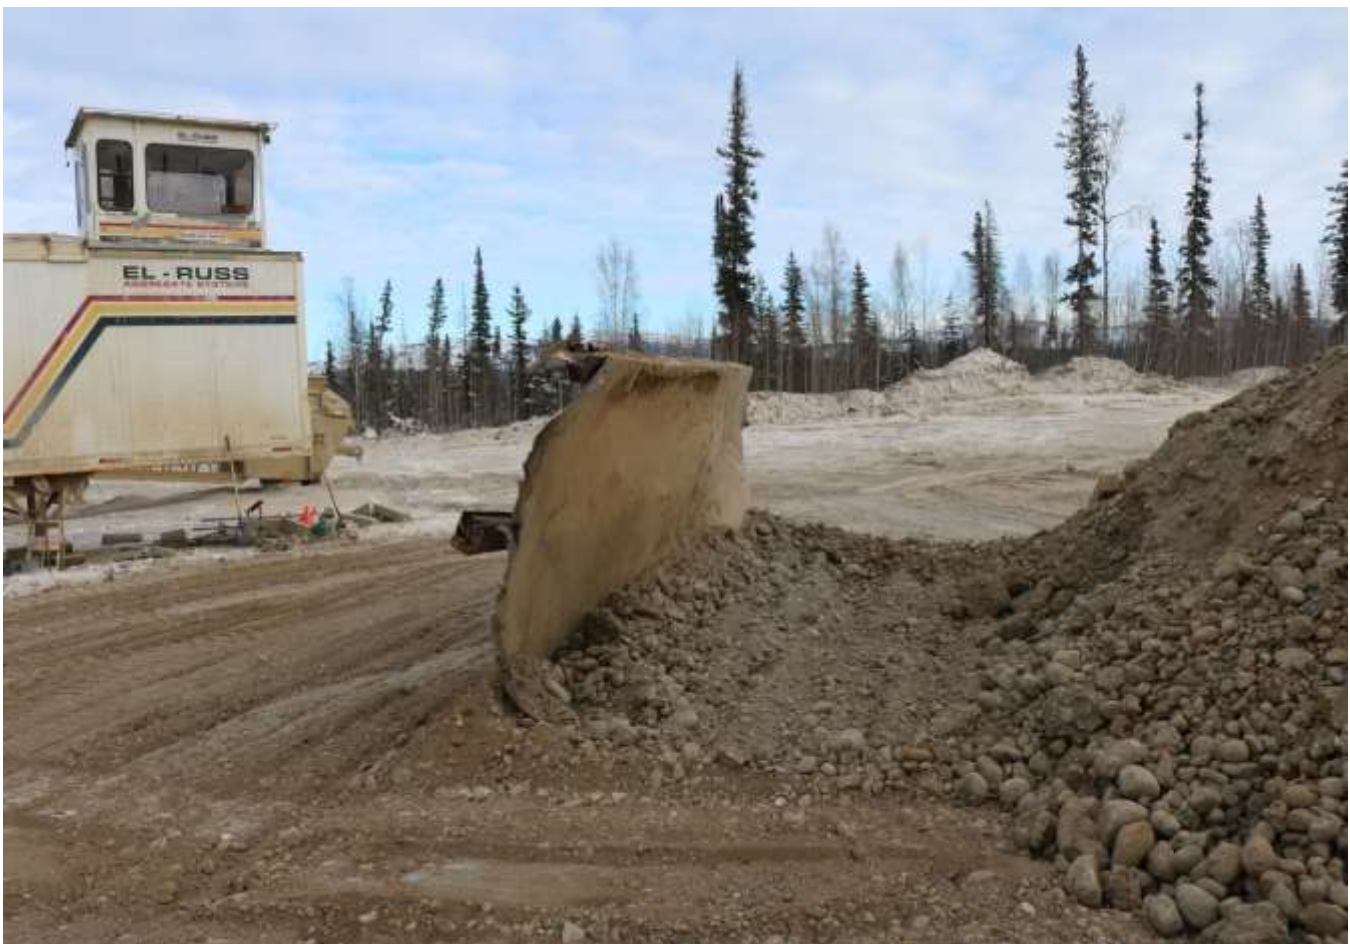
Figure 8

Large piece of scrap metal found on site.

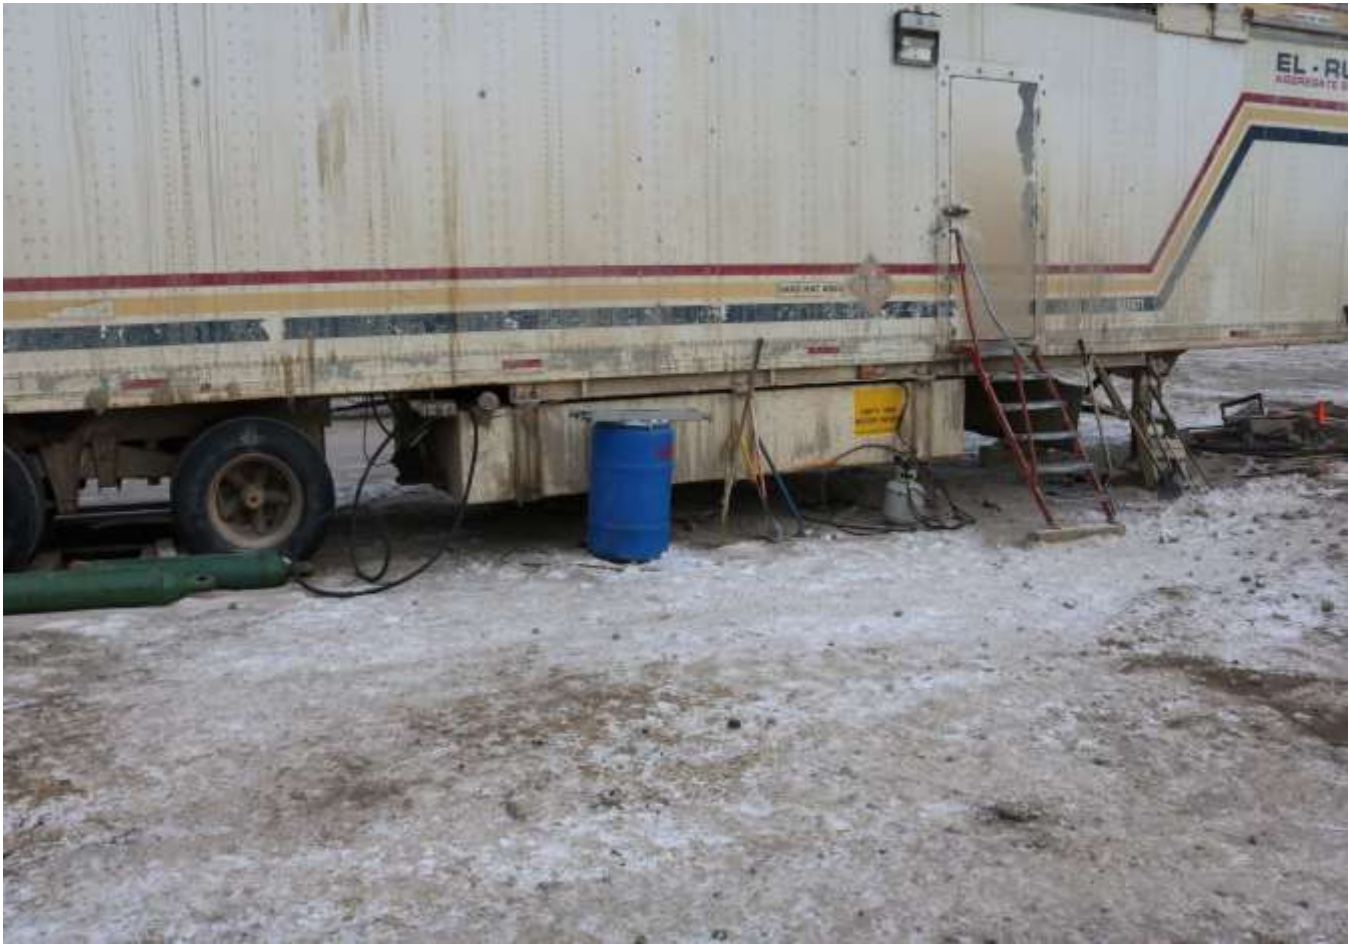
Figure 9

Spill kit and hand tools near control plant trailer.

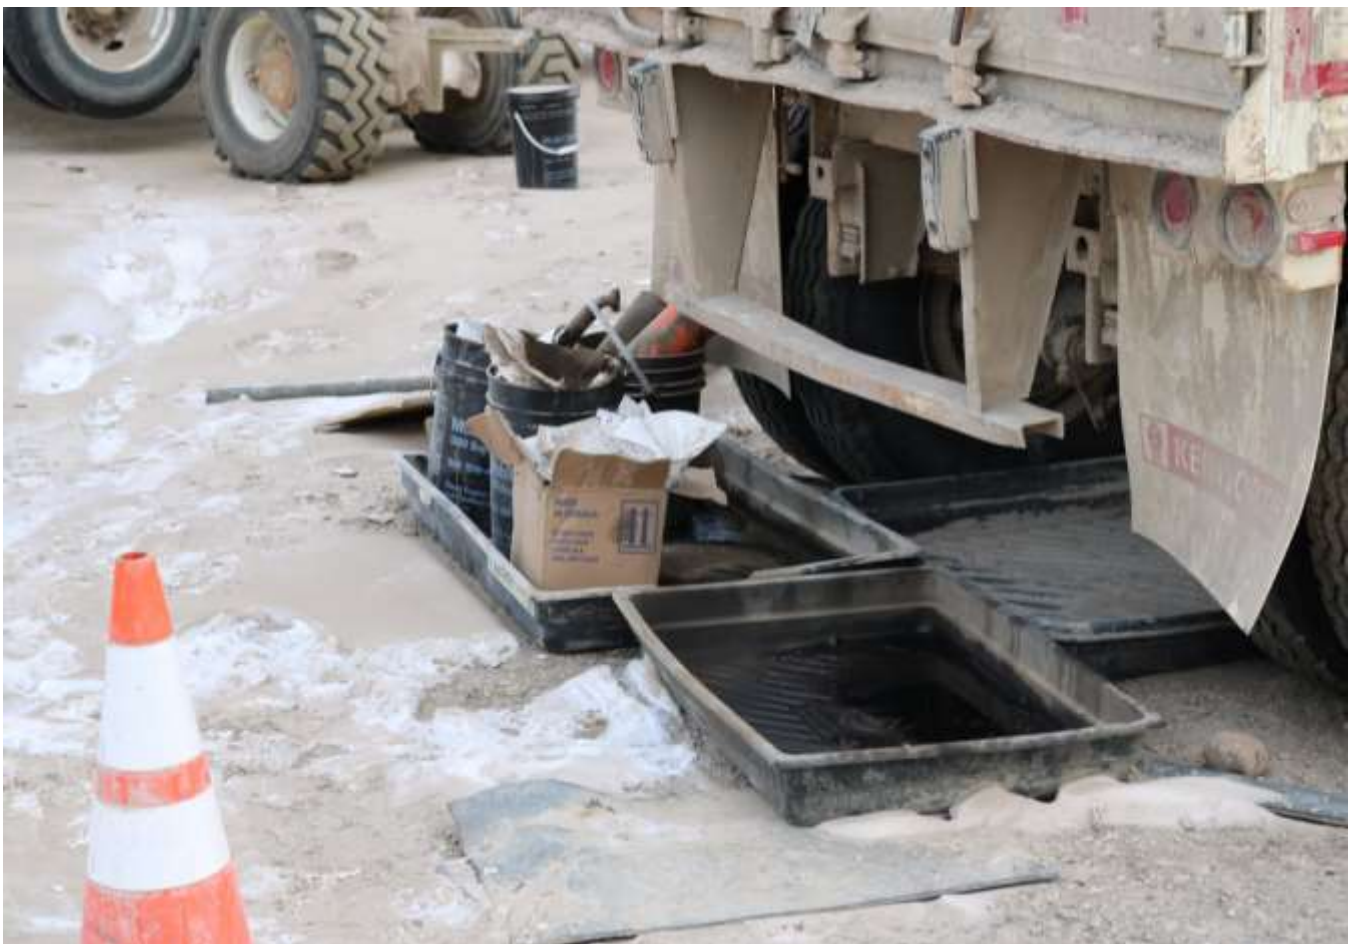
Figure 10

Inspectors found some debris around the crushing plant, most was in smaller piles. A spill kit was located next to the control tower/power plant with some hand tools nearby. Used oil absorbent pads were found in buckets and boxes that were sitting in a drip tray near the generator for the crushing plant. Two conveyors were also on site with one being near the excavation and the other situated next to the produced stockpile.

Old filters and rags being stored within drip tray near generator.
