File Number	MV2016E0006
Type of Operation	HWY MAINTENANCE & OPERATIONS
Location	Non-active Km 436.5 Quarry

An inspection of the above noted operation was conducted on October 26, 2016 by Resource Management Officer II Kyle Christiansen and Manager, Resource Management Jarret Hardisty.

ENVIRONMENTAL INSPECTION REPORT

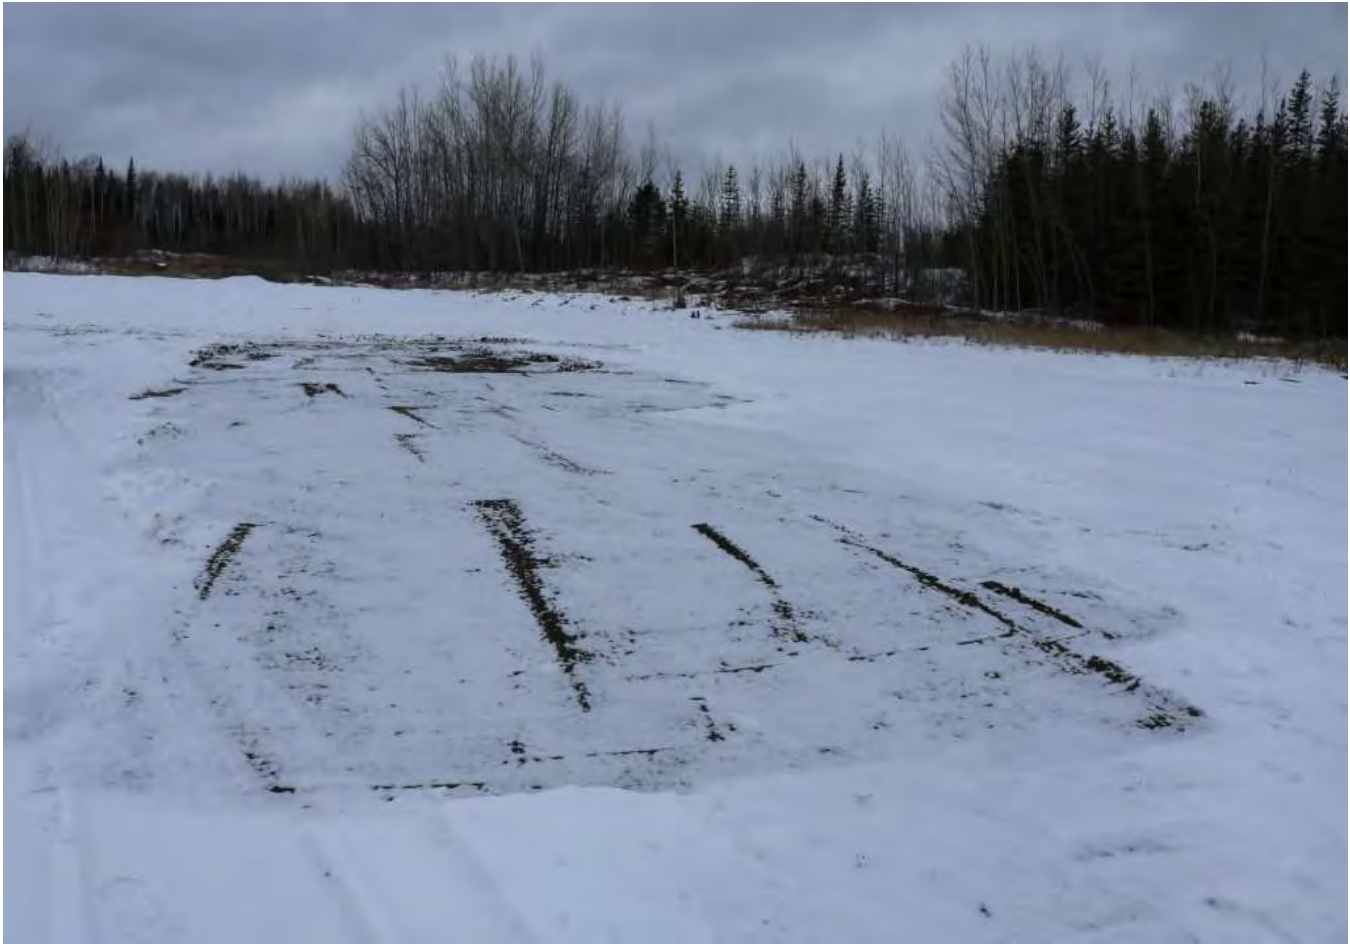
Figure 1

Area near access road where asphalt was cleaned up.

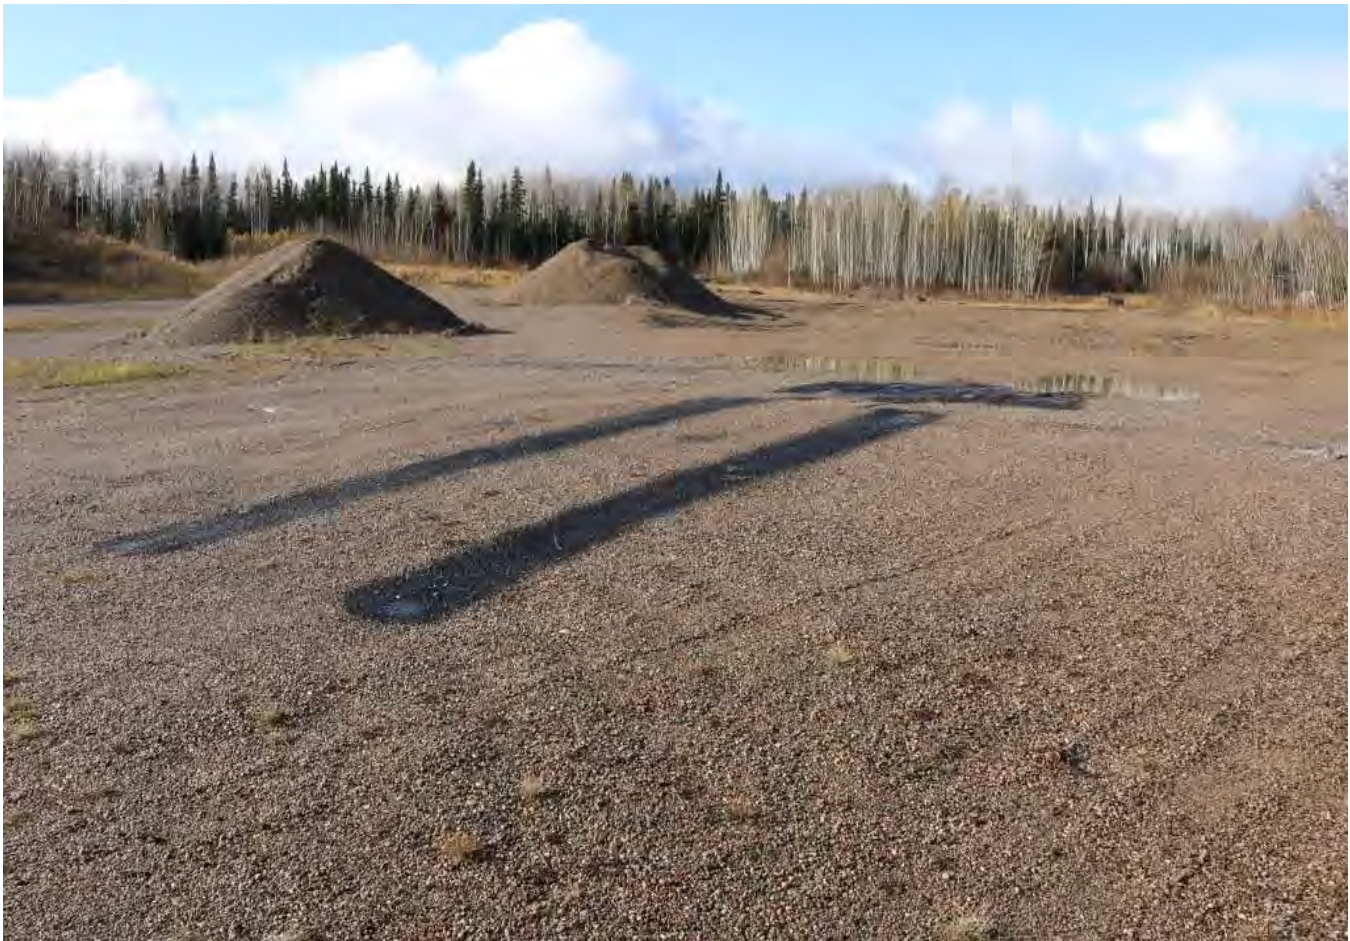
Figure 2

Figure 1 prior to clean up.

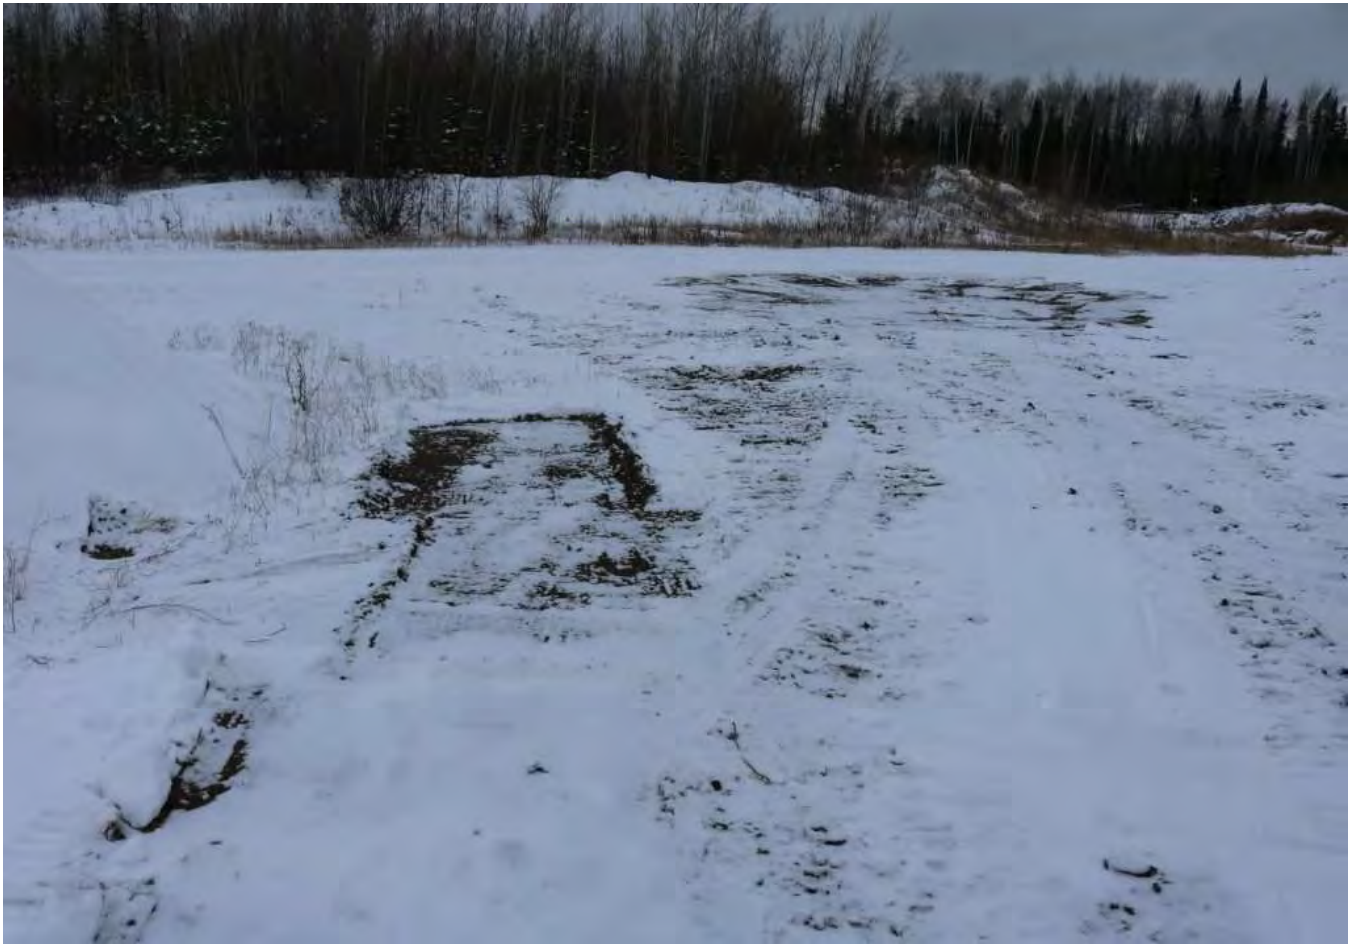
Figure 3

Location where asphalt covered hose was found. Location is now cleaned and hose was removed.

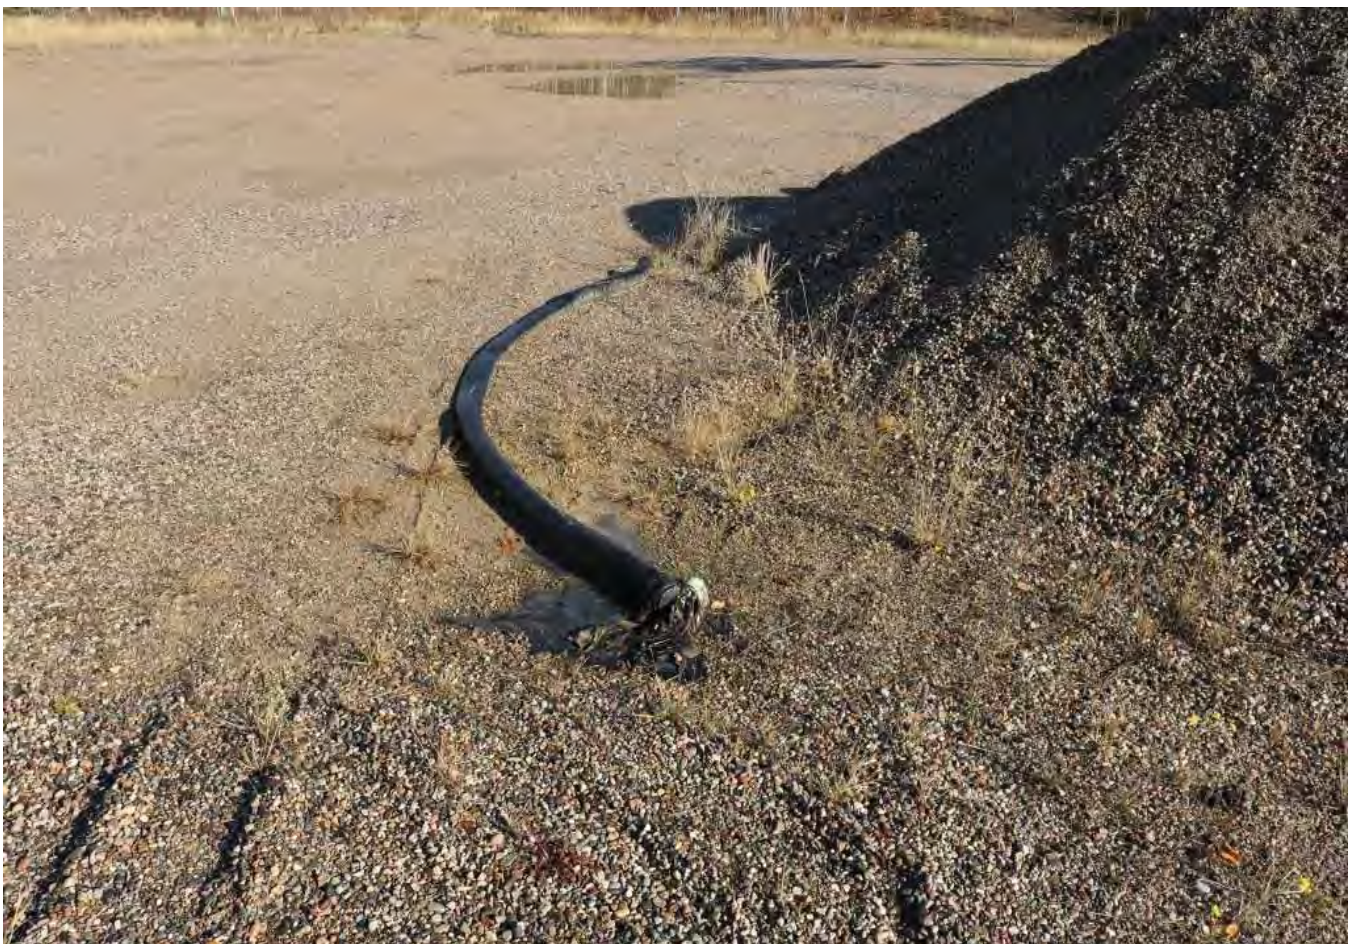
Figure 4

Figure 3 prior to clean up.

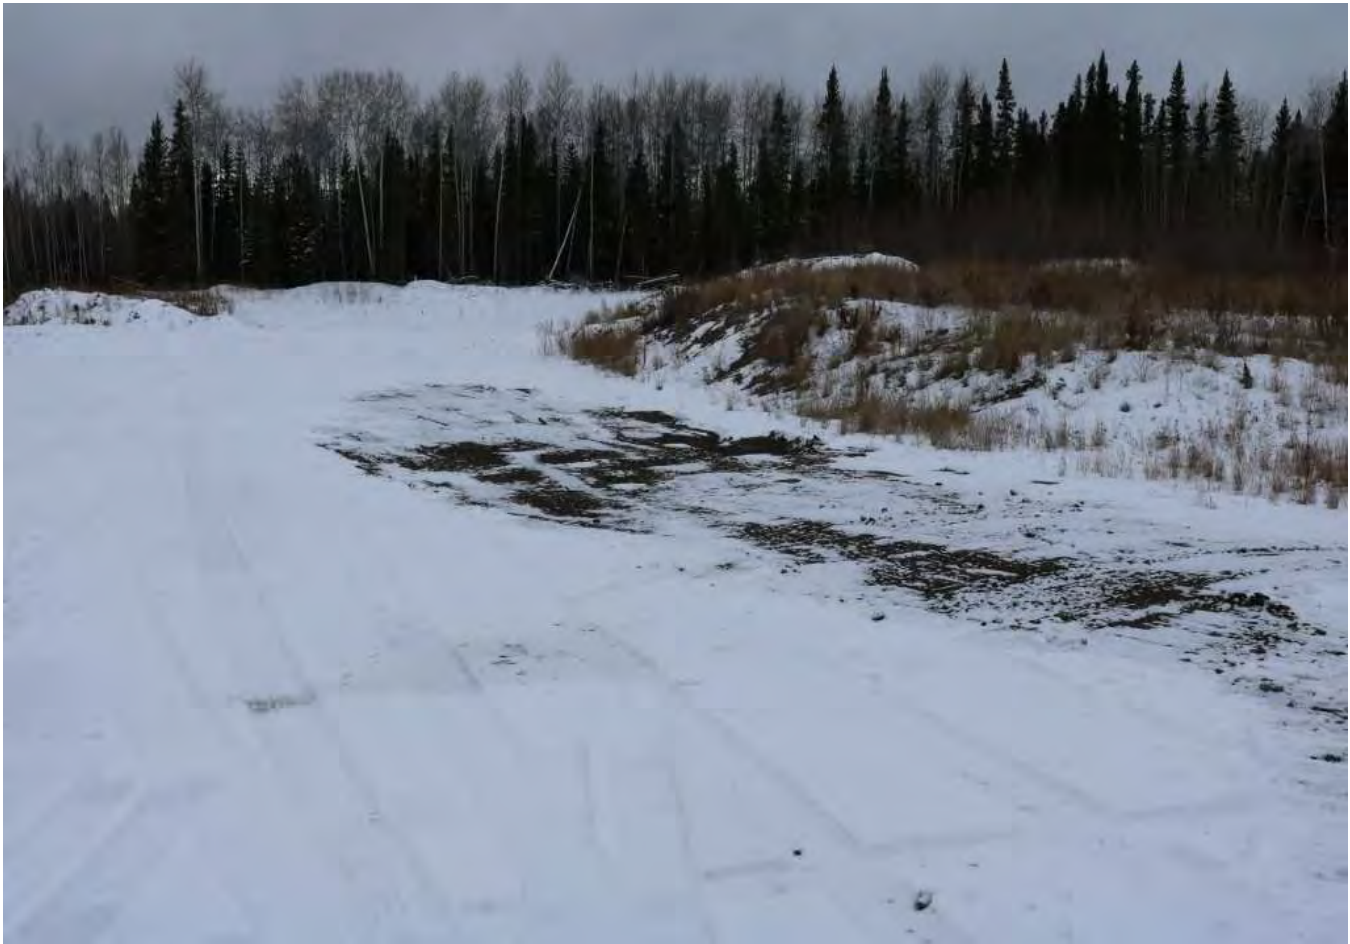
Figure 5

Another location where asphalt was located and now cleaned up.

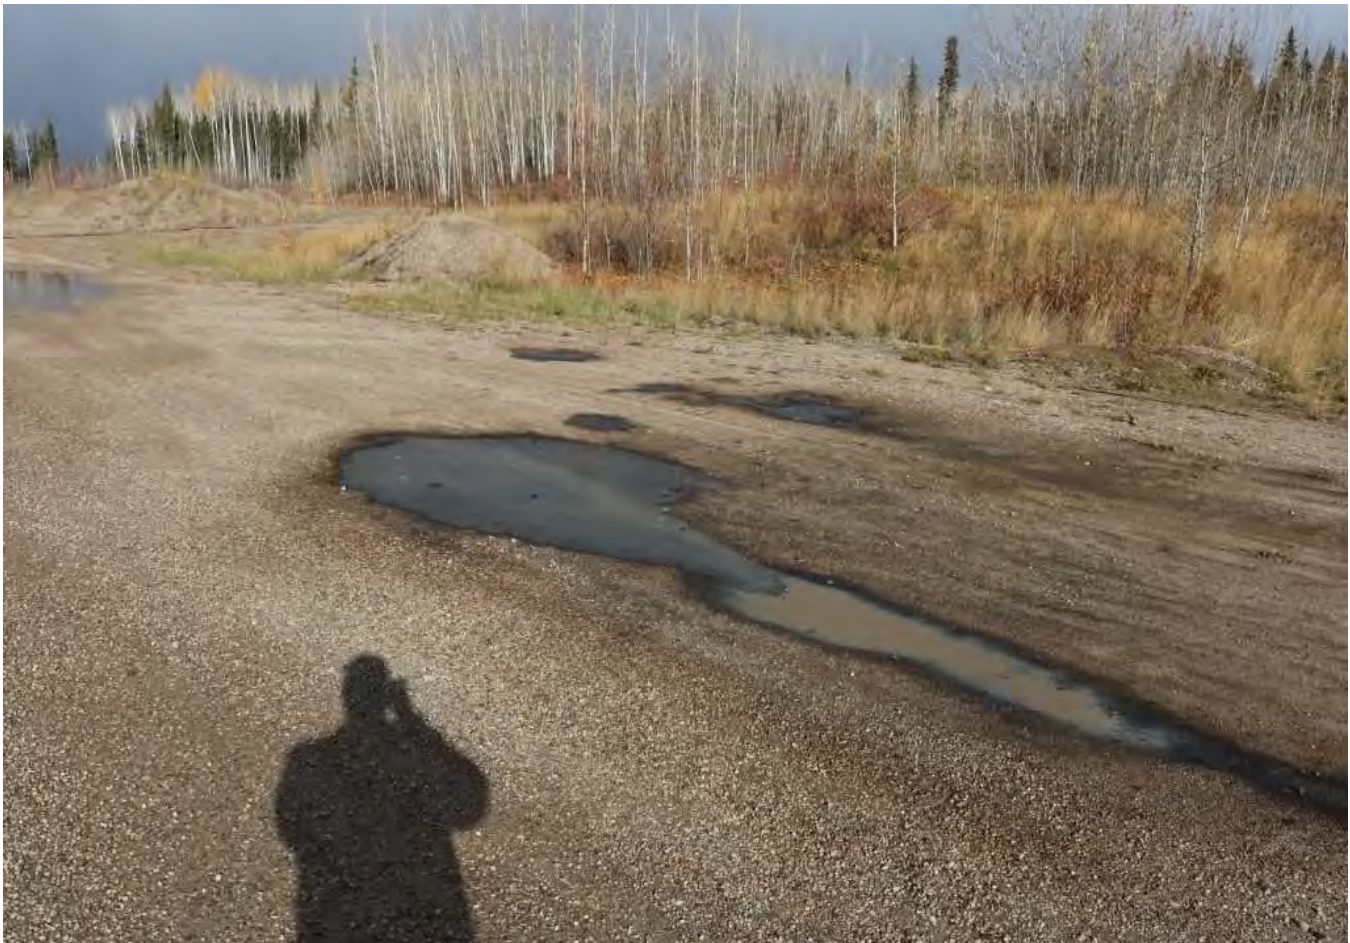
Figure 6

Figure 5 prior to clean up.

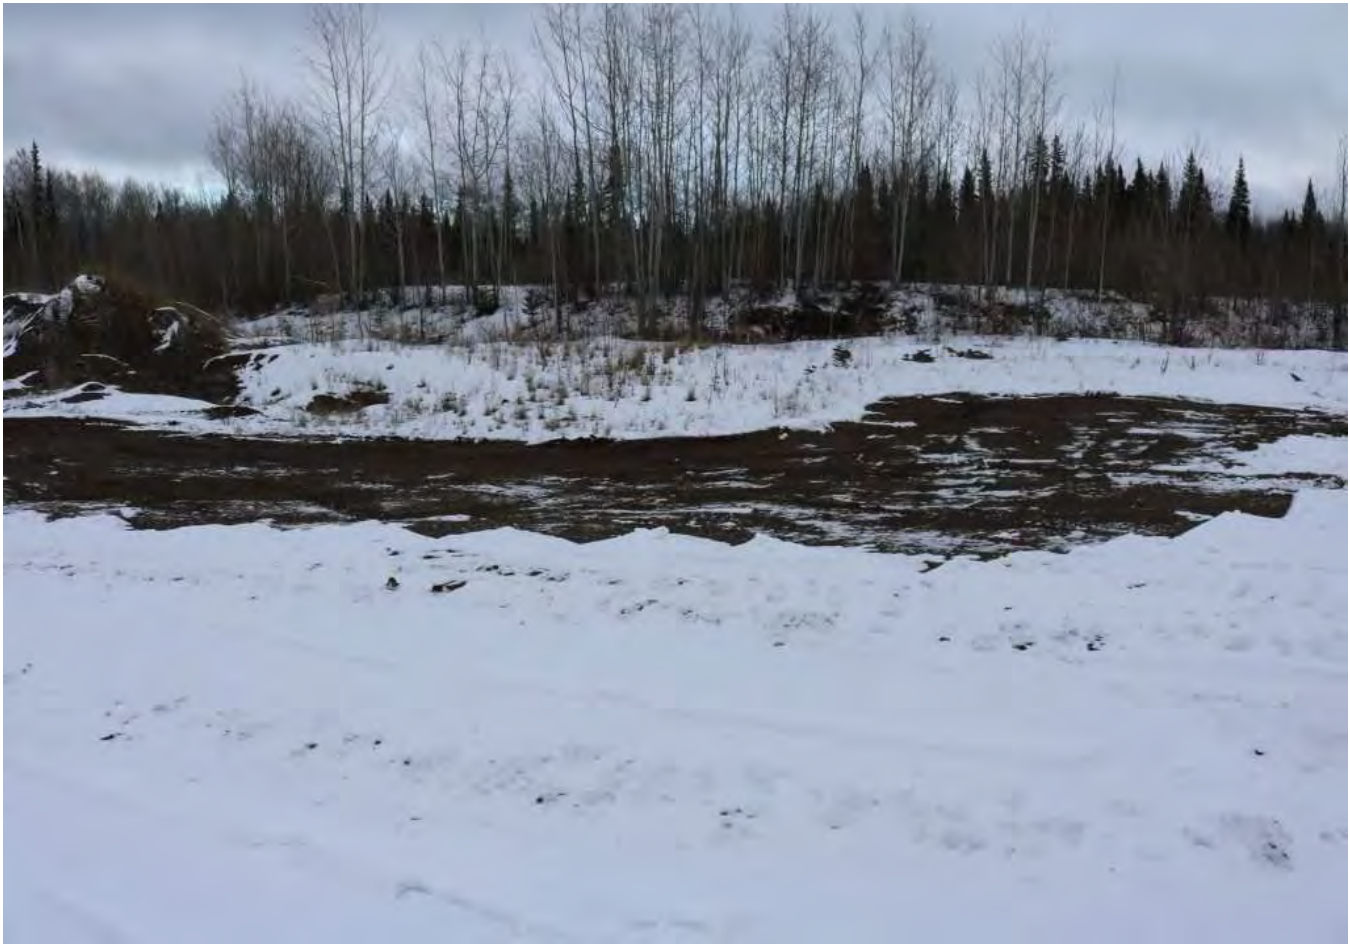
Figure 7

Final location where asphalt was found and is now cleaned up.

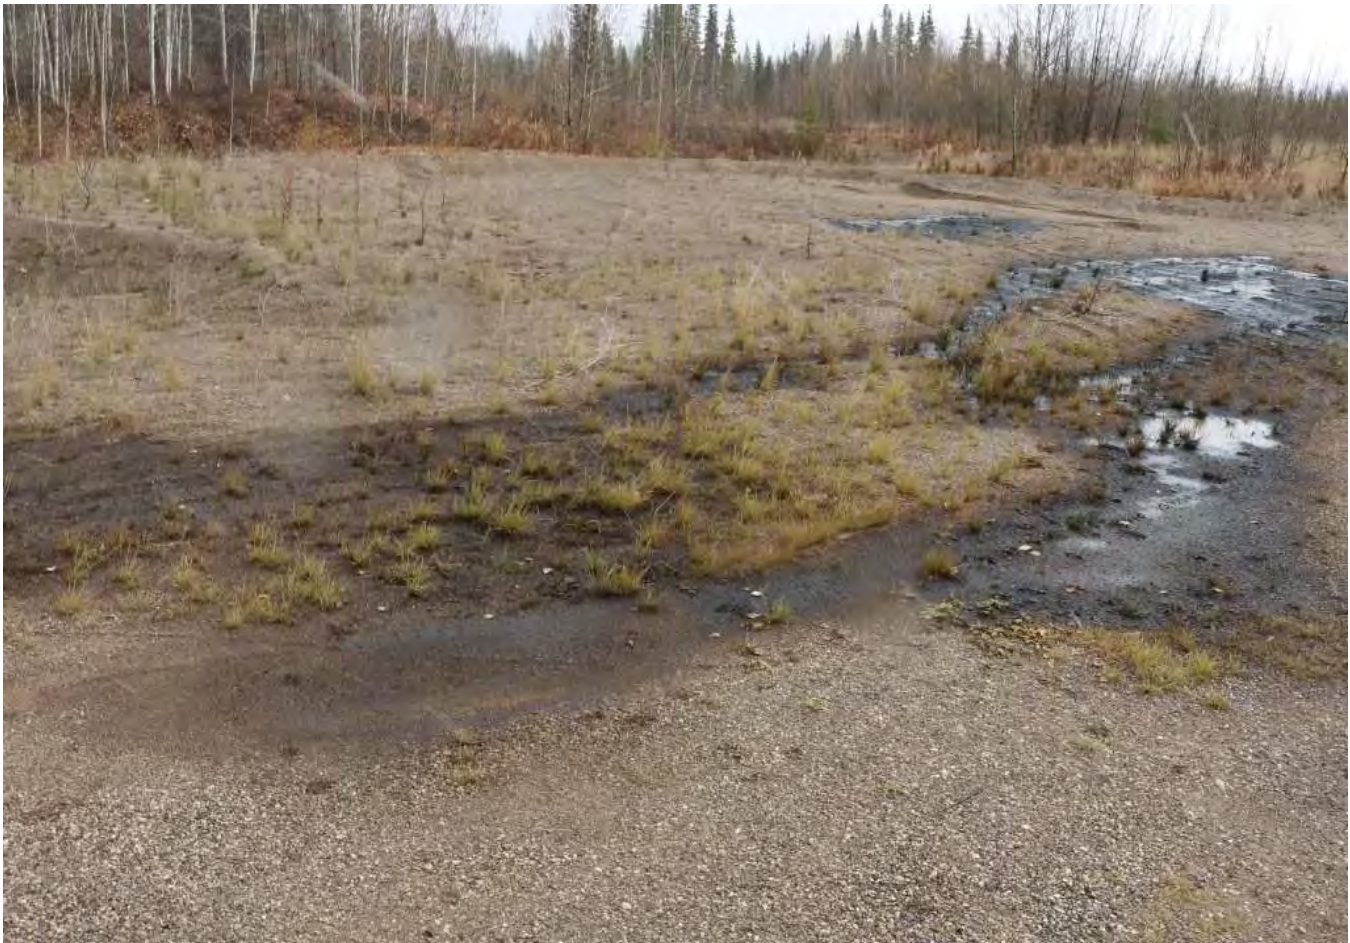
Figure 8

Figure 7 prior to clean up.
