File Number	MV2016E0006
Type of Operation	HWY MAINTENANCE & OPERATIONS
Location	Highway 1 - Non-active Quarry - Km 545

ENVIRONMENTAL INSPECTION REPORT

Permittee:	GNWT - Department of Infrastructure	Permit Expiry Date:	June 08, 2021
Land Use Permit No.	MV2016E0006	Previous Inspection:	May 07, 2019
Quarrying Permit No.	16/12, 16/29, 17/0027, 18/0008, 19/0007 and 19/000	Inspection Date:	May 07, 2019
Contractor:		Subcontractor:	
Location(s) Inspected:	Highway 1 - Non-active Quarry - Km 545		
Current Stage of Operation:	Maintenance		
Program Modifications Approved:	None

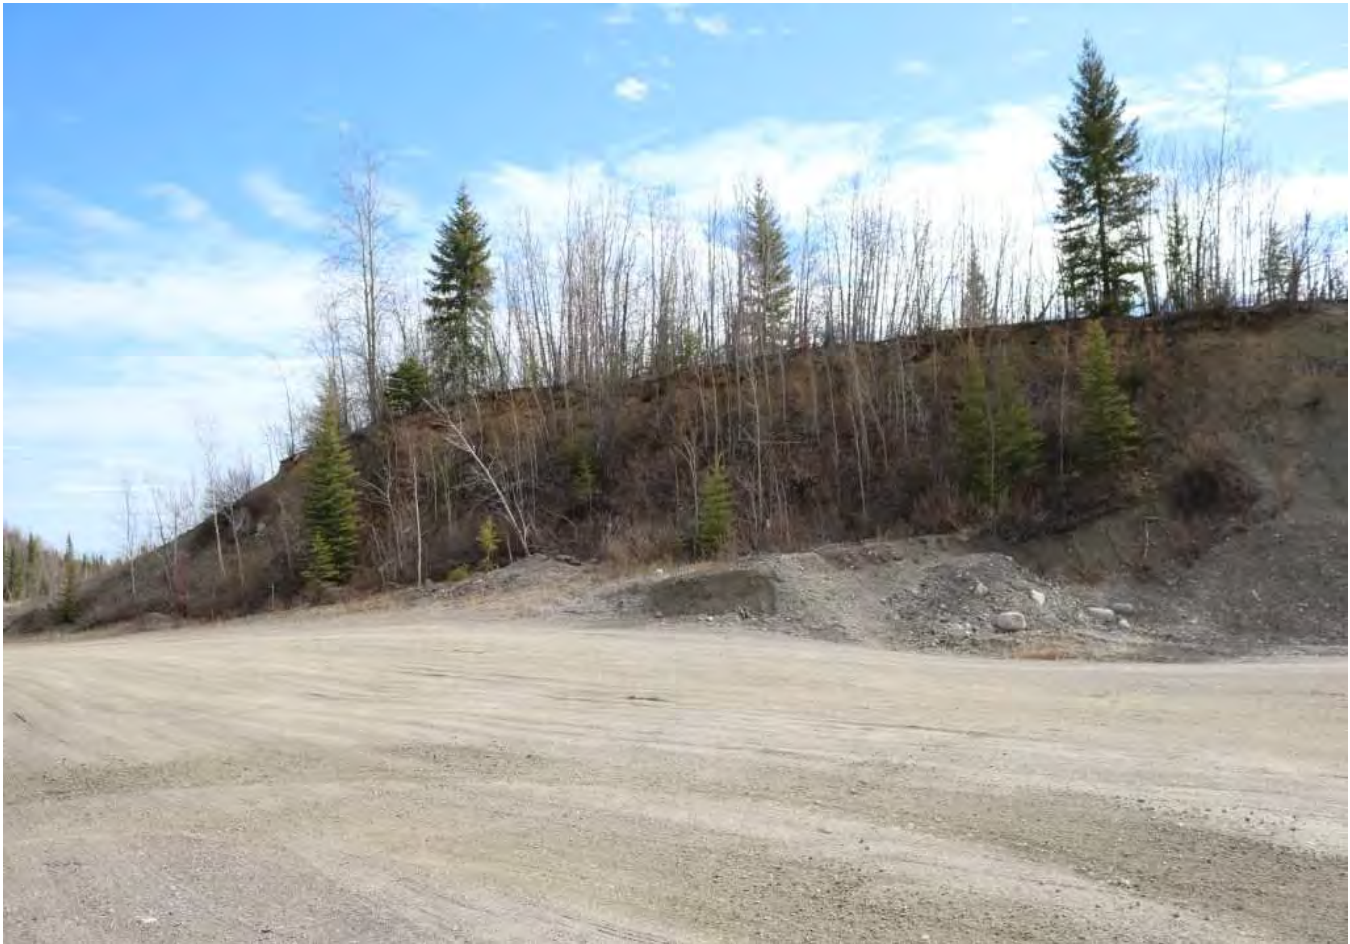
Figure 1

The access road was in good condition. Two small stockpiles were noted within the quarrying area. Water was pooling in the low lying area of the quarry. Water extraction was occurring during the inspection. With an intake hose and water truck leaving the site. A steep slope was noted during the inspection with vegetation established on it.

Steep slope with vegetation established on it.

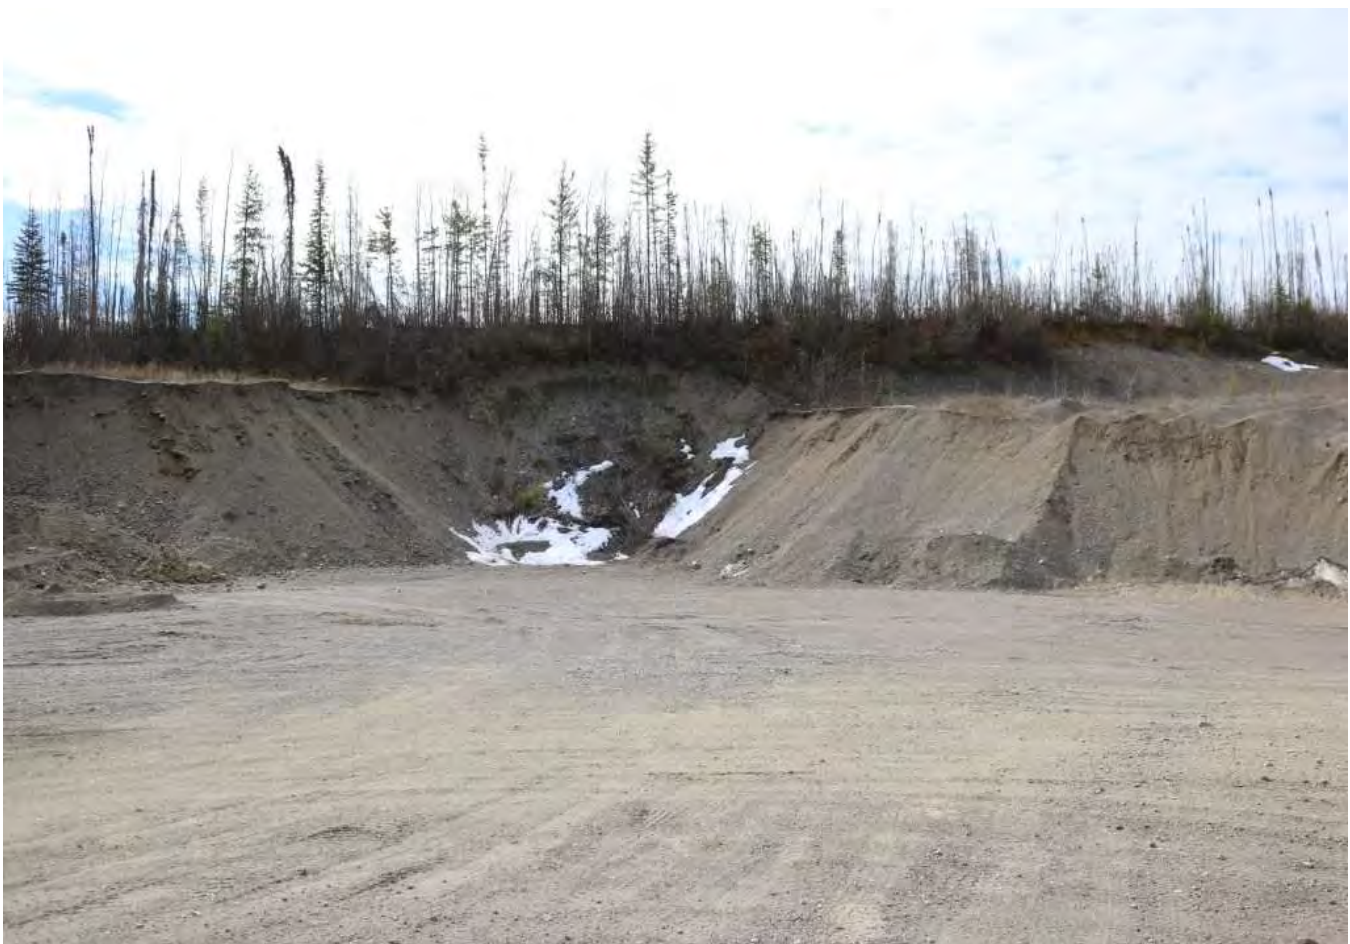
Figure 2

Old active face.

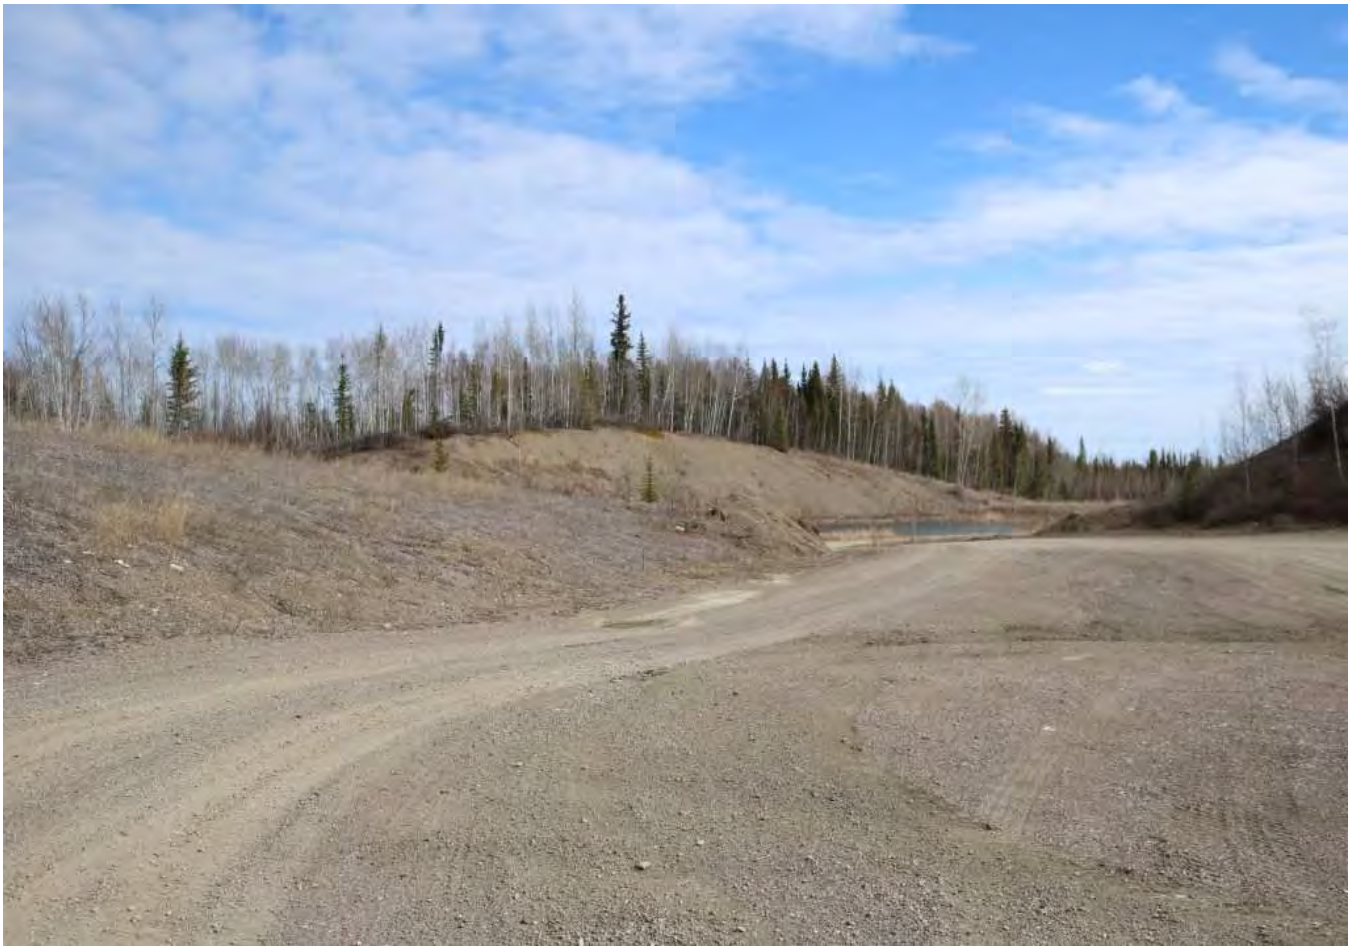
Figure 3
Quarrying area.

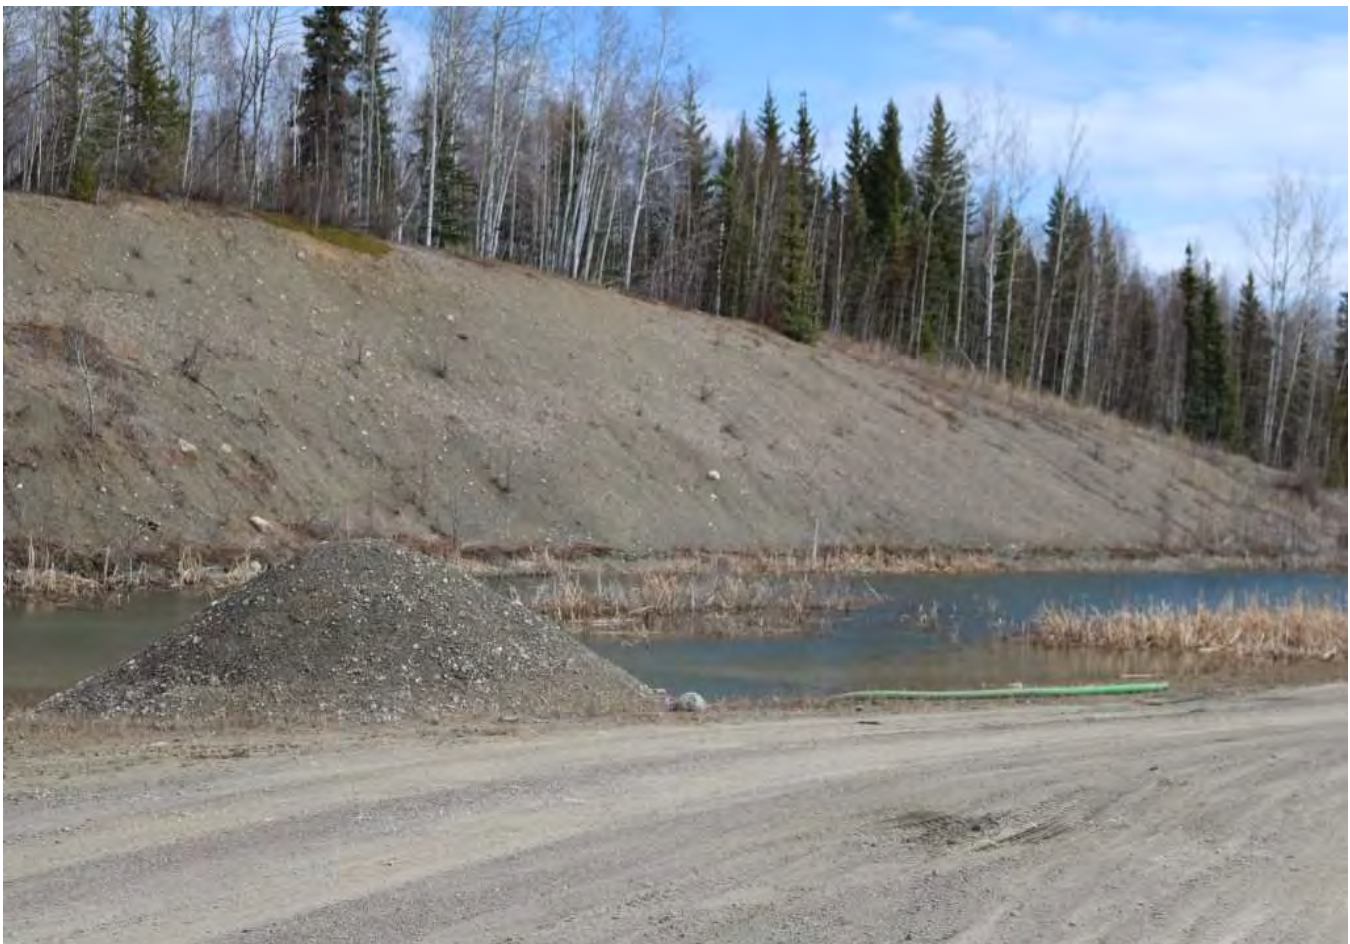
Inspectors spoke with representatives from Infrastructure noting that this location was not identified for water extraction. Inspectors will continue to monitor the location.

Figure 4
Pooling of water with green hose for water extraction.

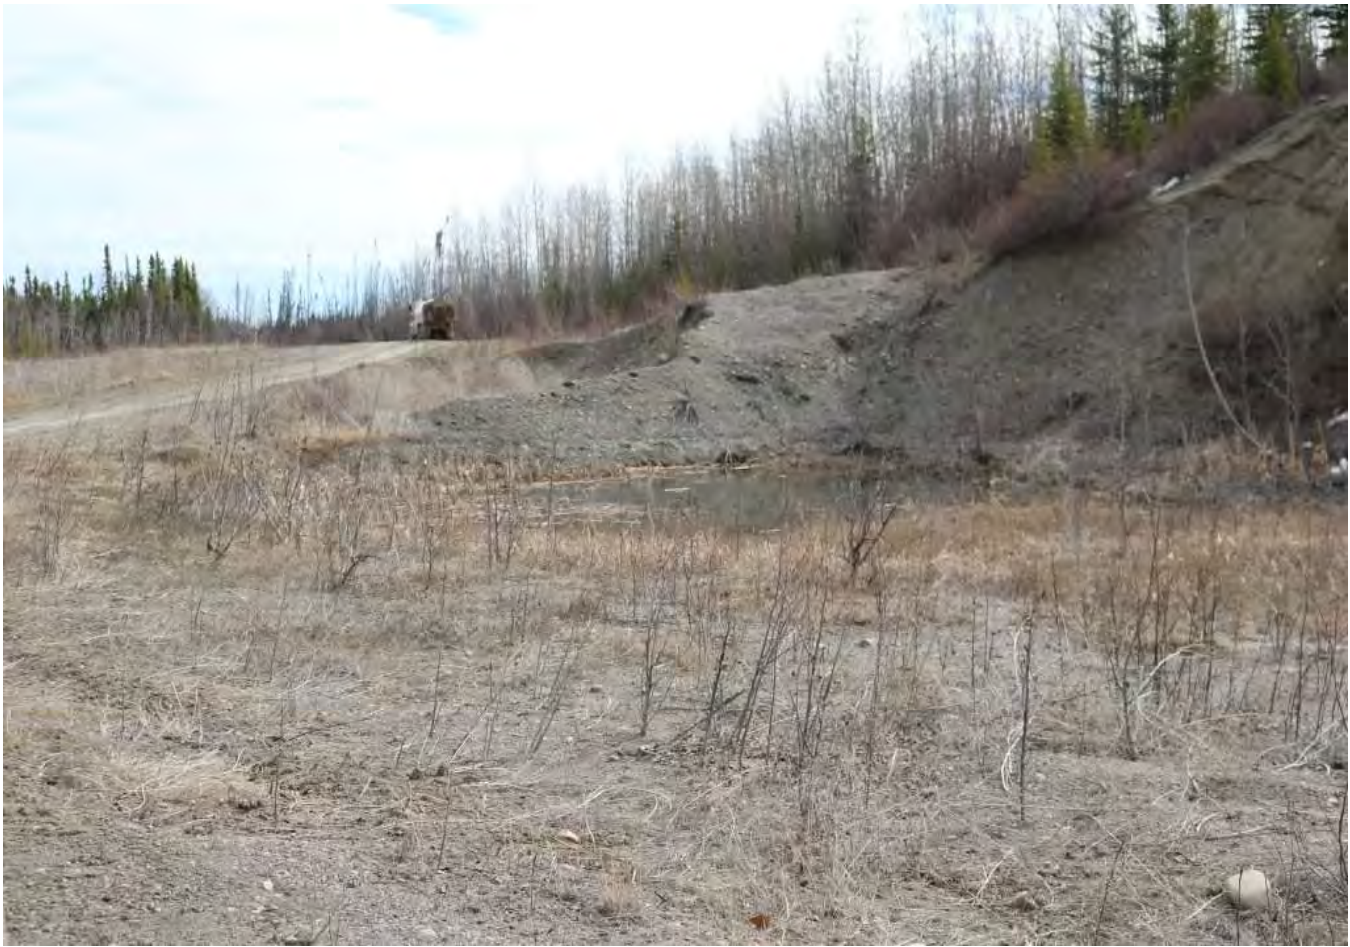
Figure 5

Water truck can be seen in the distance.

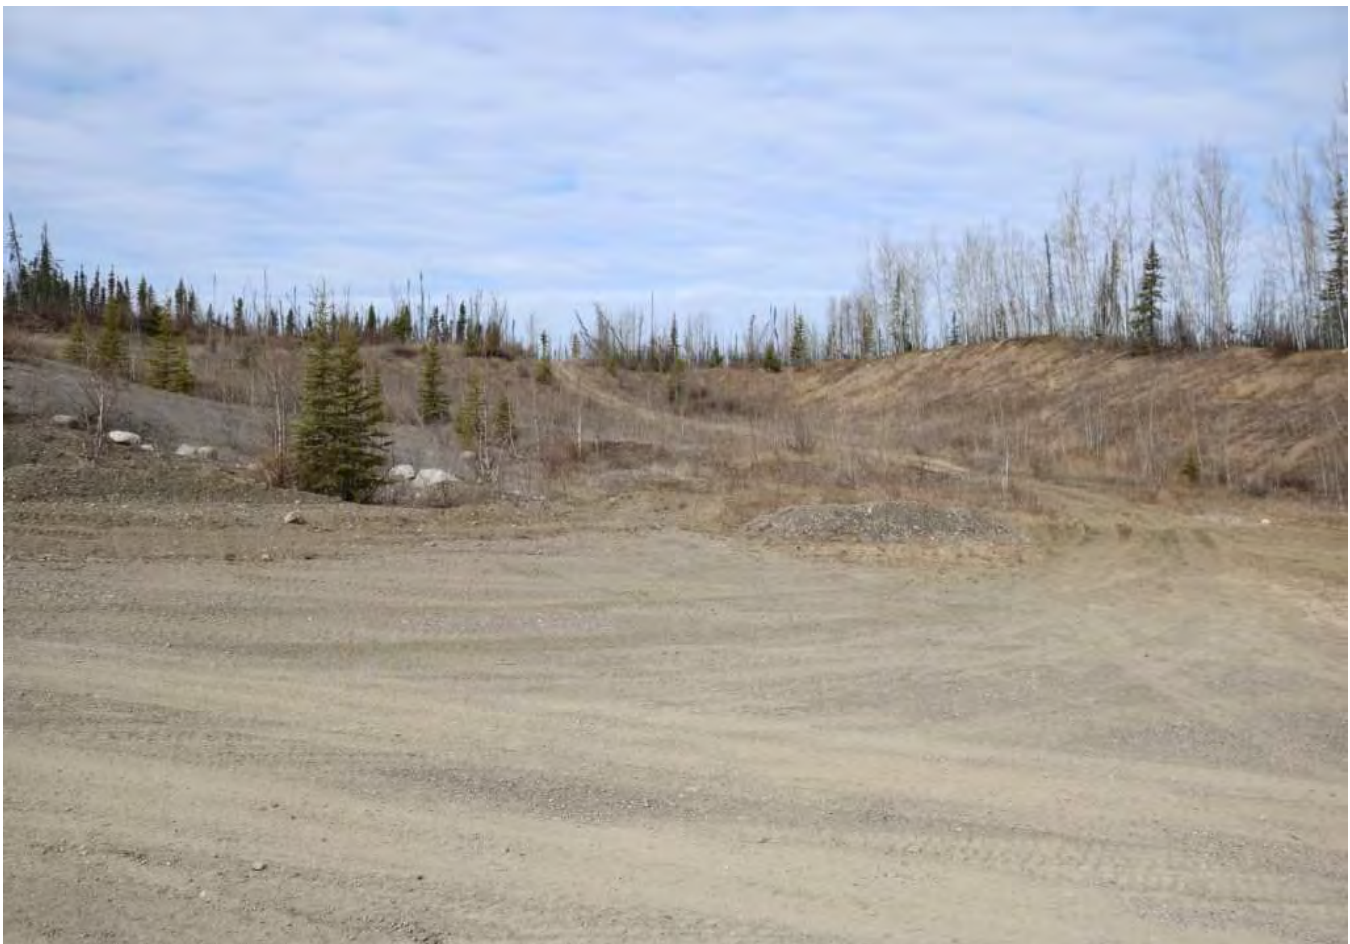
Figure 6

Trail that is found leading into the pit.
